## 7G-TRONIC (722.9) in the Workshop Tips and Tricks

Service Information Brochure

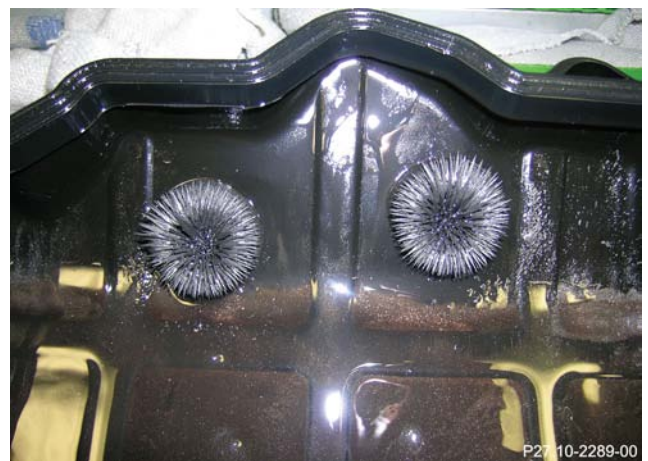
If there is a significant amount of wear debris in the transmission oil pan (see picture), it must be assumed that the torque converter lockup clutch is already seriously damaged.

*Oil pan with significant wear debris*

In this case, it is recommended that the entire transmission including torque converter be replaced because the shavings will have spread out within the transmission. In addition, the oil cooler must be flushed. If an additional oil cooler with thermostat is installed, this must also be replaced because it cannot be flushed (thermostat does not open until temperature of approx. 85 °C is reached).

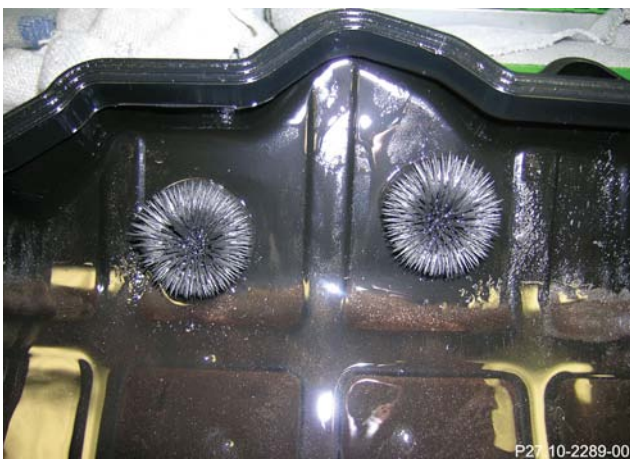
If the above-specified fault codes occur in combination with significant wear debris, there is mechanical damage inside the transmission or torque converter. In this case, the transmission and torque converter must be replaced and the oil cooler must be flushed as per the current documentation. If an additional oil cooler with thermostat is installed, this must also be replaced because it cannot be flushed (thermostat does not open until temperature of approx. 85 °C is reached).

*Oil pan with significant wear debris*

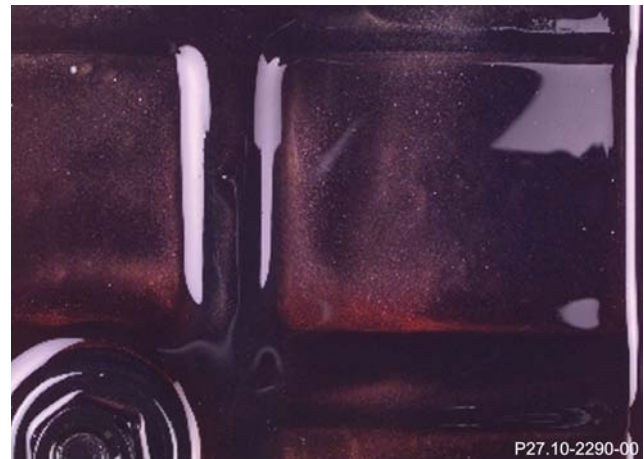
A pattern of wear debris in the oil pan which corresponds to the picture "Oil pan with normal wear debris" does not justify replacement of the transmission because this is normal wear debris which collects in the oil pan during operation.

*Oil pan with normal wear debris*

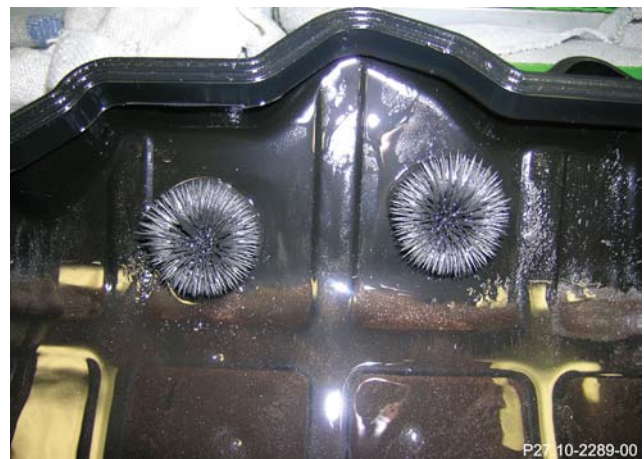
If the problem cannot be eliminated by adapting the torque converter lockup clutch, the transmission oil pan must be checked for wear debris. If the wear debris pattern corresponds to the pattern in the picture but no fault codes are stored, the torque converter must be replaced and a transmission oil change must be performed.

*Oil pan with significant wear debris*

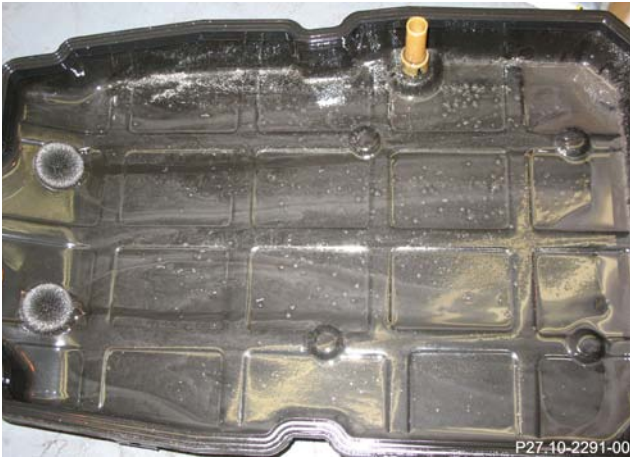
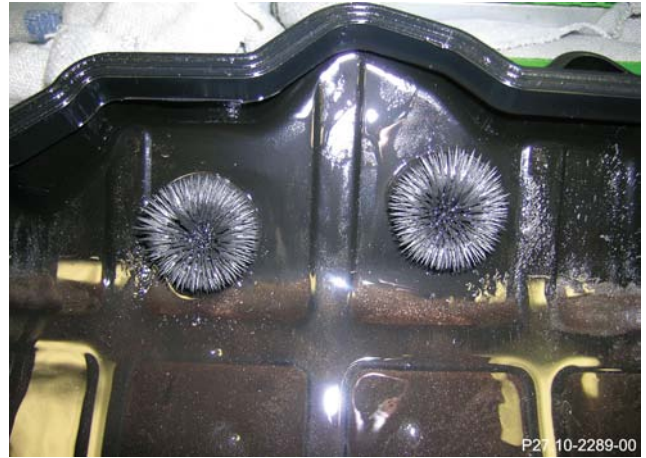
These pictures show examples of transmissions which are obviously mechanically damaged.

Transmissions with obvious mechanical damage

We currently recommend replacing the transmission if the following damage is present:

- Oil pump has seized in housing
- Rear planetary gear set is defective
- Torque converter lockup clutch is worn (very large amount of shavings in transmission oil pan without any visible transmission defects)

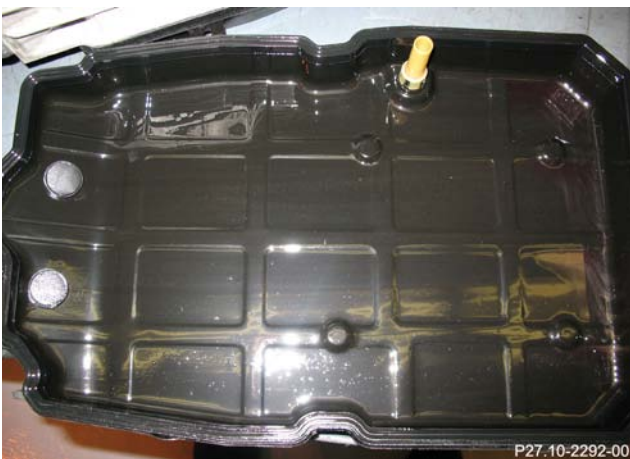
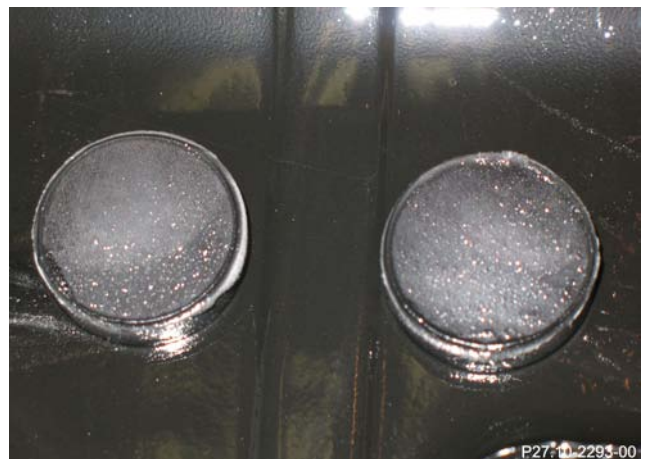
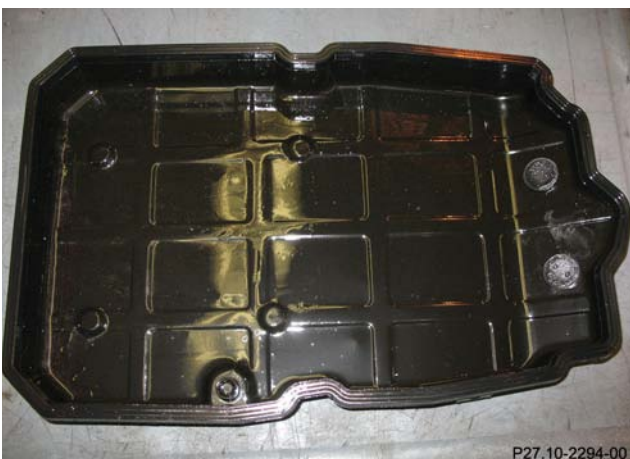
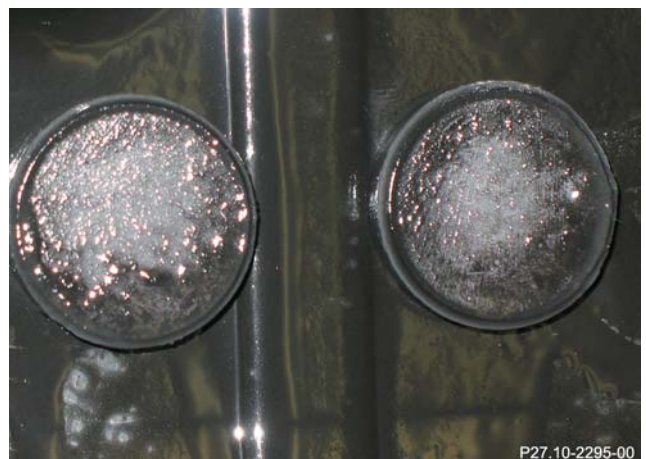
These pictures show examples of transmissions where it is not possible to conclude that the transmission is damaged based on the pictures.

Mechanical damage not visible based on pictures
