Document title Evaluation of elastomer bearings

Document number ah0010p000101a

MODEL ALL

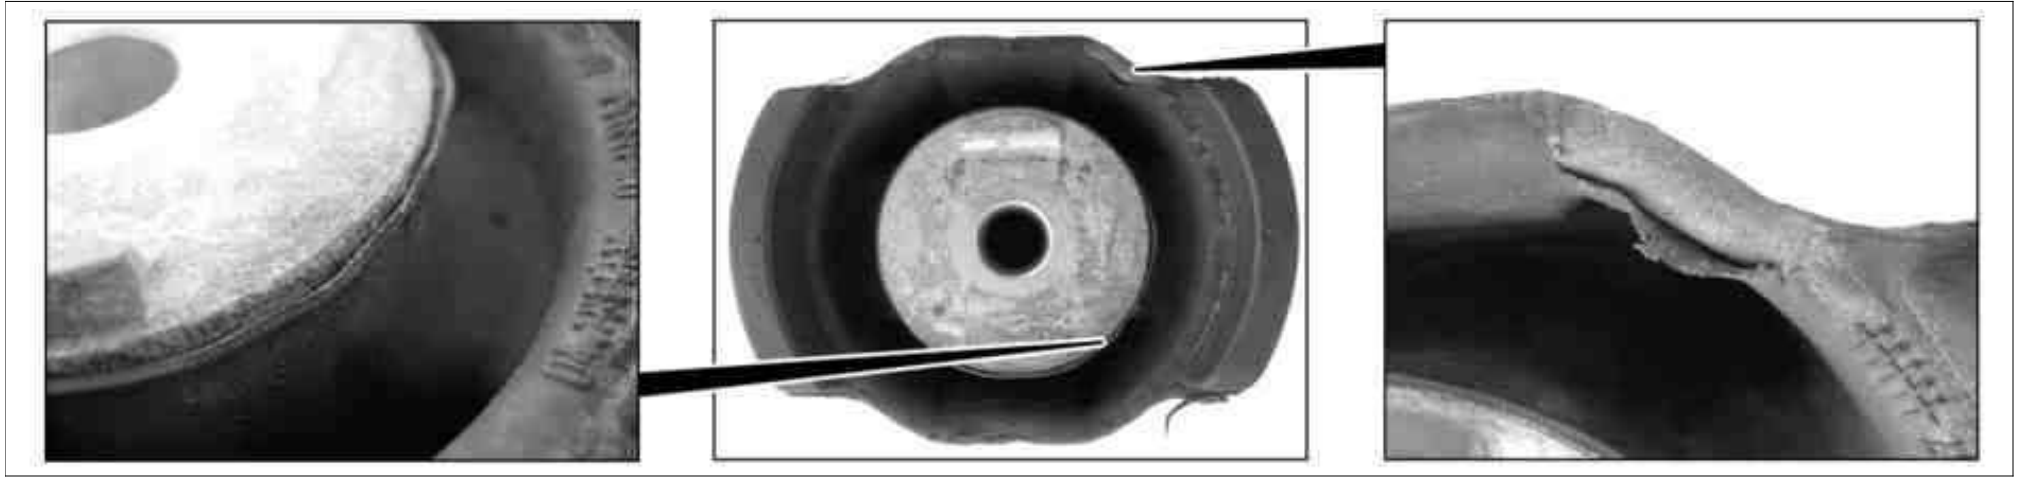
P35.10-2459-07

**Topic: Sub-surface corrosion/flaking of the elastomer due to corrosion, on example BR169/245 rear axle center bearing
Component OK**

Peeling/flaking of the elastomer on the core or on the outer bushing is acceptable up to approx. 30 %.
This does not impede function in any way and should not be considered defective.

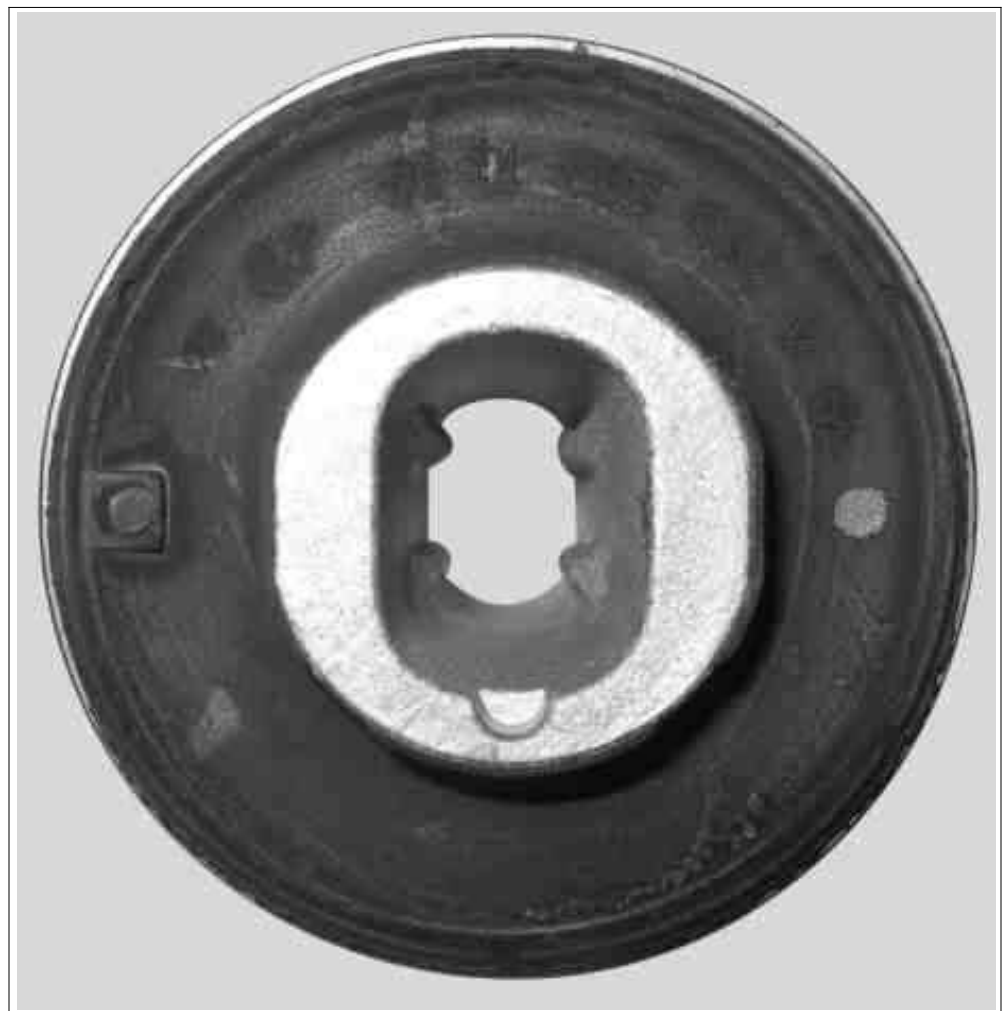
P35.10-2460-12

**Topic: Front axle hydromount
When new**

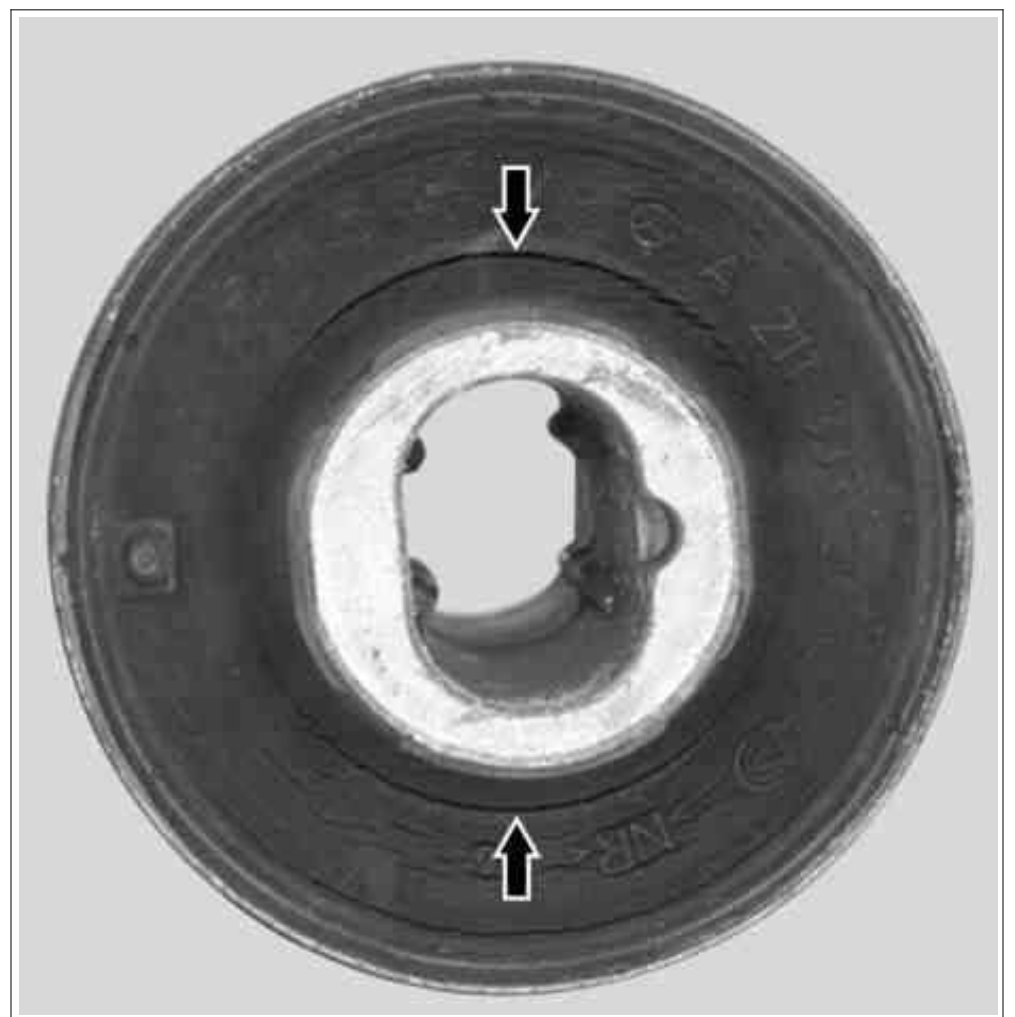
P35.10-2461-12

Component OK

Microfissures up to approx. 30 mm in length which do not lead to fluid loss do not impede function in any way and should not be considered defective.

When subjected to cardanic deviation (full steering lock), these fissures may expand by 3-4 mm.

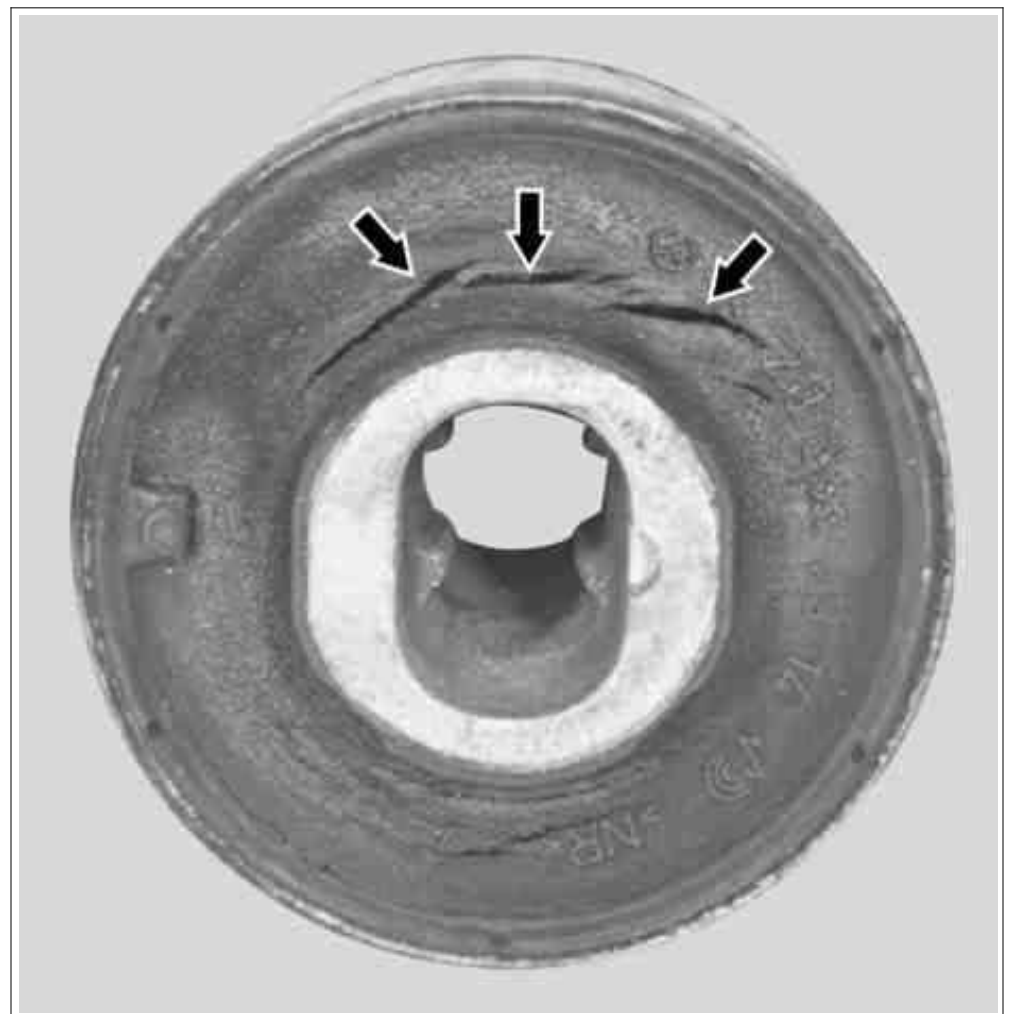
P35.10-2462-12

Component defective

Hydromount must be replaced.

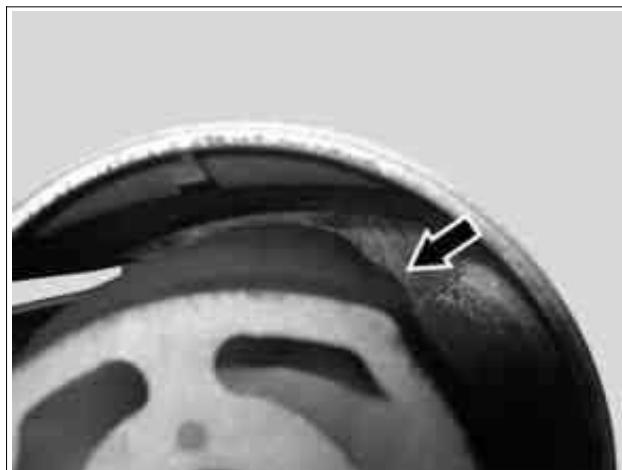
P35.10-2463-01

Topic: Injection molding film
When new

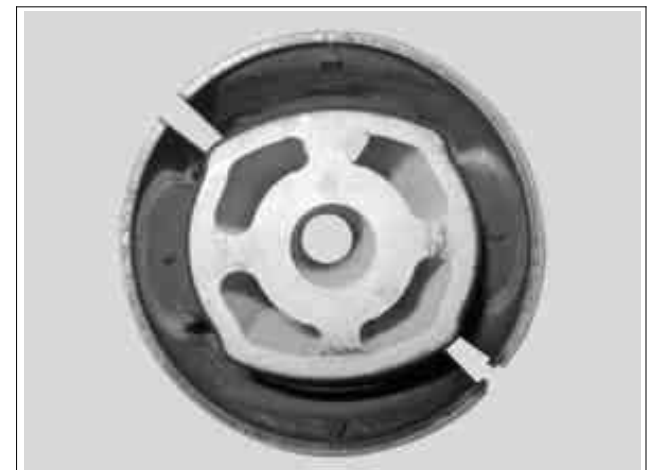
P35.10-2464-01

Component OK

During the manufacture of bearings, certain production methods or tools may cause a film to be left after injection molding.

This injection molding film can vary in its extent.

It does not represent a technical problem and should not be considered defective.

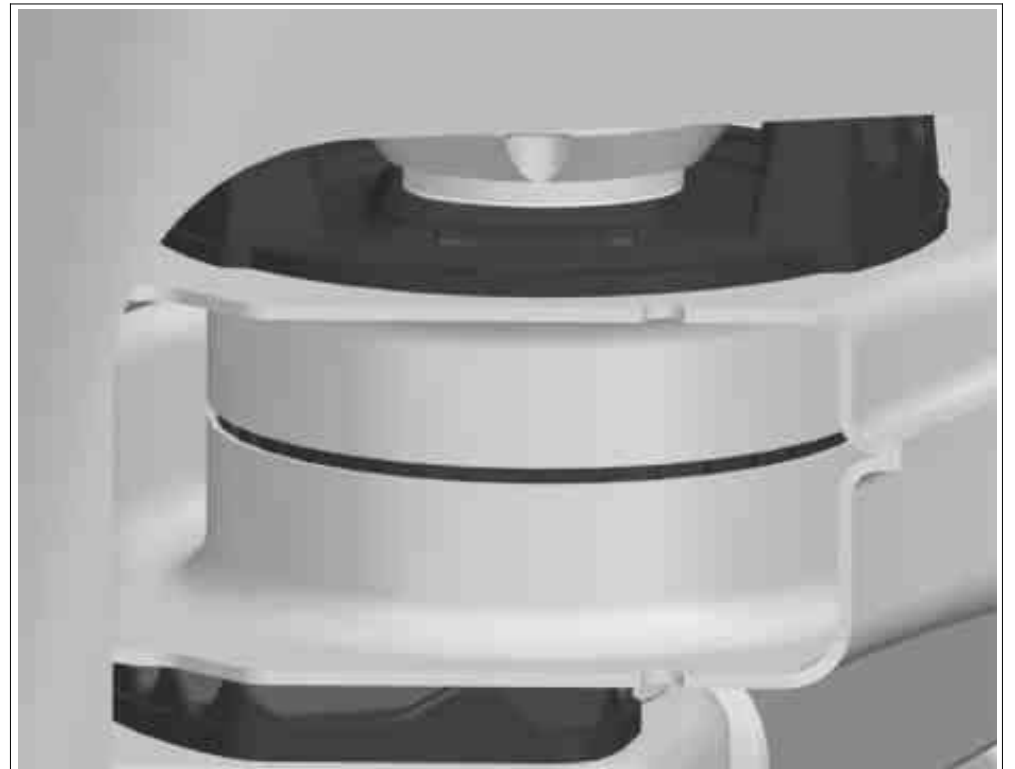
P35.10-2466-11

Topic: Suspension subframe carrier
When new

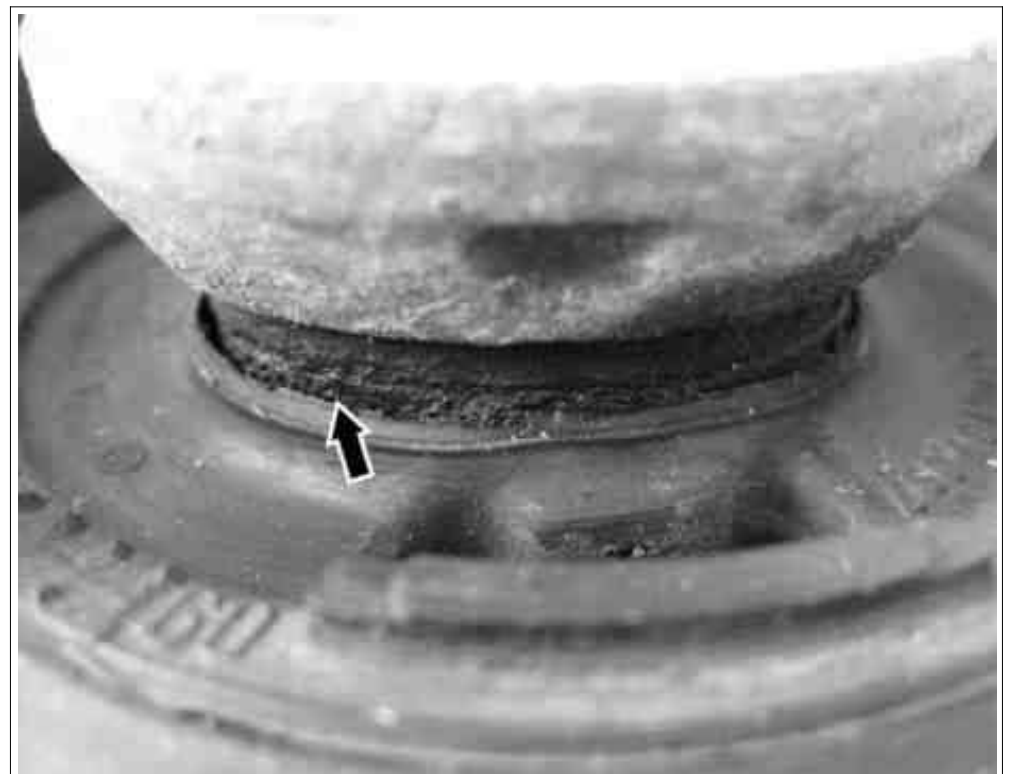
P35.10-2467-11

Component OK

The bearing exhibits slight peeling from the core.

Peeling of up to 50 % from the core does not impede the function in any way.

The lateral crease can be incorrectly identified as peeling or as a fissure.

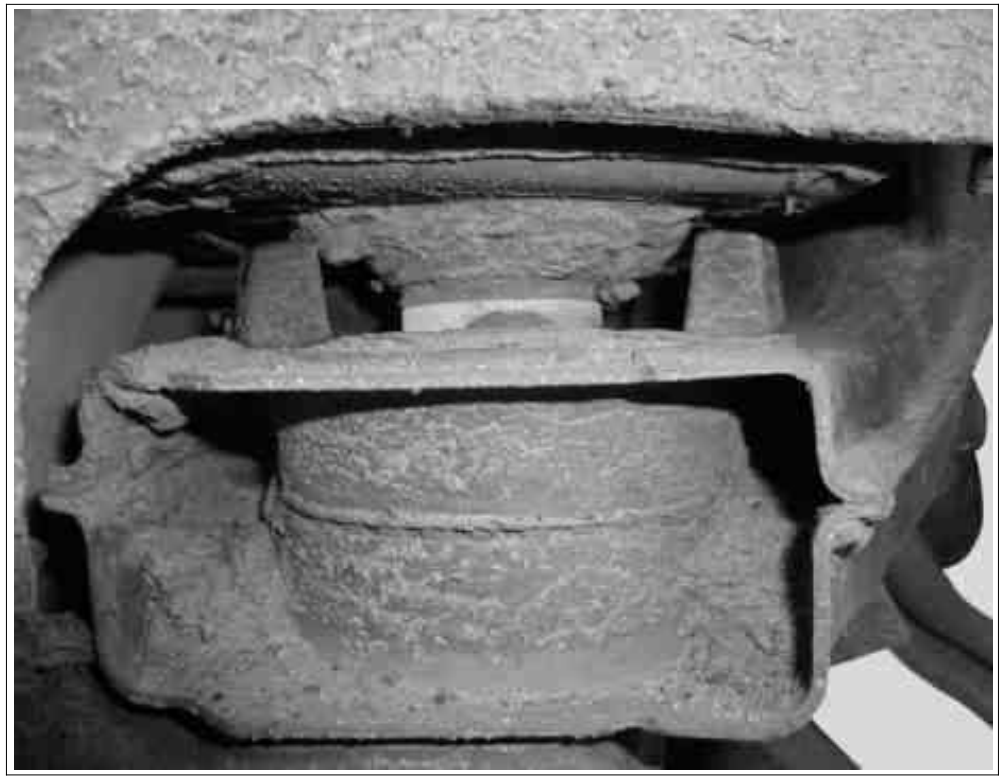
P35.10-2468-11

Component defective

The bearing has completely separated from the core.
The suspension subframe carrier must be replaced.
