Mercedes-Benz

Campaign No. 2019080011, August 2019

SUBJECT: **Model E-Class (213 platform), E-Class Coupe (238 platform), and CLS-Class (238 platform)**  
**Model Years 2018-2019**  
**Replace Steering Rack**

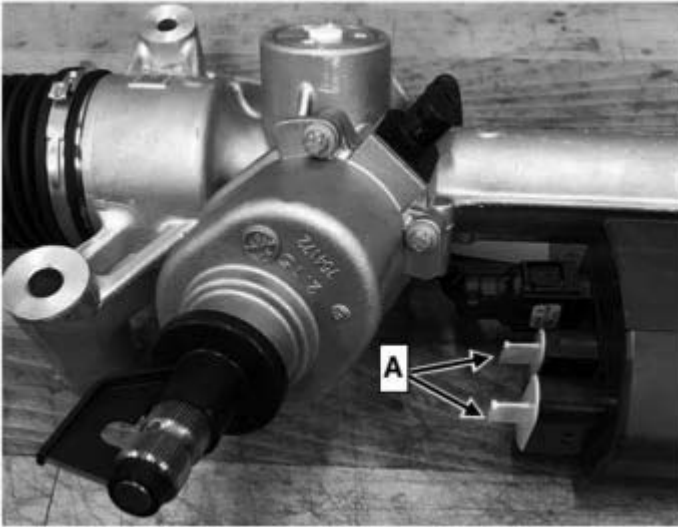
Figure 1

**i** To prevent dirt from entering the connector couplings or damage from ESD (electrostatic discharge), it is **absolutely essential** to fit the yellow dust caps (**A, Figure 1**) on the connector couplings of the steering gear to be returned. The **caps** from the **new** steering gear are to be used for this.
