## Scratches on surface of touchpad without external force

Topic number	LI54.21-P-068464
Version	1
Function group	54.21 Control units / basic modules
Date	07-25-2018
Validity	Model series 166/205/213/217/222/253/238/292 with code 448
Reason for change	
Reason for block

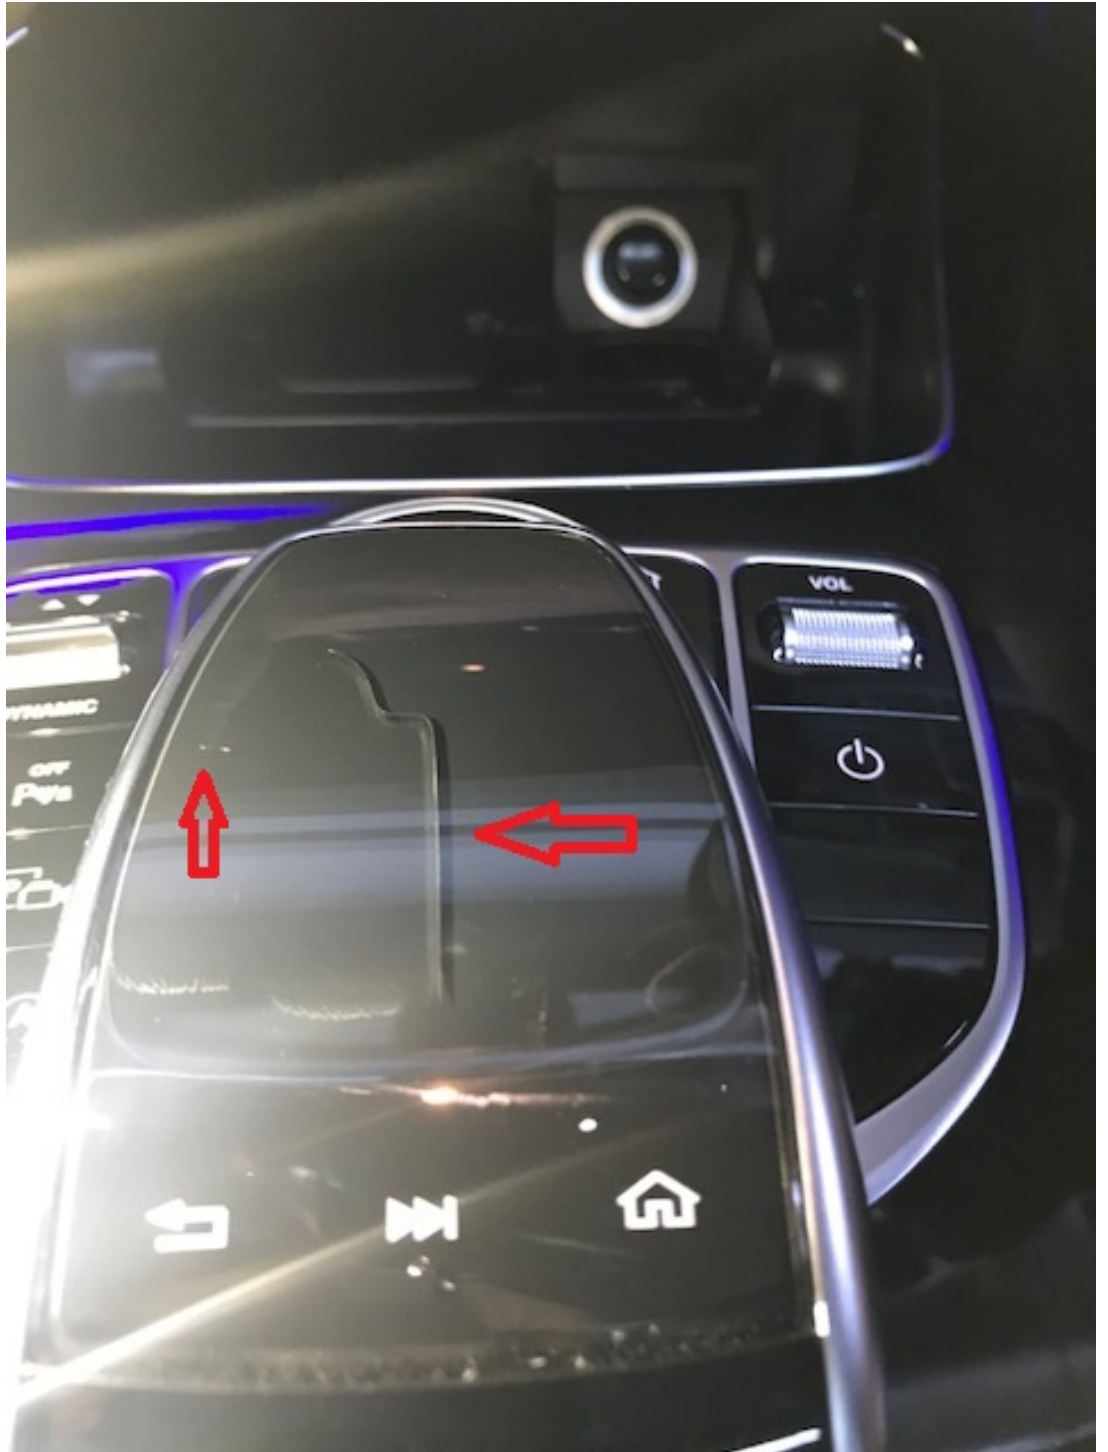
A.jpg:

Cracks occur on the surface of the touchpad without any external force application (see Attachments A and B). This problem mostly occurs at high outside temperatures.

Due to the complex production process, internal stresses can develop inside the component, which can result in cracks at high outside temperatures in isolated cases.

Replacement of the touchpad.

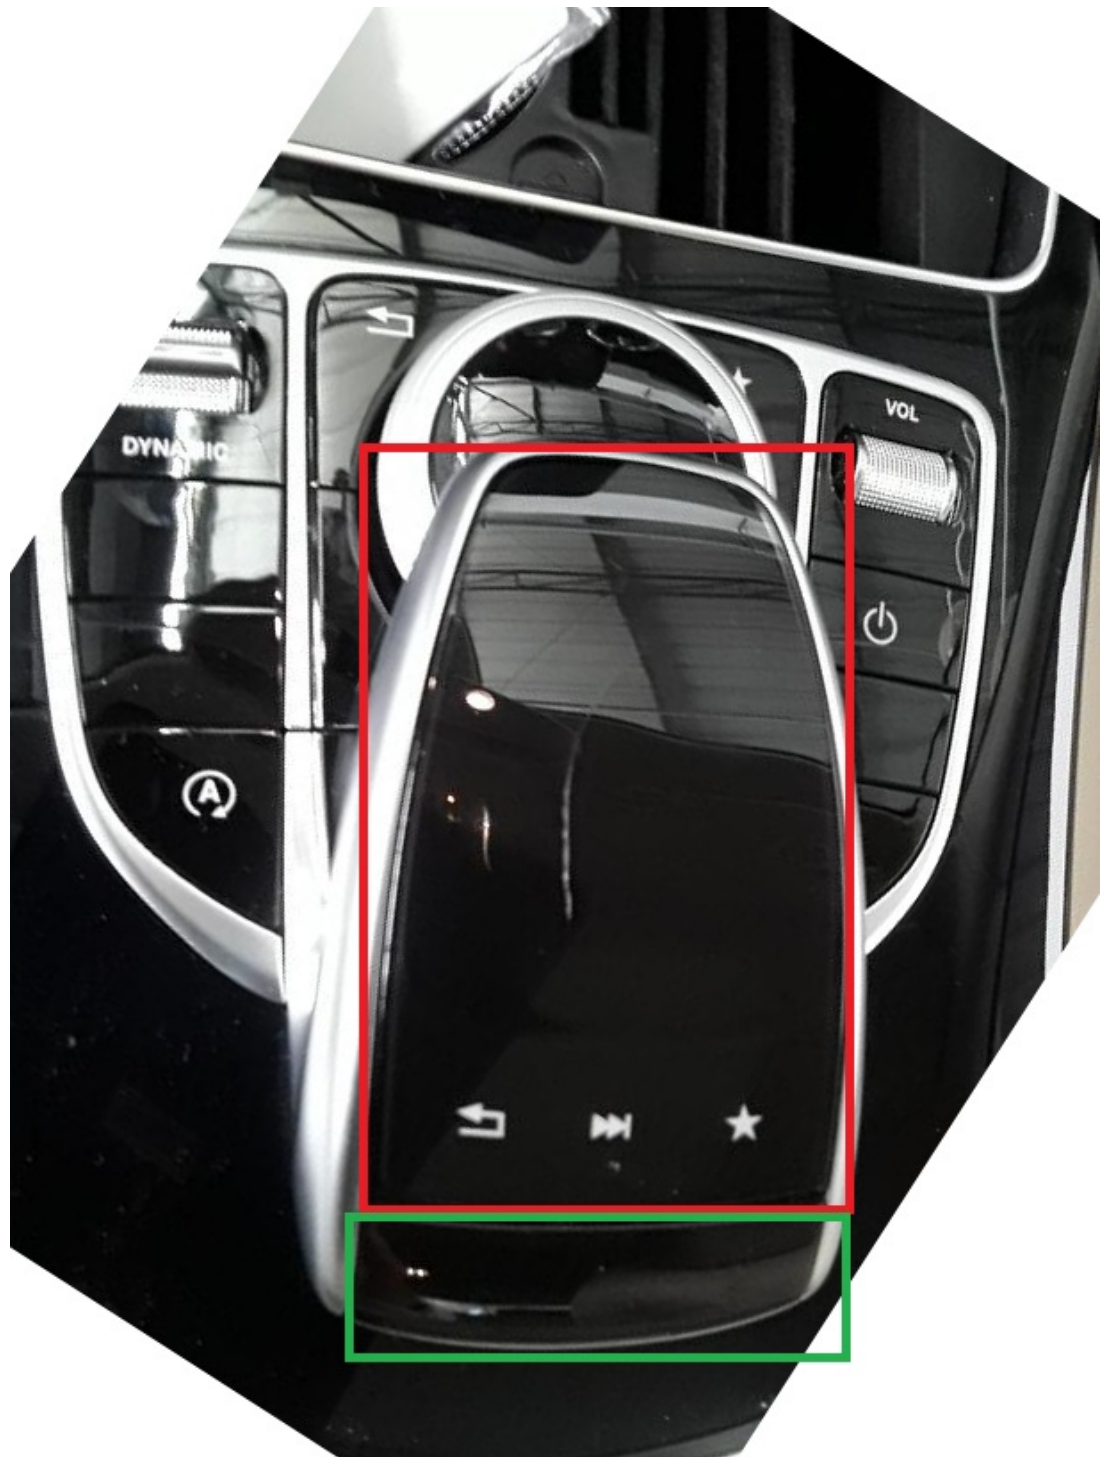
C.jpg:

Only the red area is affected (see Attachment C). The problem cannot occur in the green area (see Attachment C).
