Recall Campaign Bulletin

Campaign No. 2010110008, January 2011

SUBJECT: Model 463, Model Years 2002 - 2010

Remove Headlamp Grill, Replace Front Turn Signal Lenses

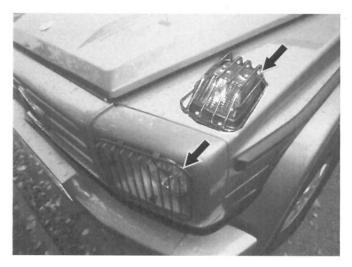
Affected Headlamp Grills and Turn Signal Grills

The headlamps of the affected vehicles are equipped with a protective grill for protection of the headlamps during off-highway operation. FMVSS 108 S7.8.5 specifies that a grill shall not be installed in front of the lamp. The affected vehicles with the protective grills installed fail to meet all luminosity requirements of FMVSS 108 thereby increasing the risk of a crash. The affected vehicles may also be equipped with an allowable grill cover for front turn signal protection which also affects compliance with FMVSS 108 by reducing the turn signals' light visibility to other motorists.

MBUSA will conduct a recall campaign for the subject vehicles described above. The recall will be conducted to remove the headlamp grills and install improved turn signal units optimized for usage with front fender mounted grills (if installed). MBUSA will reimburse you for the cost of the removed headlamp grills.

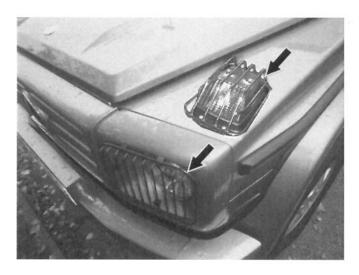
Affected Headlamp Grills and Turn Signal Grills

The headlamps of the affected vehicles are equipped with a protective grill for protection of the headlamps during off-highway operation. FMVSS 108 S7.8.5 specifies that a grill shall not be installed in front of the lamp. The affected vehicles with the protective grills installed fail to meet all luminosity requirements of FMVSS 108 thereby increasing the risk of a crash. The affected vehicles may also be equipped with an allowable grill cover for front turn signal protection which also affects compliance with FMVSS 108 by reducing the turn signals' light visibility to other motorists.

MBUSA will conduct a recall campaign for the subject vehicles described above. The recall will be conducted to remove the headlamp grills and install improved turn signal units optimized for usage with front fender mounted grills (if installed). MBUSA will reimburse you for the cost of the removed headlamp grills.
