TRACES OF OIL IN AREA OF OIL COOLER (INNER V) ON ENGINE 642

TECHNICAL SERVICE BULLETIN

Reference Number(s): LI18.30-P-055434 Version 2, Date of Issue: February 19, 2014

MERCEDES-BENZ: All passenger car/light truck models with engine 642

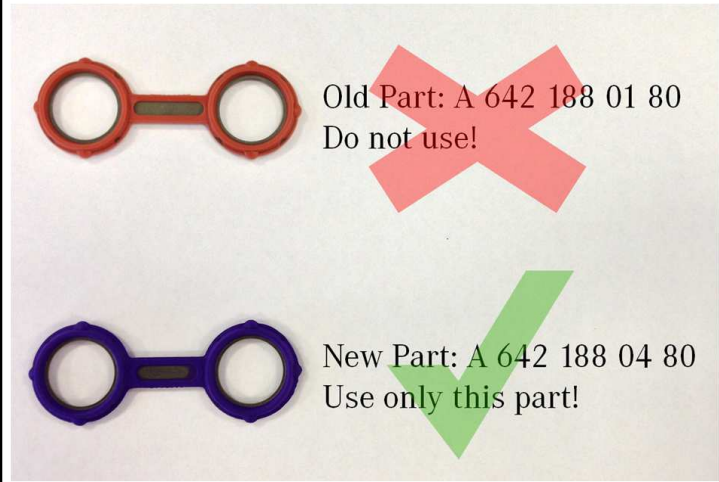
<p>Old Part: A 642 188 01 80 Do not use!</p> <p>New Part: A 642 188 04 80 Use only this part!</p>	Picture of old and new O-rings

Replace seals, observe installation instructions.
