Date: November 5, 2008
 Order No.: S-B-91.10/112e
 Supersedes: S-B-91.10/112d dated October 21, 2008
 Group: 91

SUBJECT: Model 164.122/172/175/177/186/822/886

Front Seat Noise Complaints

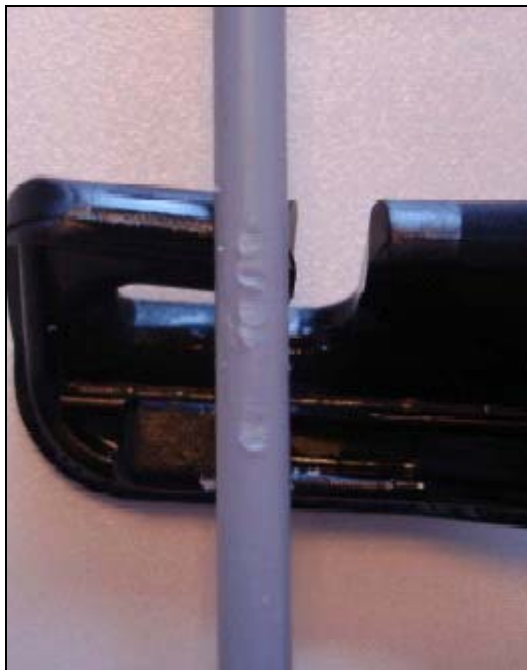
Figure 1 S-B-91.10/112a

1. Verify noise during cold temperatures.
2. Remove backrest cover. Refer to WIS document AR91.10-P-1910P (203, 209), AR91.10-P-1910T (211 up to MY05), AR91.10-P-1910TB (211 as of MY05) and AR91.10-P-1910TX (219).
3. Check if the guide wires are damaged (Figure 1) at the interface with the lumbar support basket.

4. If there is minor damage to the guide wires, apply lubrication (A000 989 36 60) to the guide wires.
5. In the case of major damage to the guide wires (Figure 3), sand down the guide wires of the padding

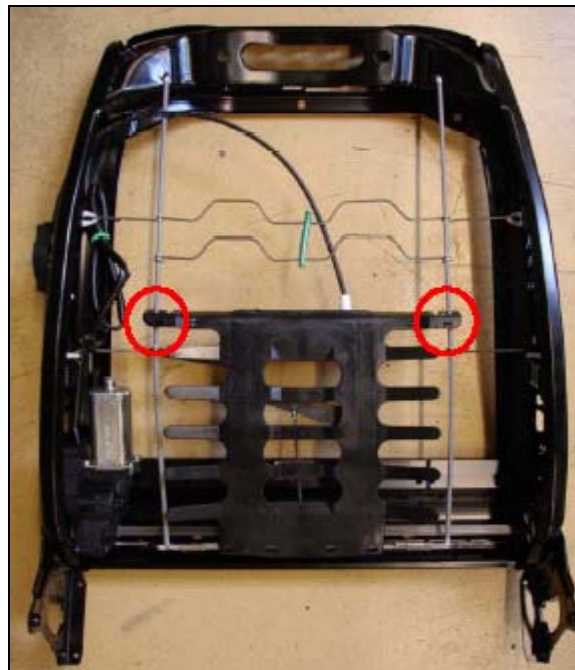
Figure 2 S-B-91.10/112a

i **Note:** Figure 2 shows the seat backrest frame with the seat cover and seat pad removed for clarity, it is not necessary to remove these parts to inspect and lubricate the guide wires.

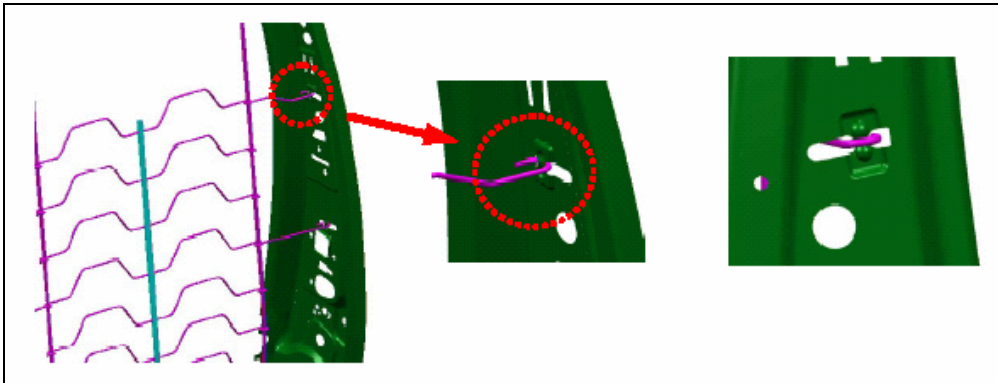
Figure 4

b. Padding Support Grid Rubs on Attachment Points on Backrest Frame (Models 164, 203, 209, 211, 219 and 251 produced up to 09/2005)

1. With backrest cover still removed, remove side bag.
2. Disconnect padding support grid from the four suspension points (Figure 4), two on the right side and two on the left side.
3. Cut four pieces of felt, approximate size is 25 mm by 2 mm. Apply lubrication (A000 989 36 60) to the felt and then adhere the felt to the suspension points of the padding support grid (Figure 5).
4. Reconnect the padding support grid to the four suspension points (two on the right and two on the left).

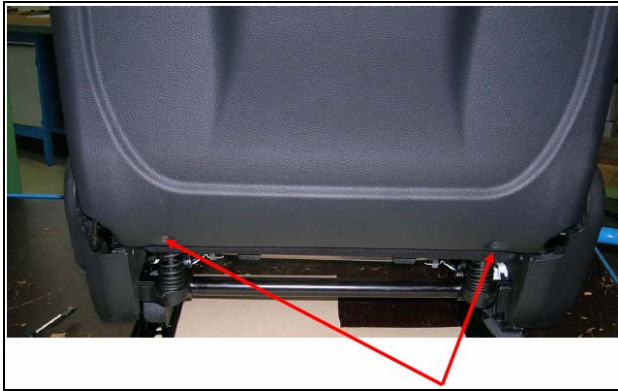
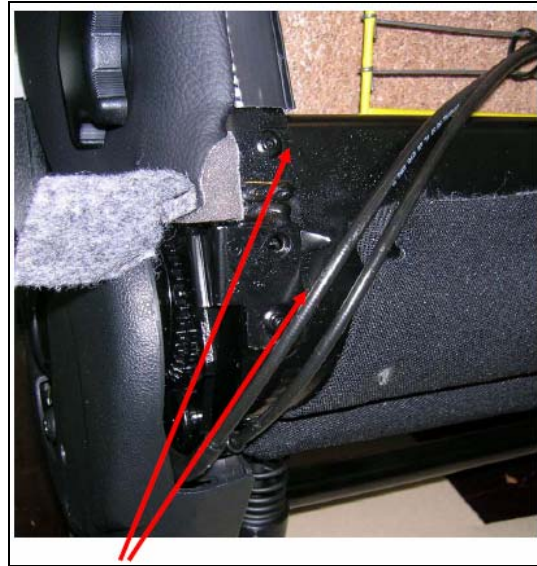
c. Relative Movements Produce Noise at Bottom of Backrest (Models 203.740/747/764 only & 209.356/365/372/375/376/377/456/465/472/475/476/477)

1. Backrest cover is still removed and the seat is in installed position.
2. Detach seat cover and spray the rivets (Figures 6 and 7) in area between side section of frame and cross member with grease (A002 989 06 51).

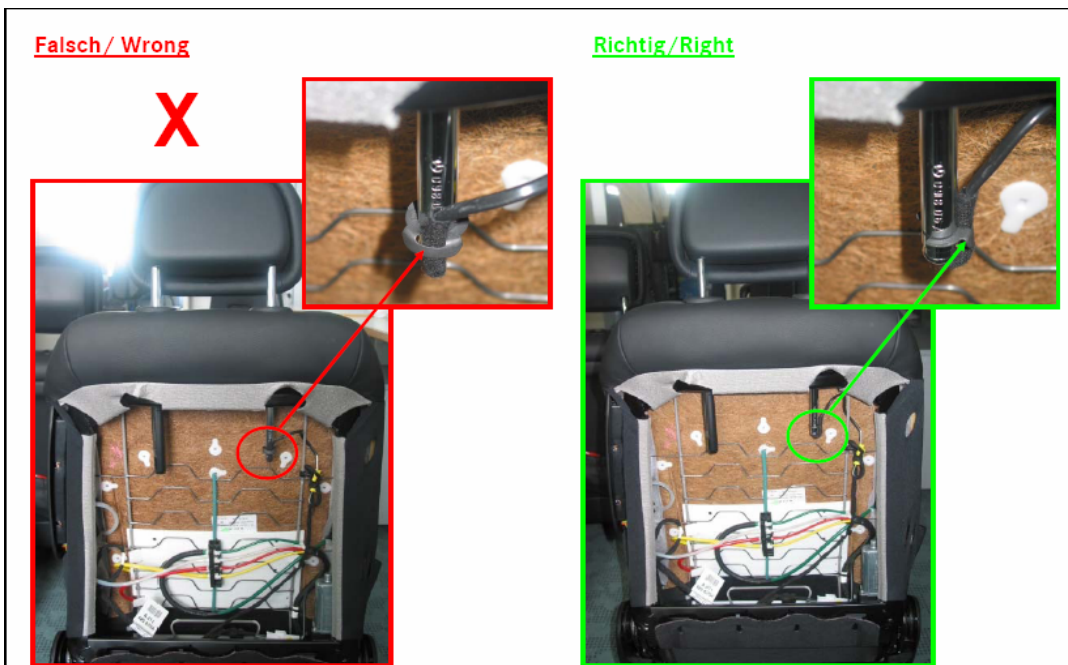
Figure 8

d. Noise from Backrest Under Load Due to Incorrect Positioning of Circlip (Models 211, 219 only)

1. Check if the alignment of the circlip on the head restraint guide sleeve is correct (refer to Figure 8).
2. Reattach the seat cover and backrest cover then check that the noise does not occur again.

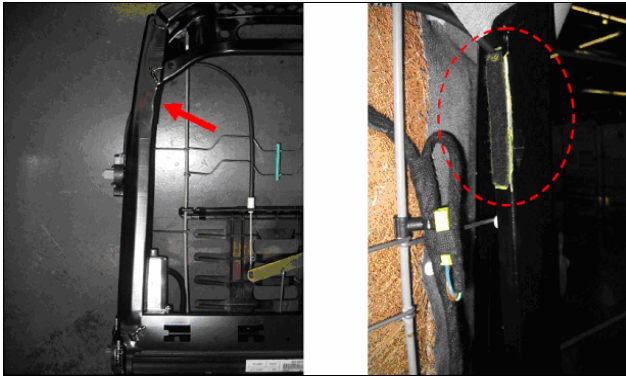
Figure 9 – Felt 6 x 2.5cm

e. **Noise from Seat Backrest (Models 203, 209 and 219)** – Apply felt (A126 782 01 97) to seat back lining bracket so the bracket does not rub against the backrest frame. Refer to Figure 9 (inside backrest frame) and Figure 10 (backrest frame)

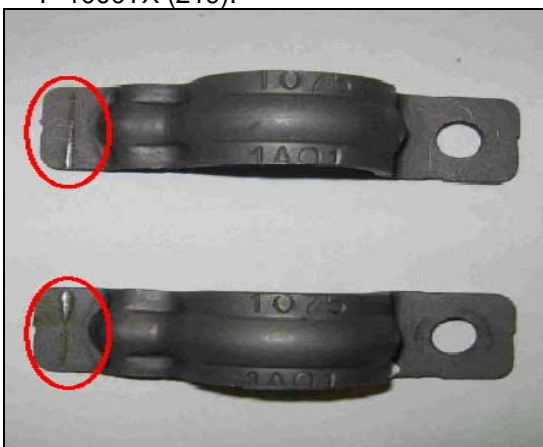
Figure 11

The seat frame brackets rub on the seat cushion frame and if there are burrs on the brackets, this may make noise.

1. If burrs are visible (Figure 11, circles), proceed as follows.
2. Remove the seat, refer to WIS document AR91.10-P-1000P (203), AR91.10-P-1000T (211) or AR91.10-P-1000TX (219).
3. Remove the brackets and replace with new brackets.

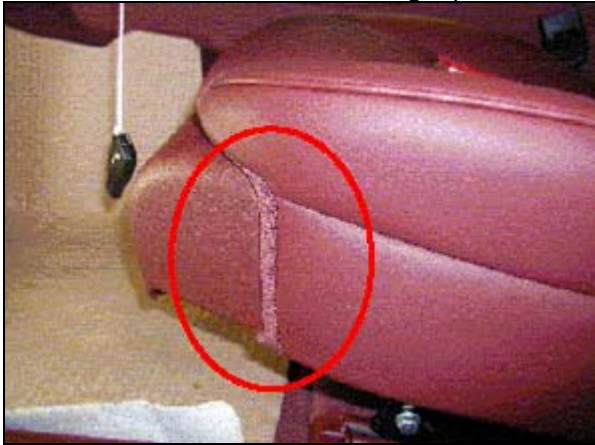
Figure 12

III. Noise from Lower Trim Cover (Models 211 and 219 only) – The rib on the back side of the lower trim covers at the front of the seat cushion may cause a noise as it rubs on the seat cover.

1. Remove trim cover (Figure 12). Refer to WIS Document AR91.10-P-1200T.
2. Line side of trim cover rib (Figure 13) with felt (A001 983 51 10).
3. Reinstall trim cover (Figure 12). Refer to WIS Document AR91.10-P-1200T.
4. Confirm that the noise is no longer present

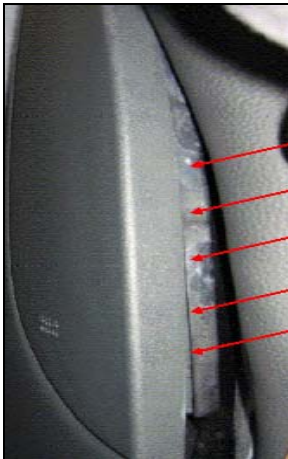
Figure 14 S-B-91.10/112a

IV. Noise Between Seat Cover and Cover of Sidebag (Models 211 and 219 only) – The hard edge of the sidebag cover may make a noise as it rubs against the seat cover.

1. Remove side airbag.
2. Apply special sliding compound (A000 989 36 60) from the inside on the cover of the side airbag close to the graining (Figure 14)
3. Confirm that the noise is no longer present

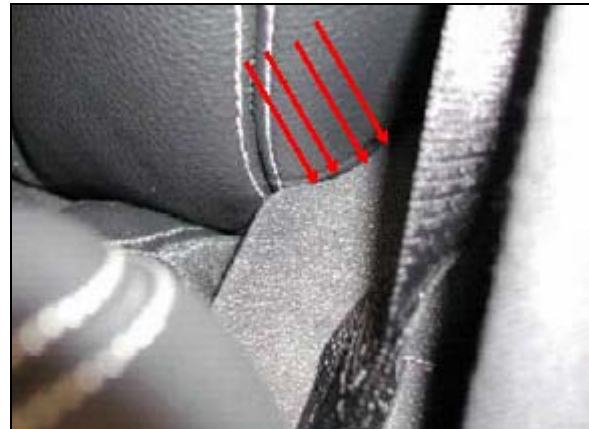
Figure 15

Rubbing noise where the seat cover contacts the trim cover (Figure 15, arrows)

1. Tilt the backrest rearward.
2. Apply special sliding compound (A000 989 36 60) to the inside of the trim cover (Figure 15, arrows).
3. Confirm that the noise is no longer present.

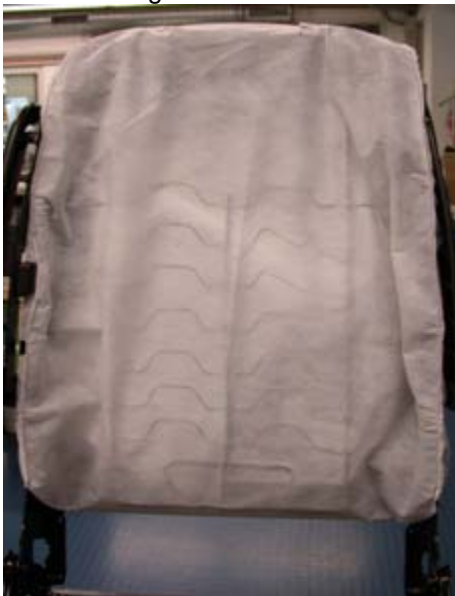
Figure 17

VII. Noise from Right or Left Front Seat Backrest (Model 204 up to VIN A184623 / F198707 / R058616, excludes AMG Models)

1. Install new padding with colored anti-creak coating. Refer to WIS document AR91.18-p-1820cw.
2. Remove fleece bag shown in Figure 17. Refer to WIS document AR91.18-p-1820cw. Do not reinstall fleece bag.

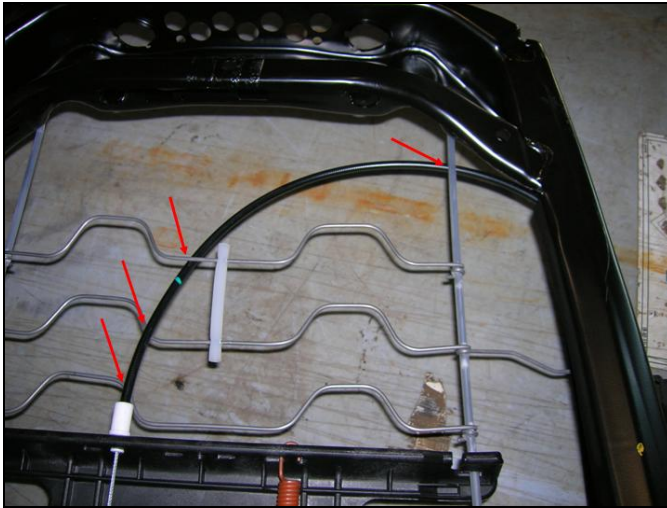
Figure 18 S-B-91.10/112e

VIII. Noise during manual lumbar support adjustment (Model 164, 251) – The Bowden cable of the manually adjustable lumbar support may rub against the spring core of the backrest.

1. Remove seat-back lining Refer to WIS document AR91.10-P-1915GZ (164) and AR91.10-P-1915RT (251).
2. With a load on the backrest (e.g. a person sitting in the seat), adjust the manual lumbar support and determine the points at which the Bowden cable rubs against the spring core (possible locations illustrated in Figure 18).
3. Apply felt tape to the areas on the spring core that are rubbing on the Bowden cable.
4. Confirm that the noise is no longer present.
