7G-TRONIC (722.9) in the Workshop Tips and Tricks

Service Information Brochure

Order no. of this publication: 6516 1356 02

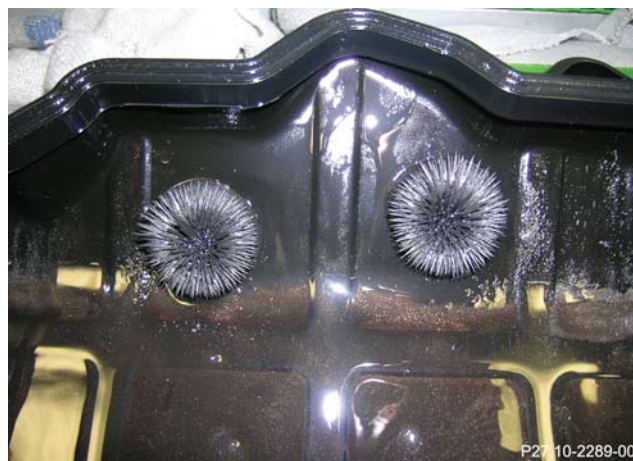
If there is a significant amount of wear debris in the transmission oil pan (see picture), it must be assumed that the torque converter lockup clutch is already seriously damaged.

Oil pan with significant wear debris

In this case, it is recommended that the entire transmission including torque converter be replaced because the shavings will have spread out within the transmission. In addition, the oil cooler must be flushed. If an additional oil cooler with thermostat is installed, this must also be replaced because it cannot be flushed (thermostat does not open until temperature of approx. 85 °C is reached).

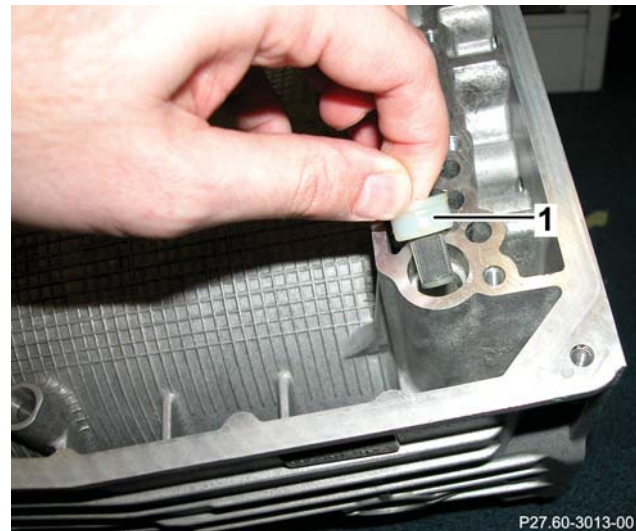
1 Converter return flow strainer
Electrohydraulic controller unit removed, front of transmission housing, on left in direction of travel

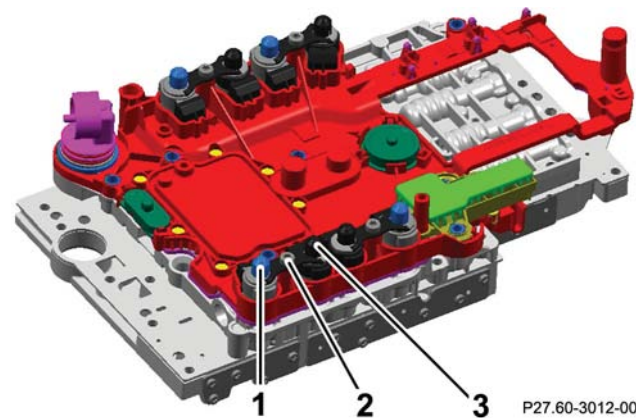
1 Torque converter lockup clutch valve
2 Bolt
3 Working pressure control valve
Clean torque converter lockup clutch valve and working pressure control valve

- 1 Unscrew bolt
- 2 Remove tension spring
- 3 Remove both valves (torque converter lockup clutch valve and working pressure control valve)
- 4 Carefully remove particles from fine-mesh filter using a cloth
- 5 Insert valves
- 6 Insert tension spring
- 7 Tighten bolt to 9 Nm

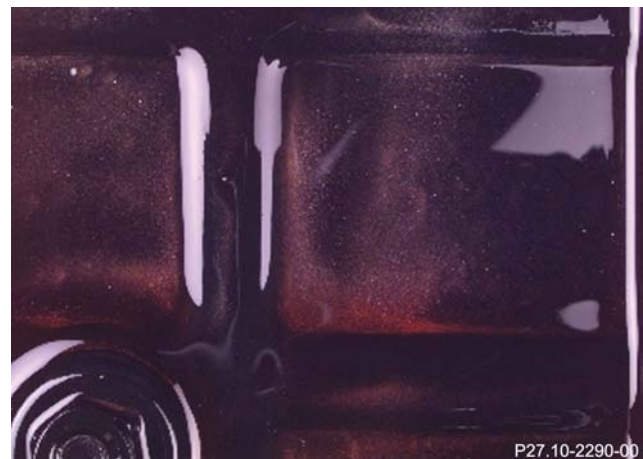
A pattern of wear debris in the oil pan which corresponds to the picture "Oil pan with normal wear debris" does not justify replacement of the transmission because this is normal wear debris which collects in the oil pan during operation.

Oil pan with normal wear debris
