Recall Campaign Bulletin

Campaign No. 2022040017, June 2022

SUBJECT: **Model GLE-Class and GLS-Class (167 platform)**
Model Year 2020-2022

Check the 48V Ground Connection

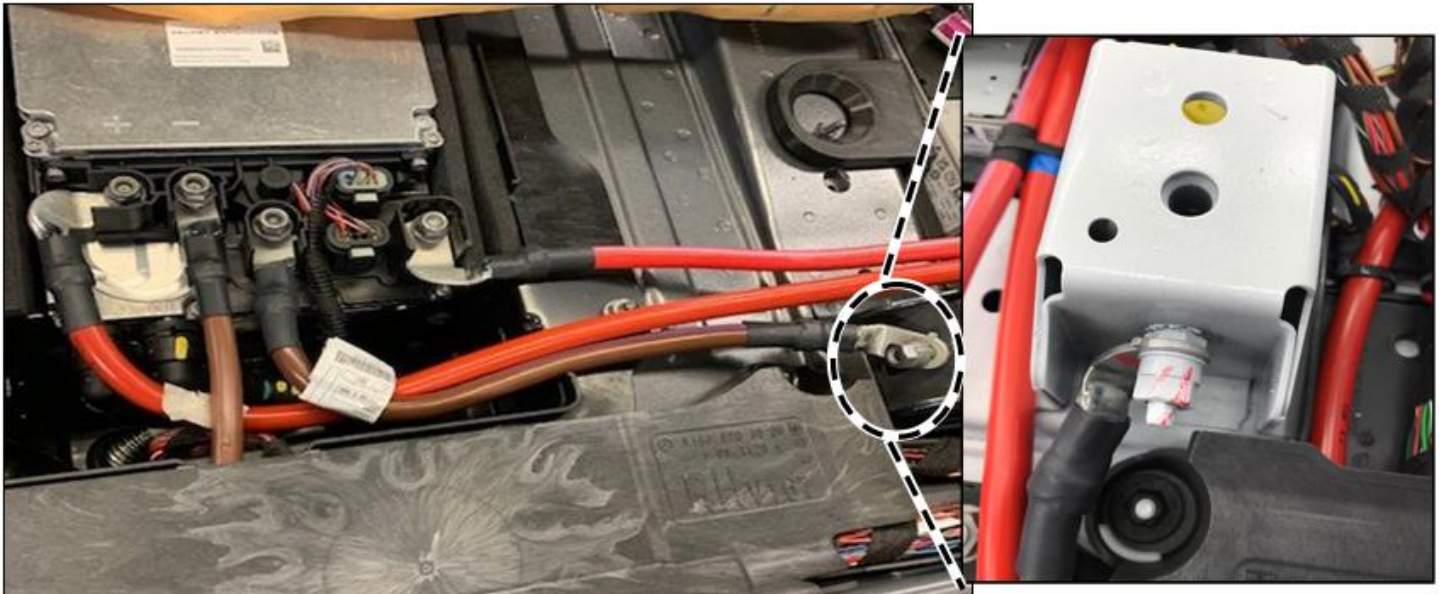
Figure 1

5. Expose right rear floor covering to the extent that the "W106/1" ground point is accessible for the electrical wiring harness of the 48 V on-board electrical system battery (**Figure 1**).

7. Disconnect and check threaded connection of the electrical wiring harness of 48 V on-board electrical system battery of "W106/1" ground point on the body (**Figures 1 and 2**).
