## BR167 ARTICO Seat Covers On Front Seat Torn

| Topic number | LI91.18-P-071629 |
| Function group | 91.18 - Seat covers |
| Validity | Model series 167 ARTICO man-made leather upholstery or ARTICO man-made leather upholstery/DINAMICA microfiber |

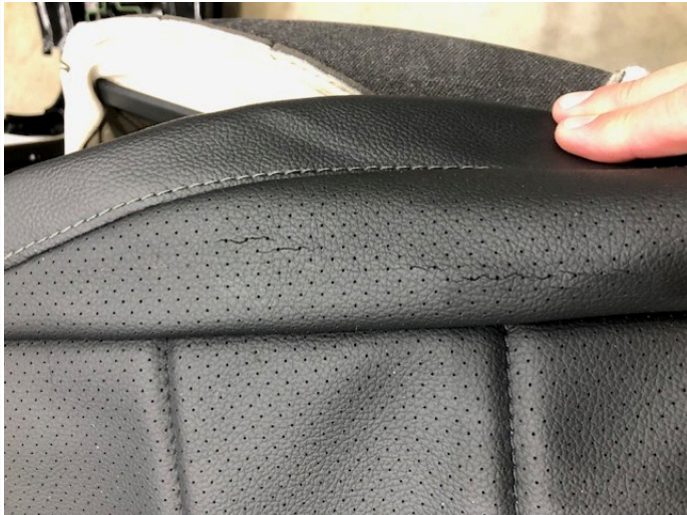
| Attachments | |
|---|---|
| <a href="#">example1.jpg</a> | Example 1 |

On vehicles with "ARTICO man-made leather upholstery" or "ARTICO man-made leather upholstery / DINAMICA microfiber - black (601A)" the material of the seat side bolster can tear. Both the seat cushion cover and the backrest cover on the front seat can be affected here.

The material may tear because the material in the side bolster is not suitable.

Optimized seat covers are available in XPPI (Xentry Portal Parts Information).

The new seat covers have the addition "PREMIUM" in the description. Please take note of this!
