[Conversion Calculator](#)**2002 Mercedes Benz Truck ML 320 (163.154) V6-3.2L (112.942)**[Vehicle Level](#) → [Accessories and Optional Equipment](#) → [Technical Service Bulletins](#) → [All Technical Service Bulletins](#) →[Audio System - Volume Fluctuates Unexpectedly](#) ←

## Audio System - Volume Fluctuates Unexpectedly

Order No.: T-B-82.60/192c

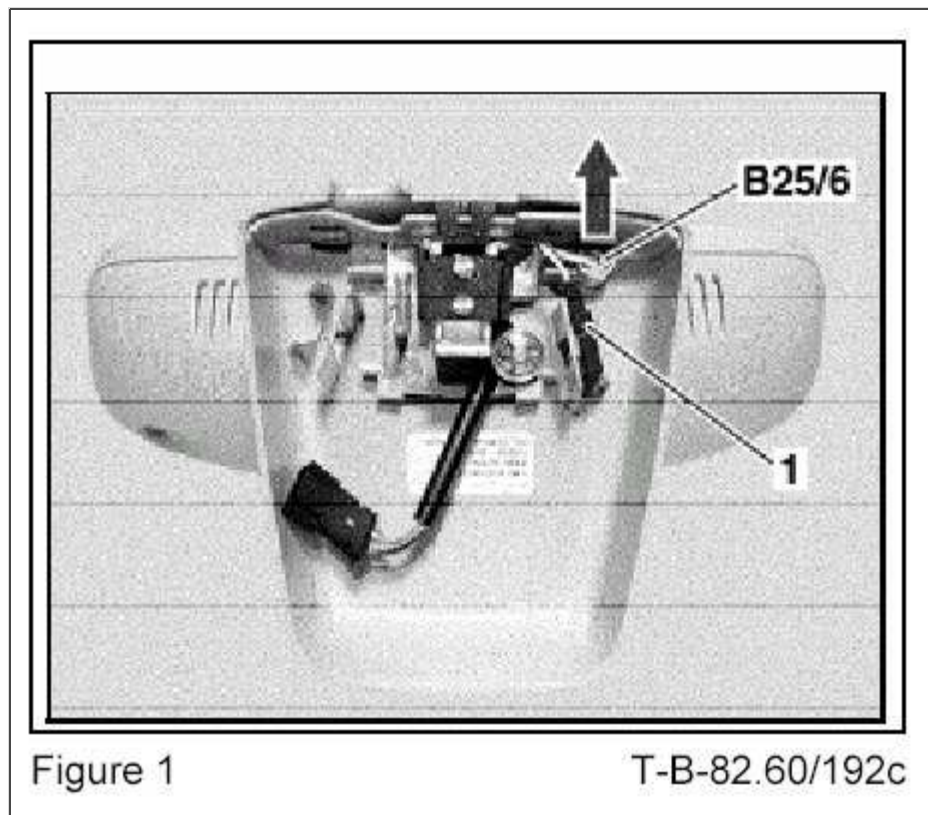
If you receive customer reports in the above model vehicles of unexpected volume fluctuation or speed dependent volume adjustment not functioning, this may be due to the Sound [Amplifier](#) (A2/13) not coded correctly to handle the wheel speed signal or due to a malfunction in the Sound Amplifier microphone (B25/6). To resolve, follow the procedure outlined below.

1. Check the Sound [Amplifier](#) Microphone (Figure 1, B25/6). Reference WIS Document AR82.62-P-1110GH.

2. If the microphone is not functioning correctly, replace it in accordance to WIS Document AR82.62-P-7700GH (Figure 1).

**NOTE:** As you remove the Microphone, insure that the wiring harness is not damaged.

3. After assembly of new microphone, re-check per step 1.
