~~2000 Mercedes Benz Truck ML 320 (163.154) V6-3.2L (112.942)~~

Campaign - Catalytic Converter Inspection/Replacement

Campaign No. 2005060014, September 2005
Revised November 2005

INSPECT CATALYST WELDS AND REPLACE [CATALYTIC CONVERTER](#) IF NECESSARY

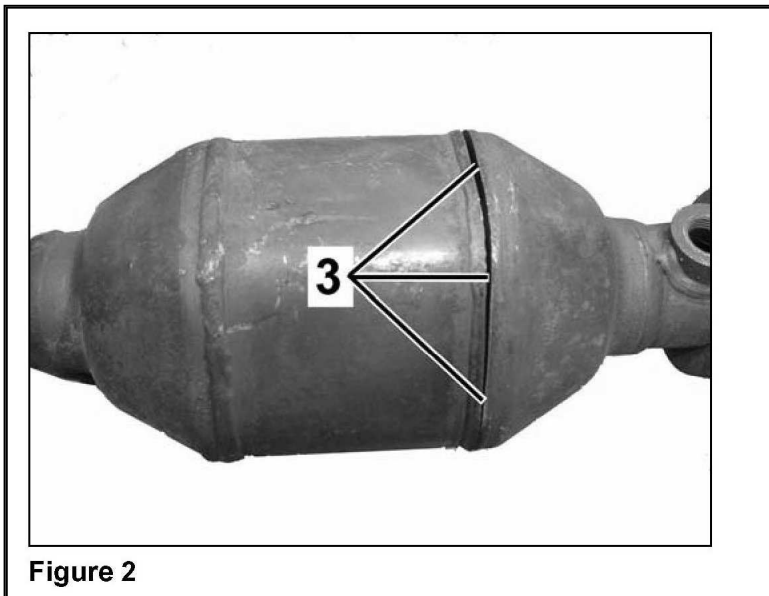
2. Visually inspect catalytic converter (1 Figure 1) for cracks and/or black exhaust residue at weld seam (arrows).

C: Replace [catalytic converter](#)/front exhaust system.

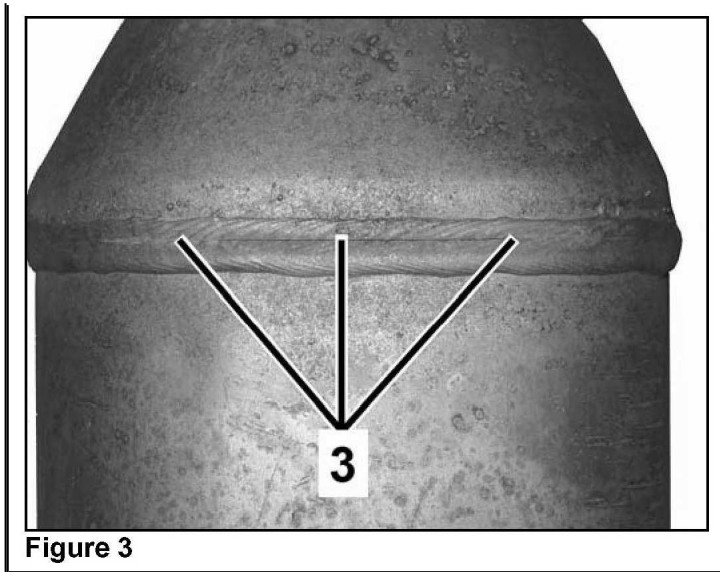
Note :Use mirror (2) to inspect upper surfaces. If cracks (3, Figures 2, 3) and/or black exhaust residue are present at weld seam proceed to subject

^ Hairline cracks on top welds of [catalytic converters](#) may be very difficult to detect during the visual inspection. Therefore, ensure this area is well illuminated when inspecting with mirror.

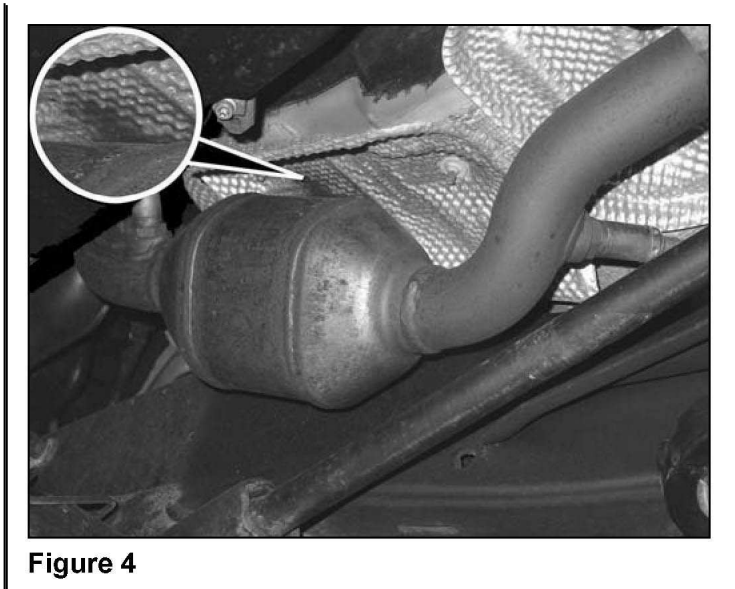
Figure 4

^ Black exhaust residue (Figure 4) found on [heat shield](#) directly above [catalytic converter](#) welds will also indicate a cracked weld.

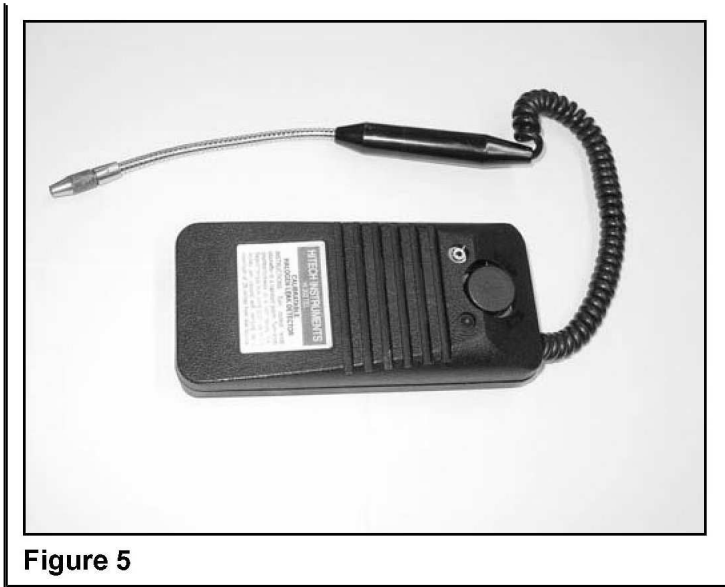
Figure 5

- HI TECH Instruments HI 300 TEL (Figure 5)
- Robinair 42-16600, TIF ZX-1
- Snap-On ACT755, CPS L5790B
- ^ Adjust leak detector (Figure 5) sensitivity to detect exhaust gas using a vehicle not involved with this campaign (this will help to prevent heating of [catalytic converters](#) on vehicle being campaigned).
- ^ Leak detector (Figure 5) will check for any change in ambient air quality. An exhaust gas leak will affect the quality of the ambient air around the [catalytic converter](#).

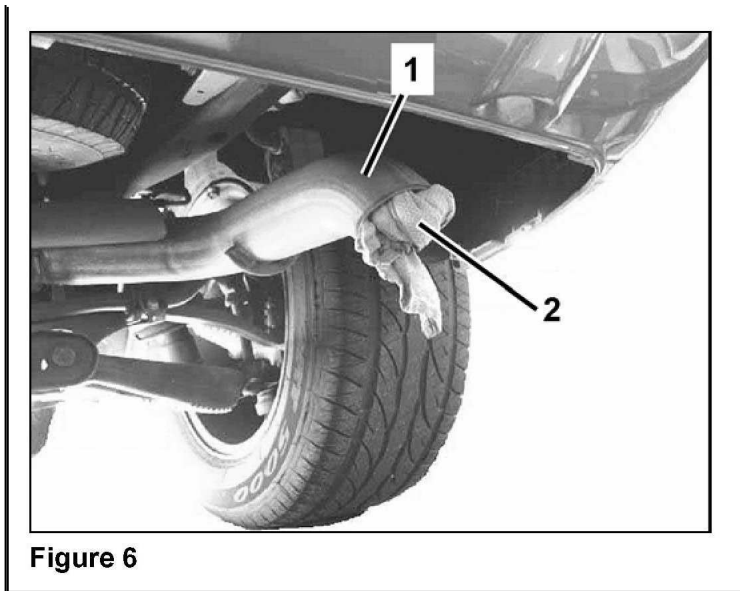
1. Plug tail pipe (1, Figure 6) of vehicle (e.g., wet rag [2]).
2. Start engine.

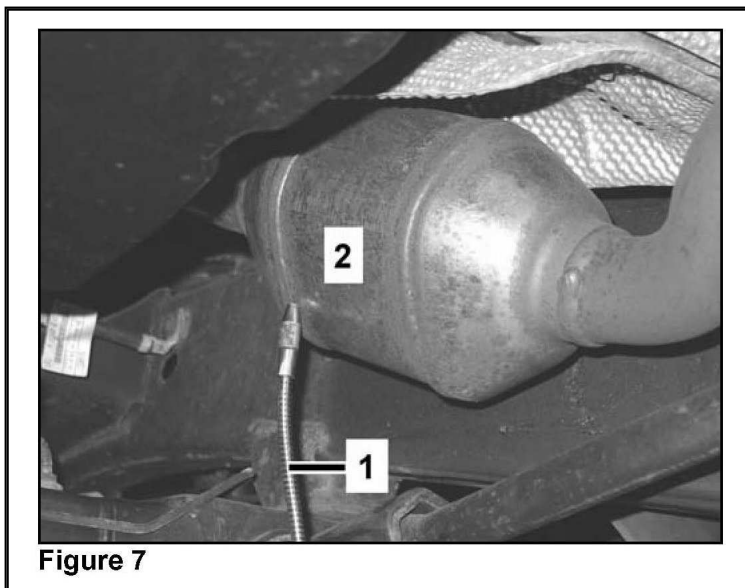
3. Check for exhaust gas leaks at weld seam with leak detector (1 Figure 7) starting with the left [catalytic converter](#) first.
4. Repeat exhaust gas leak test on right [catalytic converter](#) (2) before it becomes warm.

5. Remove exhaust plug (2, Figure 6).
6. If exhaust gas leak is detected proceed to subject C:
Replace [catalytic converter](#)/front exhaust system.

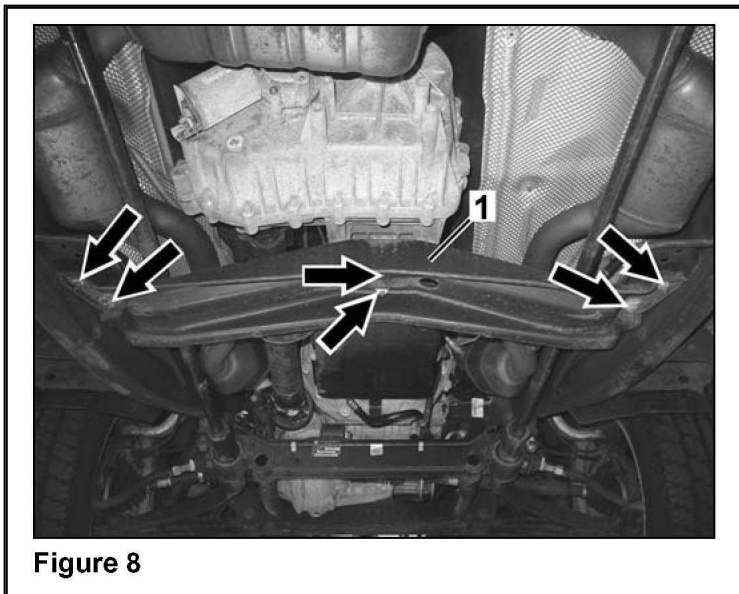
^ Remove 6 nuts (arrows Figure 8), remove cross member (1).

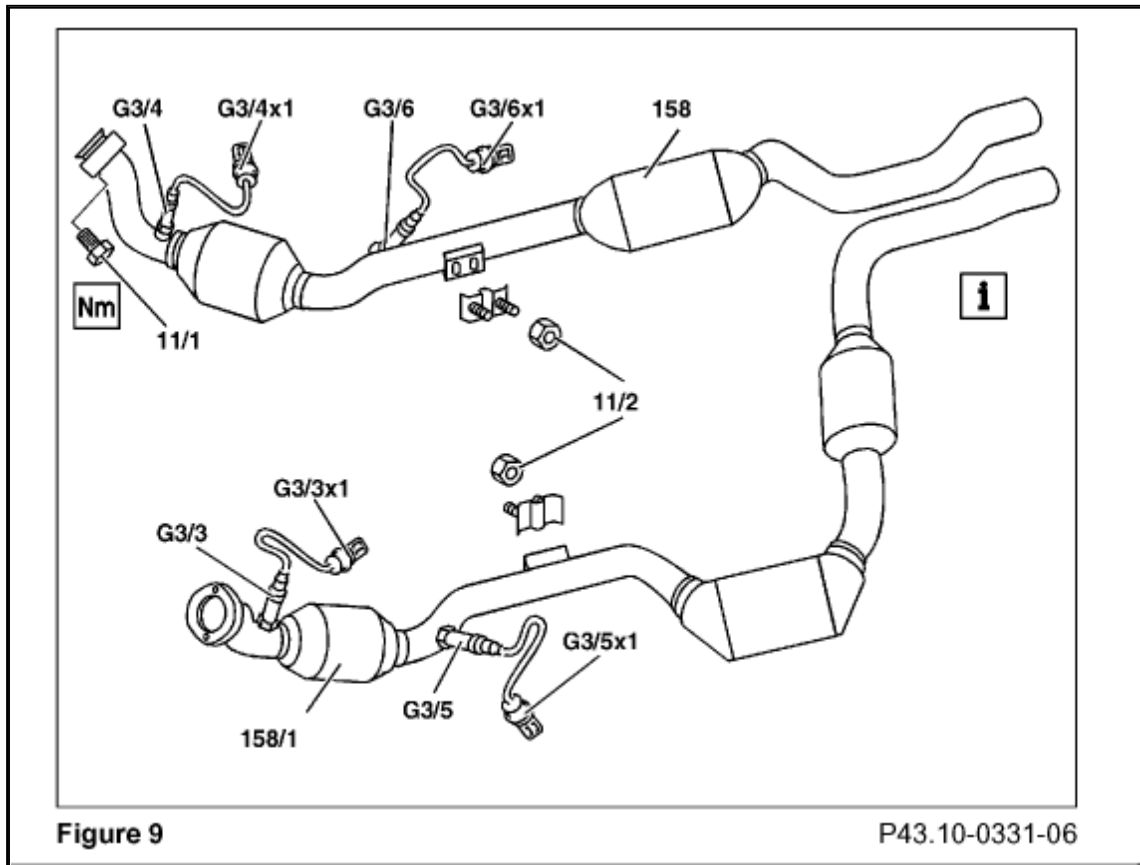
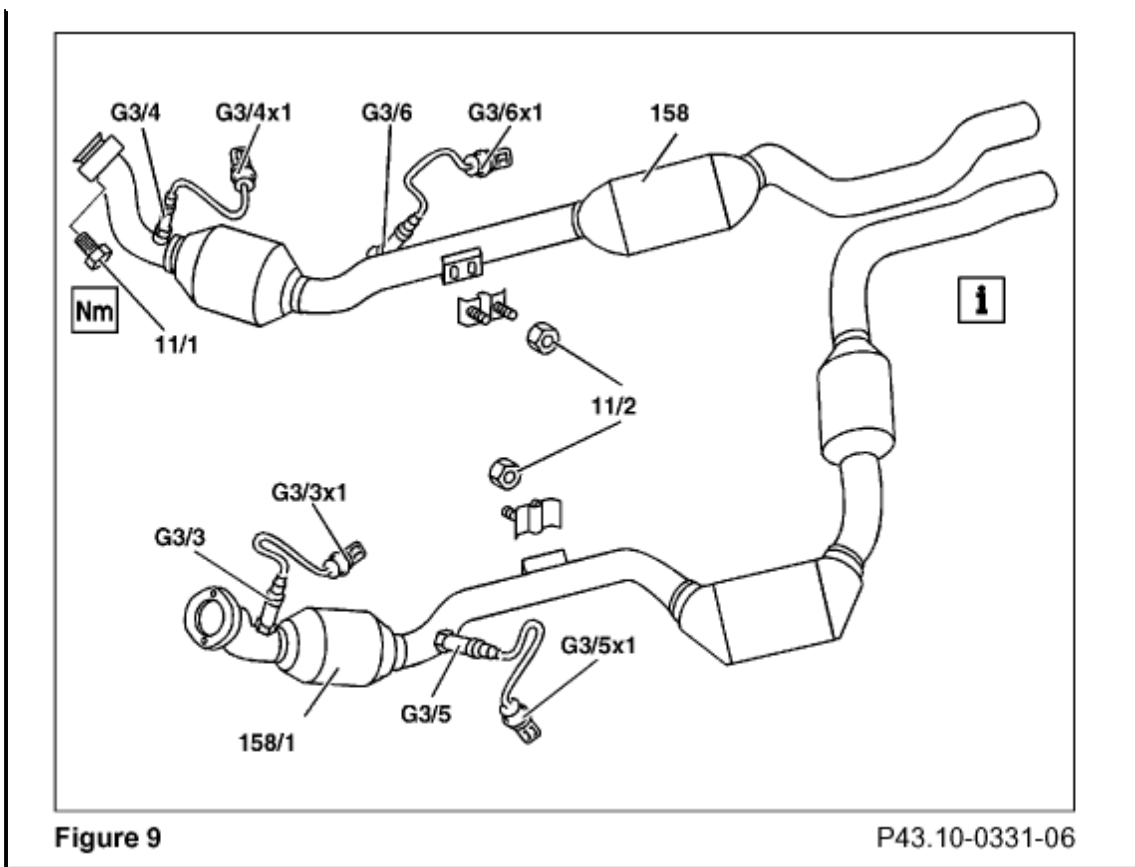
3. Disconnect oxygen sensor connectors (G3/3x1- G3/6x1 Figure 9) from wire harness connectors refer to WIS: AR14.00-P-5303GH.
4. Loosen exhaust clamps (welded to [muffler](#)).

5. Disconnect [catalytic converter](#)/front exhaust system (158, Figure 9) from rear exhaust.
6. Remove exhaust hanger bracket:

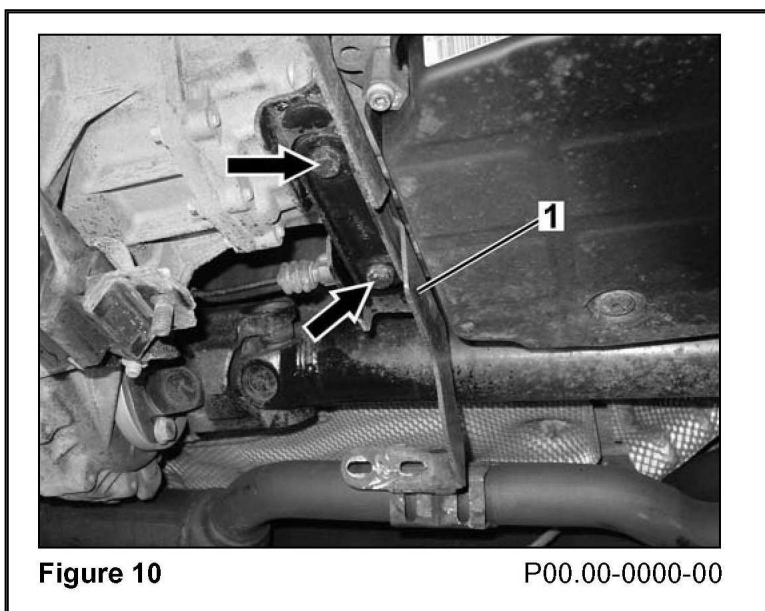
- ^ Remove 4 nuts (1 1/2, Figure 9) from exhaust hanger bracket (1 Figure 10).
- ^ Remove 2 bolts (arrows, Figure 10) securing front exhaust hanger bracket (1), remove exhaust hanger bracket (1).
- 7. Model 163.172 only: Remove both fender liners in wheel well WIS: AR88.10-P-1300GH.
- 8. Remove head pipe flange connection bolts (1 1/1, Figure 9).
