**star bulletin**

Date: April 5, 2005  
Order No.: T-B-27.00/48b  
Supersedes: T-B-27.00/48a dated October 11, 2004  
Group: 27

**SUBJECT:** **All Models 163 with 722.6 Automatic Transmission Leaking Oil in the Area of the Electric Connection**

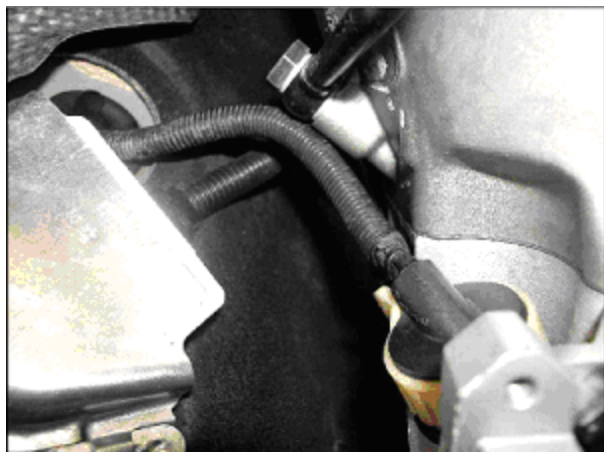
Figure 1 P-B-27.00/47

When connecting the wiring harness to the transmission, ensure that the harness is routed in a tension free path (Figure 1) and that no tension is applied to the electrical connector from the harness (Figure 2).
