2007 Mercedes Benz Truck ML 350 4MATIC (164.186) V6-3.5L (272.967)

No cooling output, fault code 9006 in air conditioning control unit

Topic number	L183.30-P-049644
Version	7
Design group	83.30 Air conditioning
Date	11-15-2016
Validity	All veh. of model series 164/251
Reason for change	Damage code adjusted

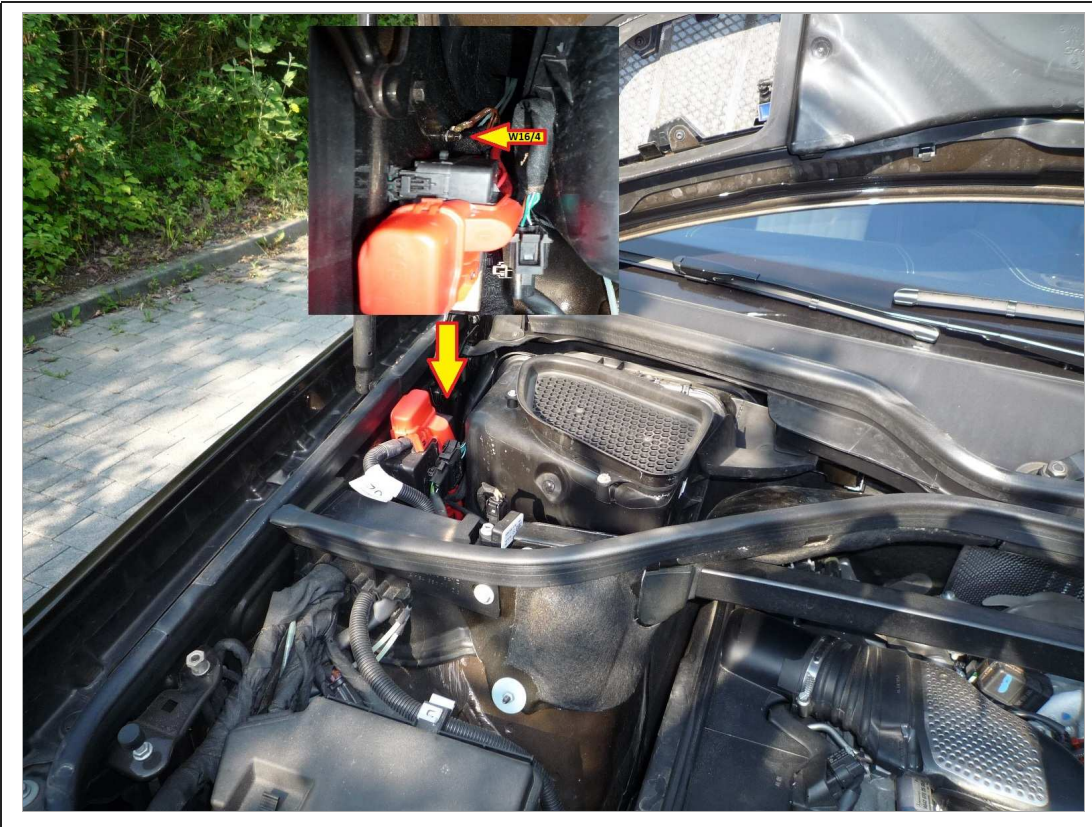
Attachments	
File	Description
Massepunkt W16-4.jpg	Ground point W16/4

7. From the connection of the regulation valve on the refrigerant compressor one cable with a cable lug is bolted onto the housing of the refrigerant compressor as a ground line; the other cable goes via the connector to the engine wiring harness. An additional ground line with a cross section of 0.75 mm² must be properly routed from the bolt-on point of the ground cable on the housing of the refrigerant compressor to ground point W16/4 in the front right of the engine compartment below the engine hood hinge (see photos in attachment).
