2007 Mercedes Benz Truck ML 63 AMG (164.177) V8-6.3L (156.980)

Vehicle » Technical Service Bulletins » All Technical Service Bulletins » A/C/Interior - Blower Won't Turn **OFF/Interior Water Leak**

Order No.: T-B-83.10/112b

Water Entry into Vehicle Interior

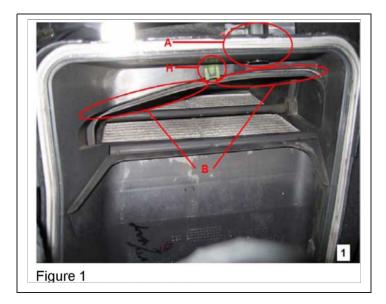
If you receive customer reports in the above model vehicles of a nonfunctional blower motor (blower motor runs continuously) or water drops in the front passenger footwell after an engine wash, this may be caused by an insufficient sealing of the air/water box when a lot of water is used when the engine compartment is cleaned near the right side of the firewall. The affected areas are the air quality sensor shown as A in Figure 1, 3 and 4 and the sealing surface between the firewall and air intake pipe housing shown as B in Figure 1 and 4. To remedy, proceed with the following.

- 7. Visually check vehicle interior for leaks. In the area of the removed interior filter, the sealing surfaces of the air quality sensor (Figure 1, 3 and 4, item A) and the sealing surface between the firewall and the air intake pipe housing (Figure 1 and 4, item B) are visible.

- 8. Seal off areas of the seal affected by water entry. Detach the air intake pipe housing by removing the retaining clip (Figure 1, H) and the two threaded connections (Figure 4, J). Seal the surfaces between the air quality sensor/air intake pipe housing (Figure 4, A) and firewall/air intake pipe housing (Figure 4, B) using Terostat 934 sealing compound (A004 985 29 20).

- 9. Repeat the leak test steps 5 and 6. If no water ingress can be found, remove the external water hose and reassemble the vehicle in the reverse order. If the retaining clip was not installed at the factory, retrofit a clip (Figure 1, H).
