## 2009 Mercedes Benz Truck ML 350 (164.156) V6-3.5L (272.967)

Vehicle » Technical Service Bulletins » All Technical Service Bulletins » Campaign - Retrofit Camshaft Adj. Solenoid Adapter Wire Harness

Campaign No. 2012070002, November 2012

Retrofit Adapter Wiring Harness on [Camshaft](#) Adjustment Solenoids

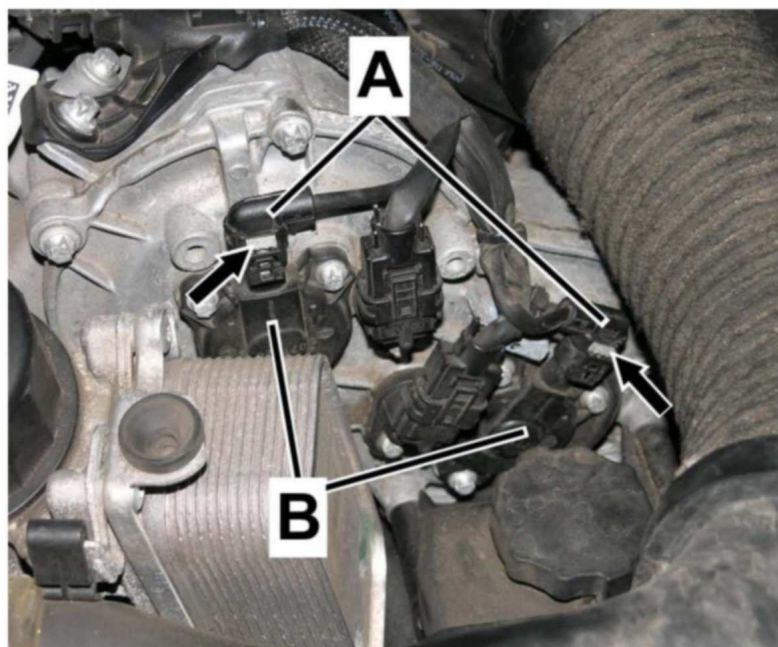
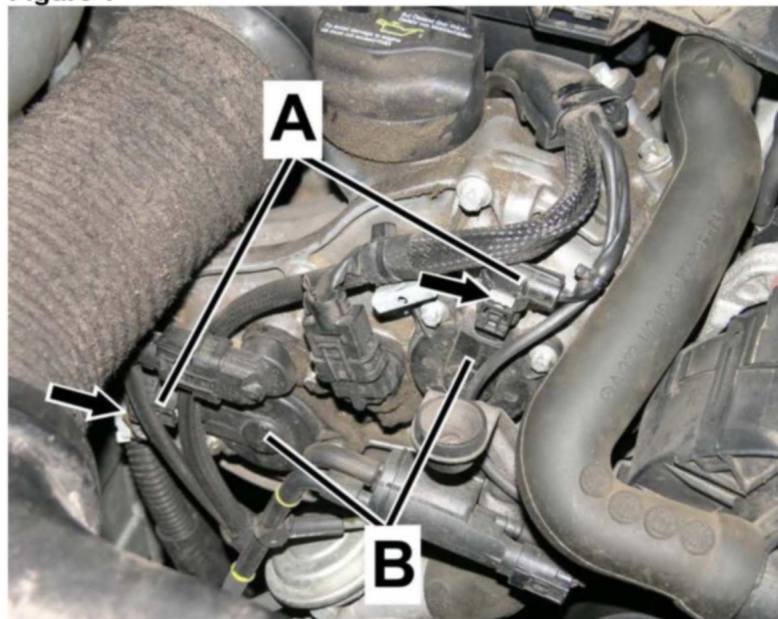
**Note:** Shown on engine 272

2. Disconnect **camshaft** adjustment solenoids from engine harness connectors (A, Figures 1 and 2) shown above.

^ Carefully unlock engine harness connectors (A) by squeezing and partially pulling out locking tabs (arrows) using pocket screw driver.

^ Disconnect **camshaft** adjustment solenoid connectors (A) from camshaft solenoids (B).
