2006 Mercedes Benz Truck ML 500 (164.175) V8-5.0L (113.964)

NO COOLING OUTPUT, FAULT CODE 9006 IN AIR CONDITIONING CONTROL UNIT

Topic number LI83.30-P-049644
Version 7
Design group 8030 Air conditioning
Date 11-15-2016
Validity All veh. of model series 164/251
Reason for change Damage code adjusted

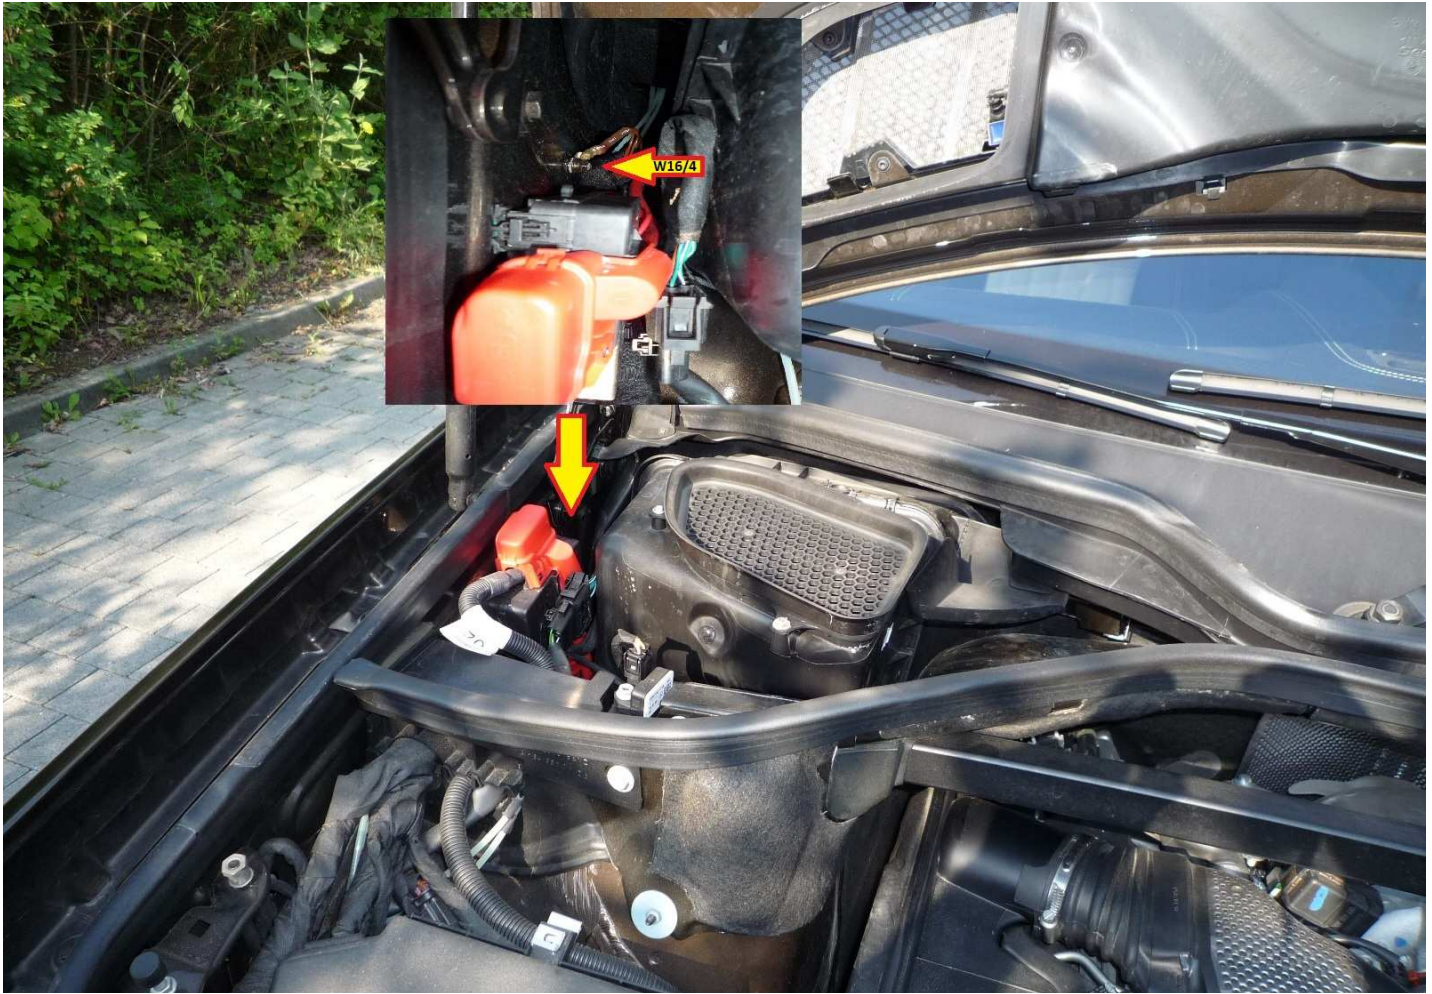
Massepunkt W16-4

7. From the connection of the regulation valve on the refrigerant compressor one cable with a cable lug is bolted onto the housing of the refrigerant compressor as a ground line; the other cable goes via the connector to the engine wiring harness. An additional ground line with a cross section of 0.75 mm² must be properly routed from the bolt-on point of the ground cable on the housing of the refrigerant compressor to ground point W16/4 in the front right of the engine compartment below the engine hood hinge (see photos in attachment).

Ground point **W16/4**
