DTB

Date: April 23, 2009
 Order No.: S-B-03.30/08i
 Supersedes: S-B-03.30/08h dated October 24, 2008
 Group: 03

SUBJECT: **Model 164.156/172/186/871/886**
Model 171.454/456
Model 203.052/054/056/087/092
Model 204.054/056/081/987
Model 209.356/372/456/472
Model 211.056/072/087/090/256/287
Model 216.371/386
Model 219.372
Model 221.171/186
Model 230.471
Model 251.156/165
Equipped with M272 or M273 Engine
Check Engine Light On / Fault Codes Current and/or Stored in ME-SFI Control
Module / Oil Leaking at Camshaft Adjustment Solenoid

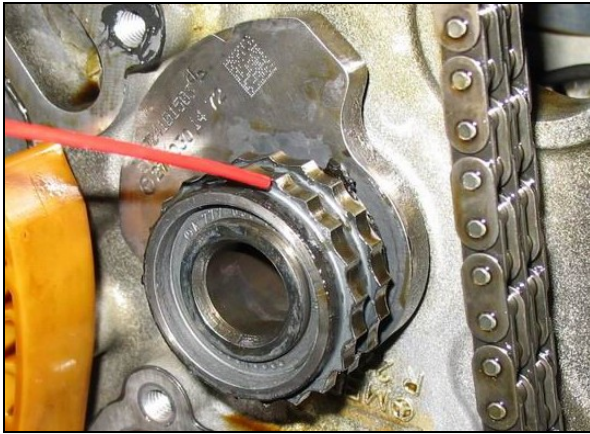
Fault Code Scenario 1: DTC ^{P0017} 1200 ^{P0016} and/or 1208 is/are present in ME-SFI control module. The fault codes are recorded as current and/or stored in the fault memory. When the fault memory is erased and the engine is restarted, the fault codes reoccur immediately. This is due to the positioning of the timing chain driven camshafts relative to the crankshaft and **can be caused by a worn sprocket on the balance shaft** on engine M272 or by a worn guide (idler) gear for the timing chain on engine M273. Figure 1, 2 and 3 show extremely worn sprocket gears. Figure 4, for comparison, shows a new sprocket gear.

Figure 1 – Damaged/worn S-B-03.30/08a

- b) Only if worn (sprocket teeth profile damaged), replace the balance shaft on engine M272 or replace the guide (idler) gear of the chain drive on engine M273 as per WIS instructions AR03.20-P-1000* (* - applies to a specific model designation e.g. AR03.20-P-1000VA – model 171).

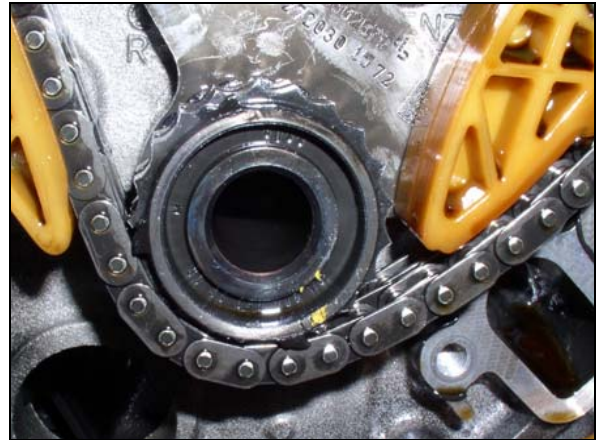
Figure 2 – Damaged/worn S-B-03.30/08i

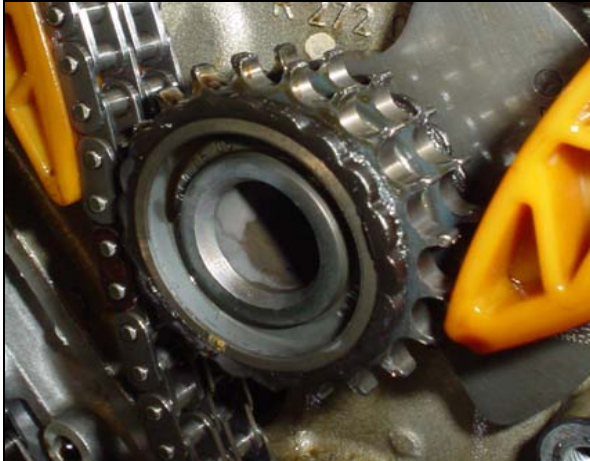
Figure 3 – Damaged/worn S-B-03.30/08i

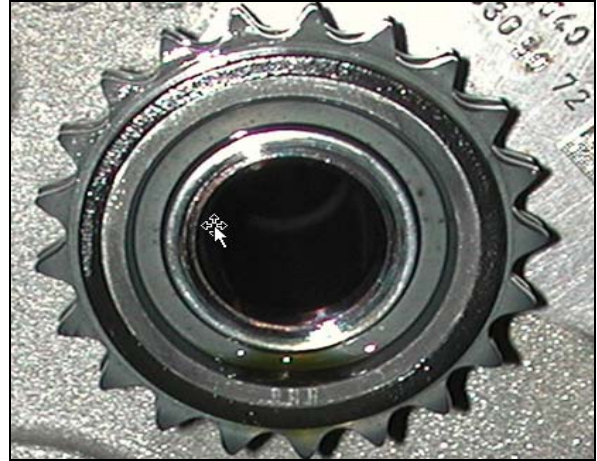
Figure 4 – **New Gear** (comparison) S-B-03.30/08i

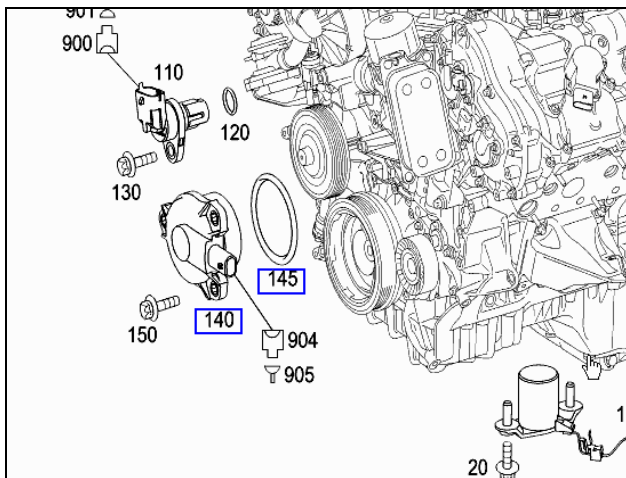
Figure 5

Fault Scenario 3: Camshaft adjustment solenoid is leaking oil, and no Fault Codes are current or stored in the ME Control Module. Determine the cause of the leak. The solenoid can be leaking from under the sealing ring or through the harness connector.

- a) If the leak appears to be between the solenoid and the cylinder head replace solenoid sealing ring (Figure 5, 145).
- b) If the leak is from the electrical connector, replace the solenoid (Figure 5, 140).
