W/X 166 – Sealing bodyshell openings Page 1-19

Date of issue: 2016.10.21 GSP/TPB I

1. BR166 - Sealing bodyshell openings

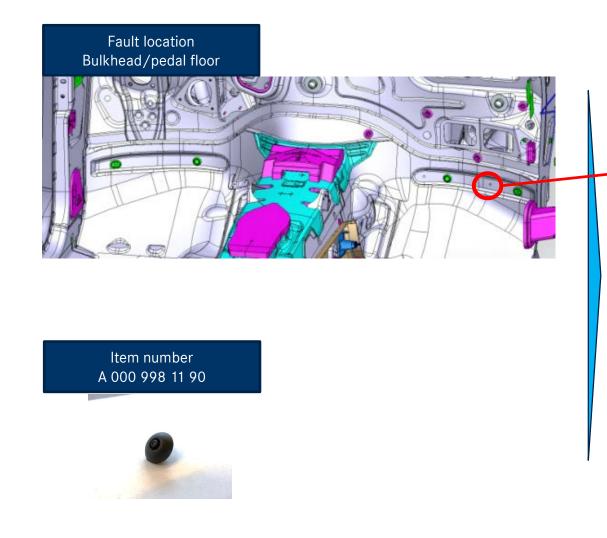
Bodyshell hole open

Bodyshell hole sealed

Note: Perform measure on the right-hand side for left-hand-drive vehicles.
