HVAC BLOWER MOTOR INOPERATIVE AND DTC 912F87 TECHNICAL SERVICE BULLETIN

Reference Number(s): LI83.10-P-063859 Version 2,Â Date of Issue:Â August 8, 2016
 Mercedes-Benz: All vehicles of model series 166
 Design Group: 83.10 Ventilation
 Reason For Change: Corrected model validity

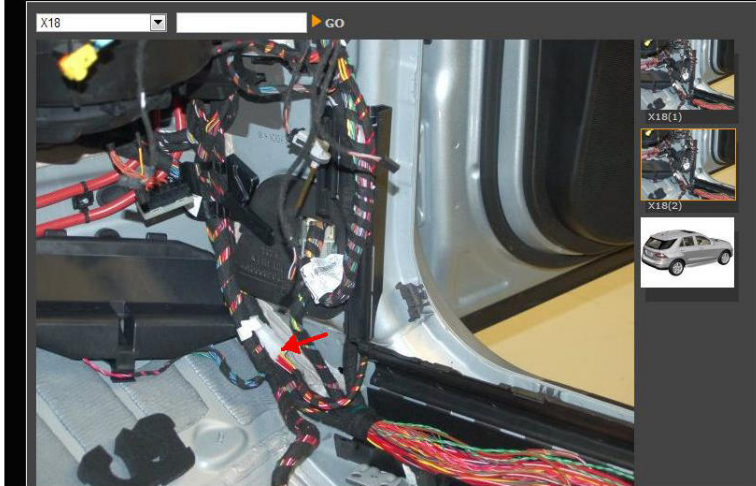
Damaged pin 2 in the X18(2) connector, which is located at the bottom of the right a-pillar. Pin 2 is the power supply to the regulator A32n1.

<p>PE 83.40.P-2105NAA - Thermotronic Automatic air conditioning (AAC (KLA))</p>	<p>X18(2) location from Star Finder</p>

If damaged, replace or repair as per WIS instructions for wiring repair. Refer to parts section for related pin and connector part numbers.

NOTE: Inspect any surrounding pins in connector for damage and repair as necessary.
