# Evaluating Wear on AMG Carbon-Ceramic Rotors

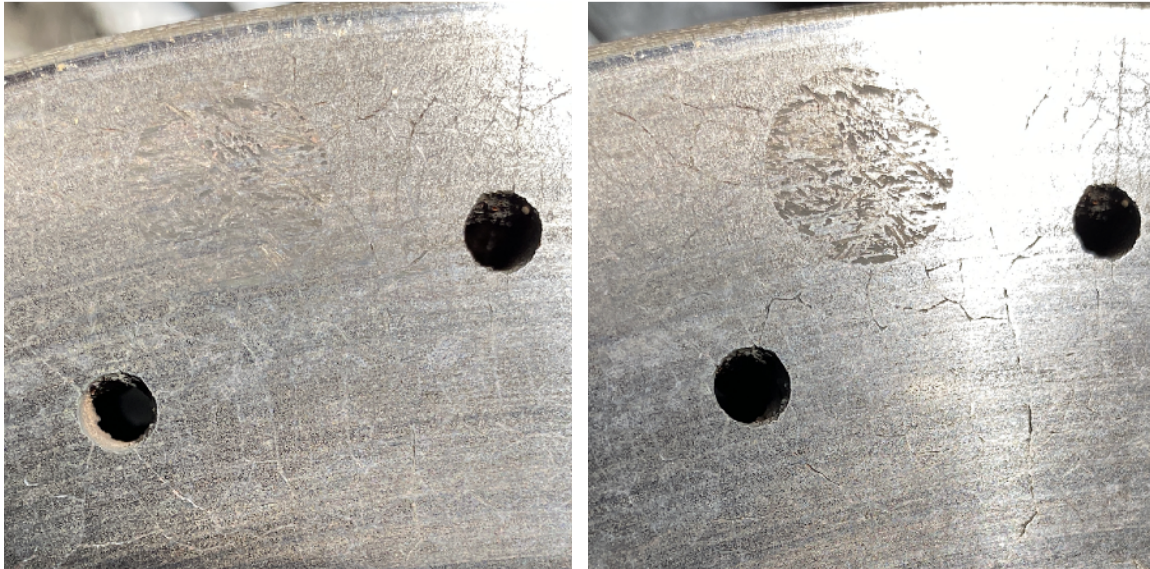
These are 2 "raw" pictures of the same rotor wear-indicator that were captured under bright-light conditions, one after another, with only a small change in shooting angle. They illustrate the type of significant differences that can result from not having a rigorous process/tool-set (i.e., filming "jig") for obtaining the pictures:

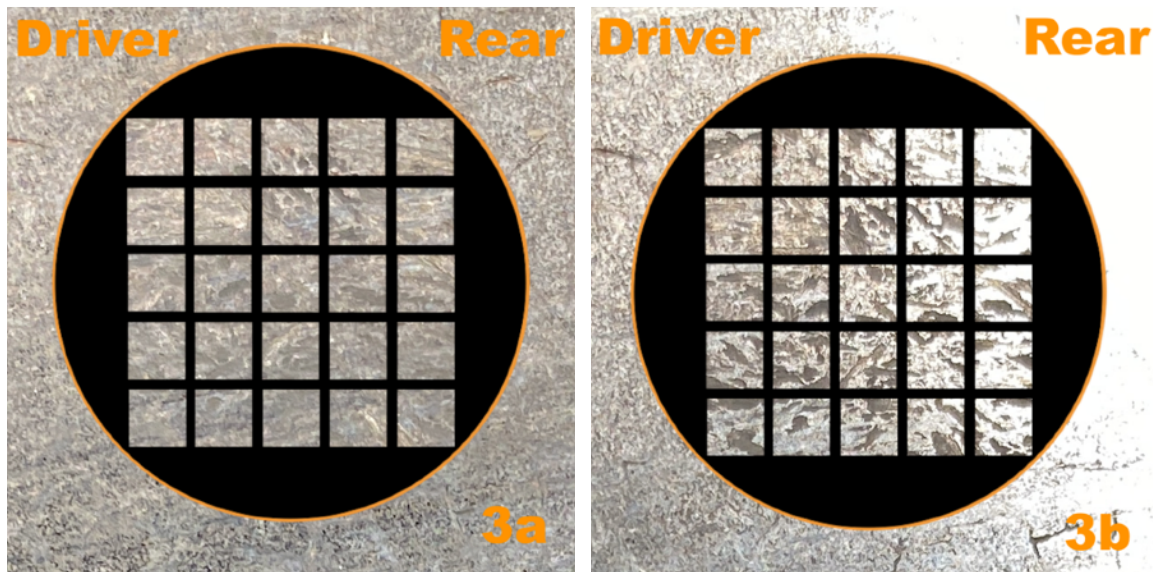
Applying a mask tool to these pictures yields the following:

Using the above left photo would imply there are very few "light point" areas. Using the above right photo would imply a very large percentage of "light point" areas, perhaps 80-90% "light point squares." In addition to the lighting-differences issue this illustrates, I strongly suspect that

much of the "white points" appearance is due to the fact that the rotor has (proper) brake-pad deposits from the bed-in process.

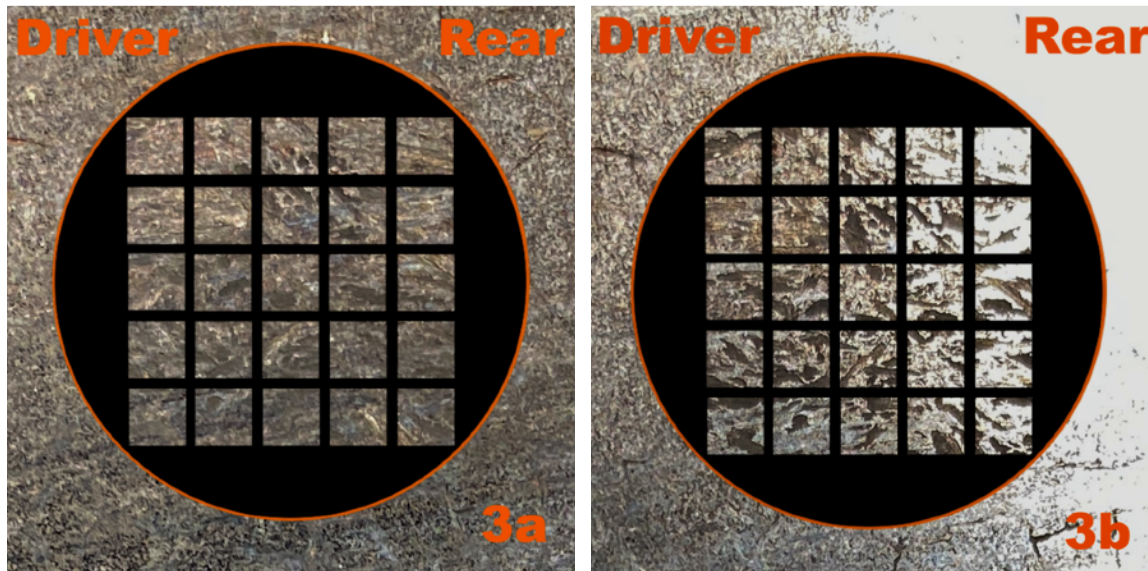
Using some image processing to somewhat normalize the above pictures yields the following:

Even with all this effort to normalize these pictures, there's still a significant difference between them and the interpretation/evaluation that could result. For this process to work, you'd first need to be able to get consistent pictures.
