**SUBJECT:**

All Models with Automatic Transmission 722.9, 7G-Tronic (NAG2) Uncomfortable Shift Quality of 1-2, 3-2 and 2-1 Gear shifts

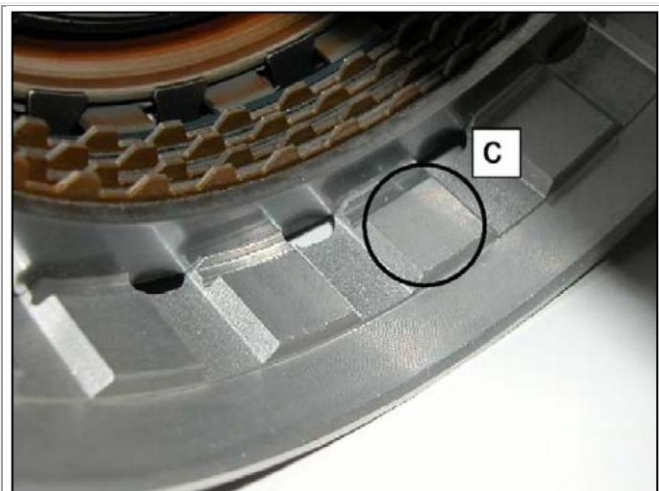
Figure 1

**NOTE:** There are two different versions of the B1 and B3 multi-disk brake. It is essential to ensure that the retaining ring is ordered correctly. Refer to Figures 1 through 3 and the parts table, identification groove on the inside/outside of the plate supports.
