NOVEMBER 2016 PASSENGER CAR TECHNICAL TOPICS

November 15, 2016

Mercedes-Benz

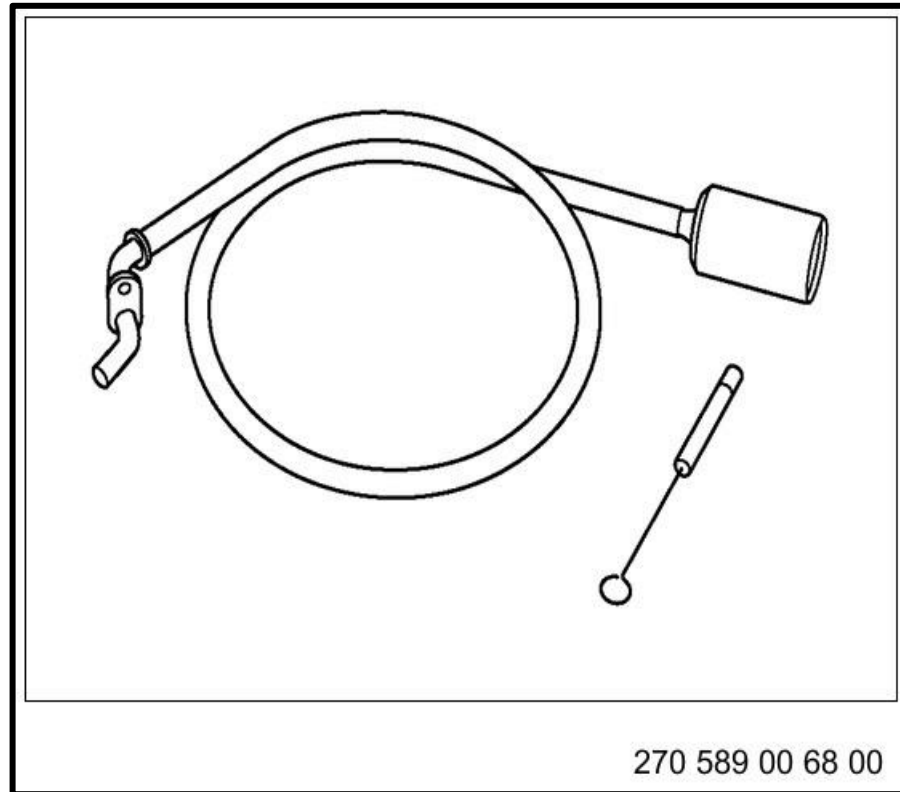
Special Tool W270 589 00 68 00 (cont.)

When dismantling spark plugs there can be dirt particles in the shaft.

After removing the ignition coils, blow out any residue in the spark plug recesses using compressed air. It may be necessary to vacuum recesses using special tool W270 589 00 68 00 to ensure no contamination or foreign objects enter the engine when spark plugs are removed.

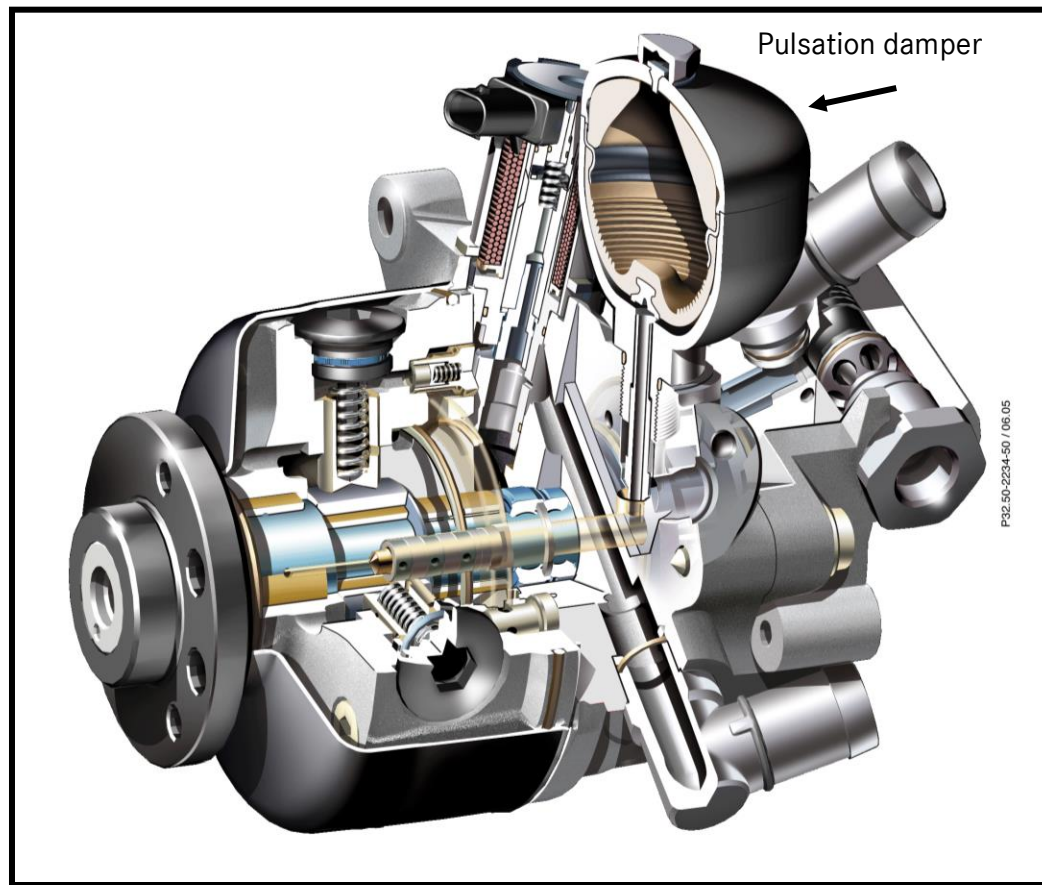
Humming / Howling Noises Heard From Underfloor Area From Idle To Approx. 2000rpm (Above 2000rpm Noise Drowned Out By Engine Noise) (cont.)

The QEC has reported that many ABC tandem pumps have been replaced when only the pulsation damper is needed.

With the introduction of ABC PLUS (as of model year 2006), the pulsation damper is located on the tandem pump and can be replaced separately. Replacement of the entire ABC tandem pump is not required. Any ABC tandem pumps replaced for noises which are synonymous to the noise described in the LI may be subject to debit. See LI32.50-P-048280 for further information.

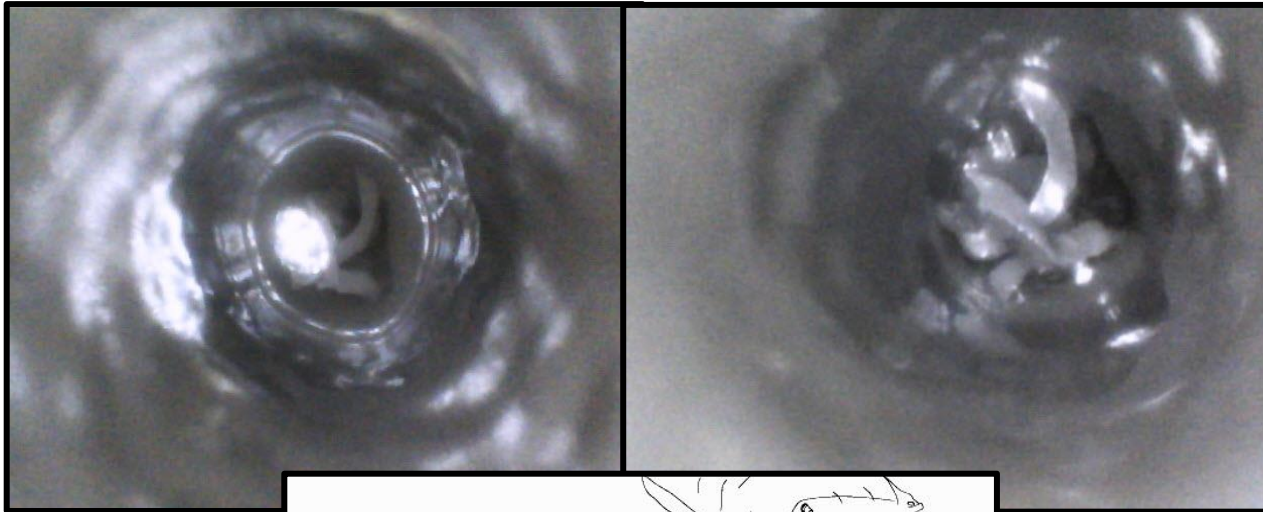
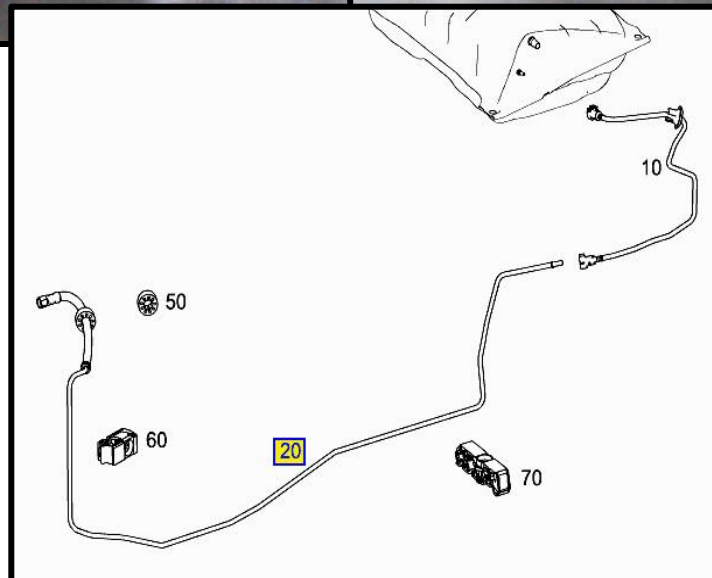
Multiple Misfires Usually During High Load Acceleration (cont.)

Inner liner of low pressure supply hose has collapsed.

Include inspection of inner liner during course of diagnoses. If issue found, replace fuel lines from tank to the high pressure side (engine side). Line A190 470 02 00 must be installed. EPC includes a note that the old part number must not be installed.

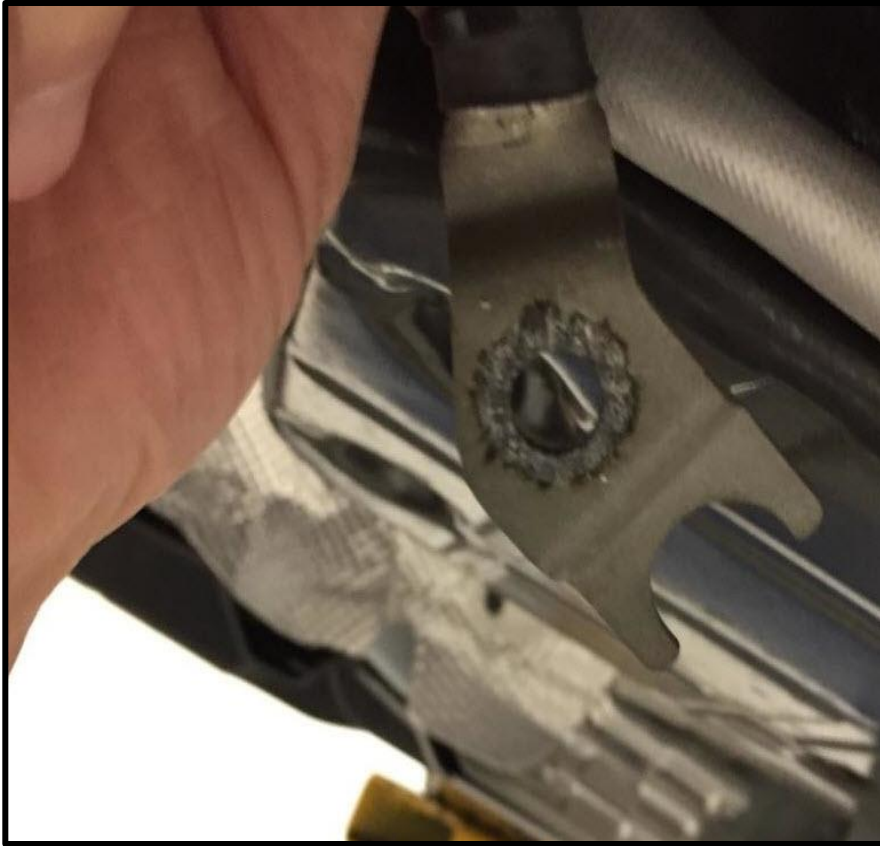
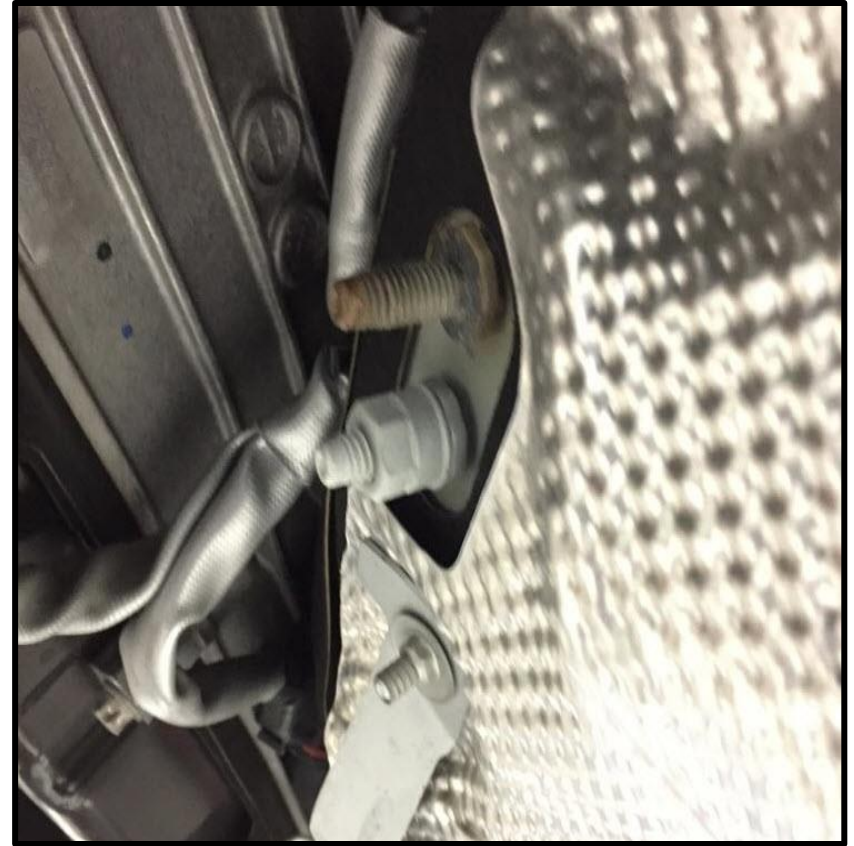
Catalyst Damage Down The Center Of The Monolith (cont.)

Improper connection at body ground strap results in power loss at injectors and coils.

NOTE: Faults for misfires in multiple cylinders may exist.

If catalyst is found melted, check body ground strap for proper connection. In most cases, previous repairs were made to the vehicle where the ground strap was removed and not properly re-installed. Ensure that proper torque procedures are followed when re-installing the ground strap.
