## FACTORY SERVICE BULLETINS

### Knocking Noise in Rear Door When Operating Power Window

Model 164.122/172/175/177  
186/822/871/886,  
up to VIN A258996,  
Model 251.122/156/165/175/177,  
up to VIN A058266

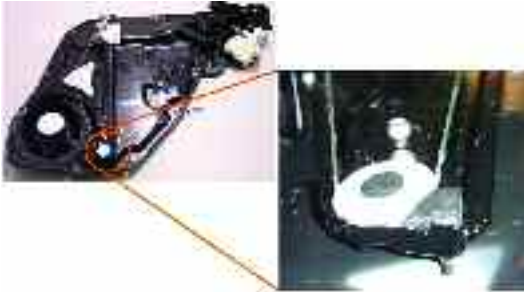
A knocking noise that occurs when the power window is operated downward and reaches the lower limit position may be caused by a broken plastic limit stop. To remedy, perform the following.

1. Remove door lining. Refer to WIS document AR72.12-P-1010GZ (164) or AR72.12-P-1010RT (251).
2. Remove door module. Refer to WIS document AR72.12-P-0103GZ (164) or AR72.12-P-0103RT (251).
3. Remove broken limit stop from door.
4. Install new limit stop (Figure 1).
5. Reinstall door module. Refer to WIS document AR72.12-P-0103GZ (164) or AR72.12-P-0103RT (251).
6. Reinstall door lining. Refer to WIS document AR72.12-P-1010GZ (164) or AR72.12-P-1010RT (251).
7. Renormalize power windows.
