Campaign No. 2006080004, November 2006

SUBJECT: **MODEL 215, MODEL YEAR 2000-2002, 2004-2005**  
**MODEL 220, MODEL YEAR 2000-2002, 2004-2005**  
**INSPECT INSTRUMENT CLUSTER AND REPLACE IF NECESSARY**

**Safety Recall #2006080004**

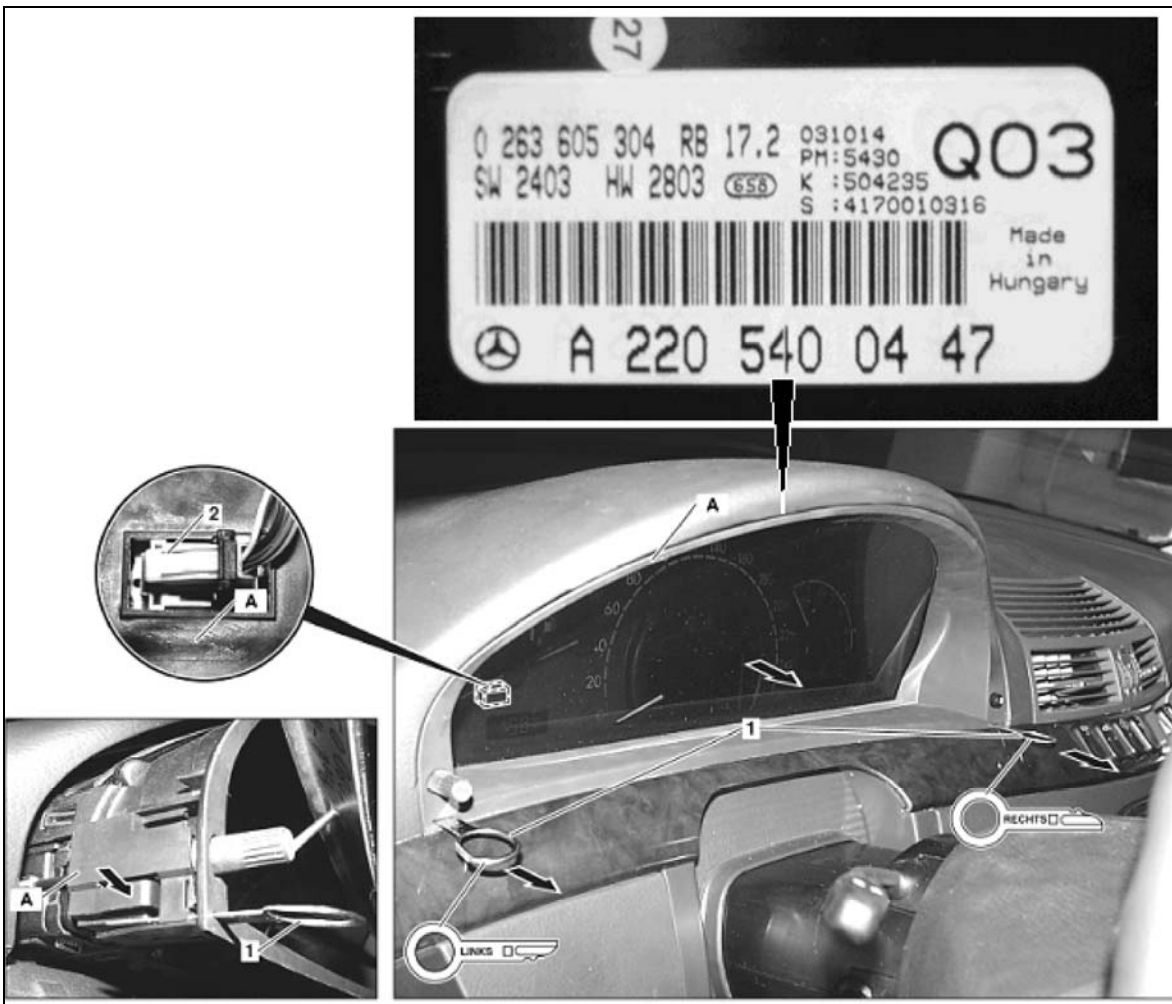
Figure 1

1. Move steering wheel out towards driver and down.
2. Remove instrument cluster (A, Figure 1) with connector (2) still attached.
  - Use removal keys (1, Figure 1; Special Tool W 963 589 01 05 00).

3. Check instrument cluster part number.
  - If part number does not match an affected part number below: Reassemble in reverse order; this campaign has been completed.
  - If part number matches an affected part number below: Proceed to Subject **B** to replace cluster.

1. Connect Star Diagnosis.
2. Read data out of old instrument cluster.
  - Navigate through following DAS menus: "Control units/ Information and communication/ ICM – Instrument cluster/ Initial startup/ Initial startup with automatic takeover of previous control unit"
  - Proceed to next step once prompted by DAS to replace control unit
3. Loosen catch of connector (2, Figure 1) and remove connector.
