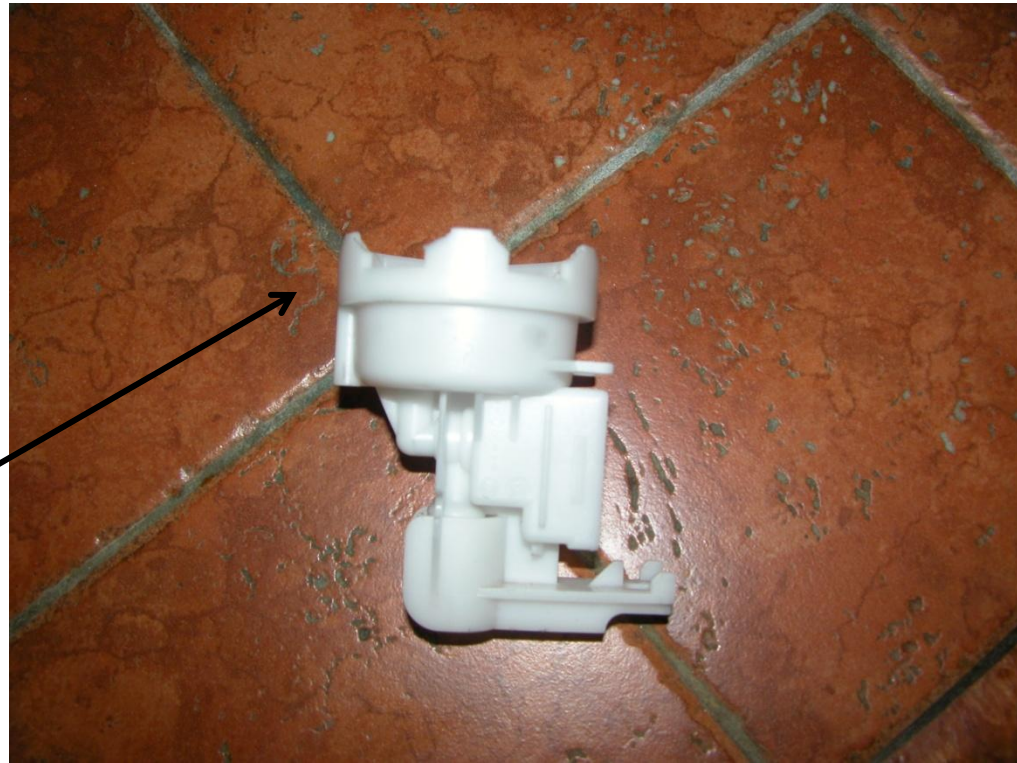
You can see here
that the cap has
sheared.

Drilled these two rivets out.
