Mercedes Benz

star bulletin

Order No.: P-B-01.20/13

**SUBJECT: MODELS 215.378 AND 220.178 WITH ENGINE M137
ENGINE RUNNING COMPLAINTS IN CONJUNCTION WITH BLUE SMOKE AND/OR HYDROCARBON
ODORS SMELLS DURING FIRST START UP**

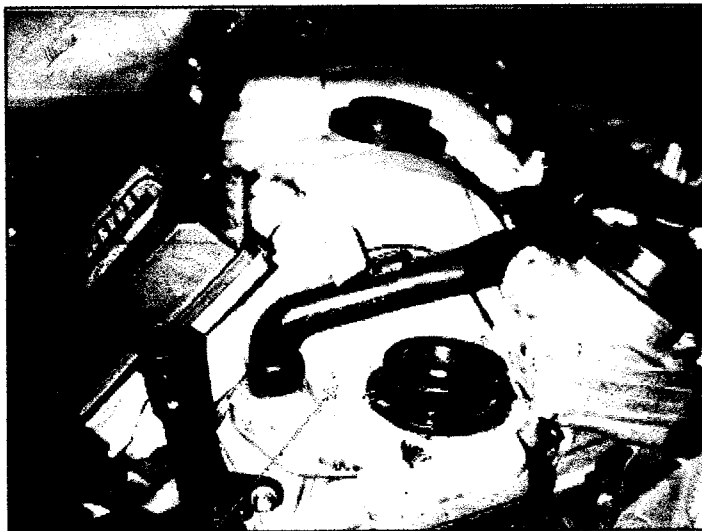
Cause: PCV (positive crankcase ventilation) System intake assembly (front cover, right cylinder head) oil condensation clogged with oil sludge. Refer to Figure 1 for part location.

Remedy: Remove and disassemble the front cover assembly of the right cylinder head. Refer to WIS document no. [AR01.30-P-6700L](#), up to and including step no. 14, for R&R of the front cover assembly of the right cylinder head. Inspect oil condensation drain for clogging (Figure 2) and clean out the oil sludge blocking the drain. Reassemble and reinstall the front cover assembly of the right cylinder head.
