**DTB**

Date: September 28, 2007  
Order No.: P-B-72.00/85  
Supersedes:  
Group: 72

**SUBJECT: Model 221.171/176/177/179/186  
Outside Door Handle Sticks in Pulled Position**

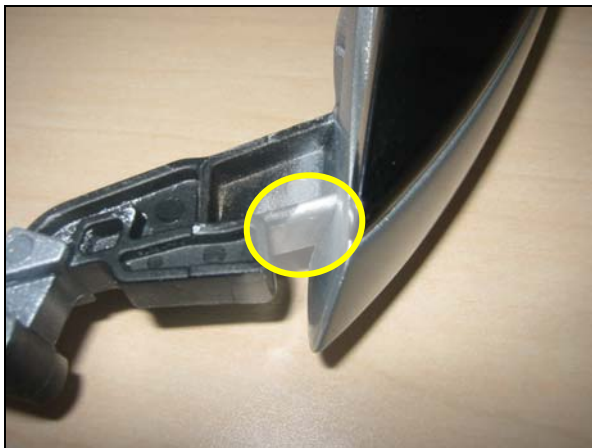
If you receive customer reports in the above model vehicles of the outside door handle sticking in the pulled out position on either the front or rear doors, the outside door handle may be contacting the door skin. Perform the procedure outlined below to resolve.

Figure 1 - Bevel the front rib P-B-72.00/85

1. Remove the outside door handle. Refer to WIS document AR72.10-P-2400SXS (front) or AR72.12-P-2410SX (rear).
2. Bevel the front rib of the outside door handle assembly (Figure 1 and 2) by approximately 45°.
3. Install the beveled outside door handle (Figure 3).

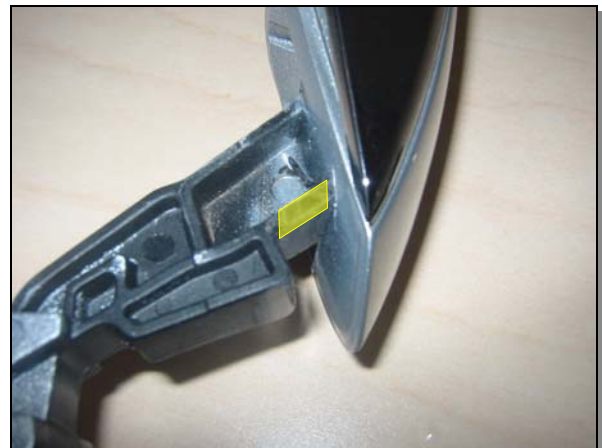
Figure 2 - Front rib beveled 45° P-B-72.00/85
