star bulletin

Date: February 7, 2012
Order No.: S-B-54.65/252
Group: 54

SUBJECT: MY-All, Models 163, 164, 166, 170, 171, 172, 197, 202, 203, 204, 207, 208, 209, 210, 211, 212, 215, 216, 218, 219, 220, 221, 230, 231, 240, 245, 251, 463 with Code 220 Parktronic system (PTS); Code 230 Advanced Parking Guidance; Code 235 Active Park Assist Parktronic Malfunctions and Faults

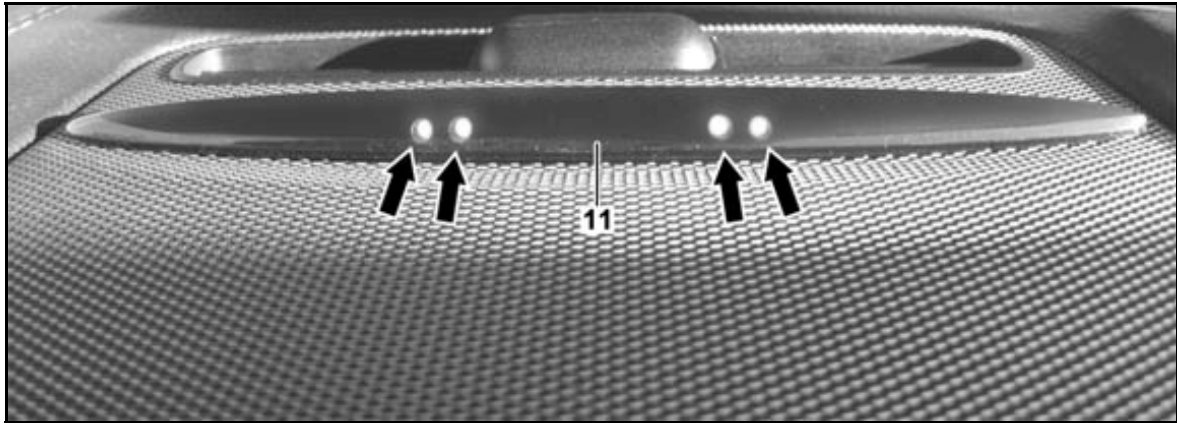
P54.65-4741-04

Malfunctions are indicated with double red (4 LEDs) warning elements and no warning tone (Figure 1).

Faults are indicated in the Parktronic warning elements with double red (4 LEDs) **with warning tone** (Figure 1) (see arrows).

Figure 1. Parktronic warning element.

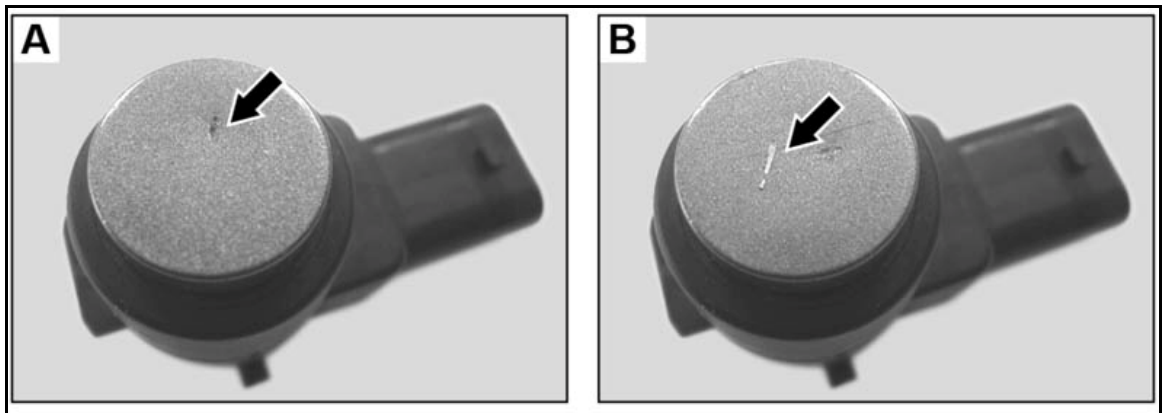
P54.65-4739-04

Figure 2. External damage through parking dents, stone chipping, etc.

To fix issues that cannot be clearly located via fault codes in fault memory, check for correct and central installation (Figure 3) (C) or for any damage caused by stone chippings (Figure 2) (A) (B).

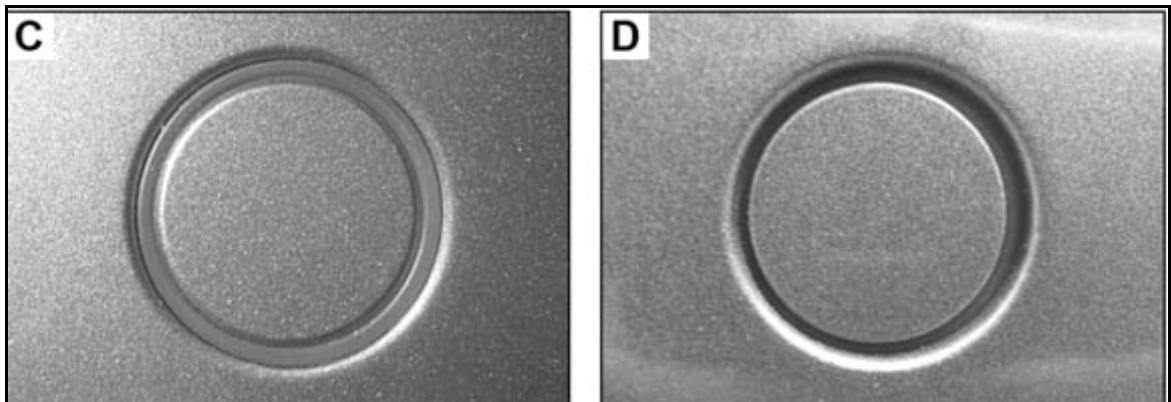
Figure 3. Correct centered installation (C); Incorrect and uncentered installation (D). P54.65-4742-04

The decoupling ring must be centered and custom fit when installed (Figure 3) (C) and Figure 4 (C).

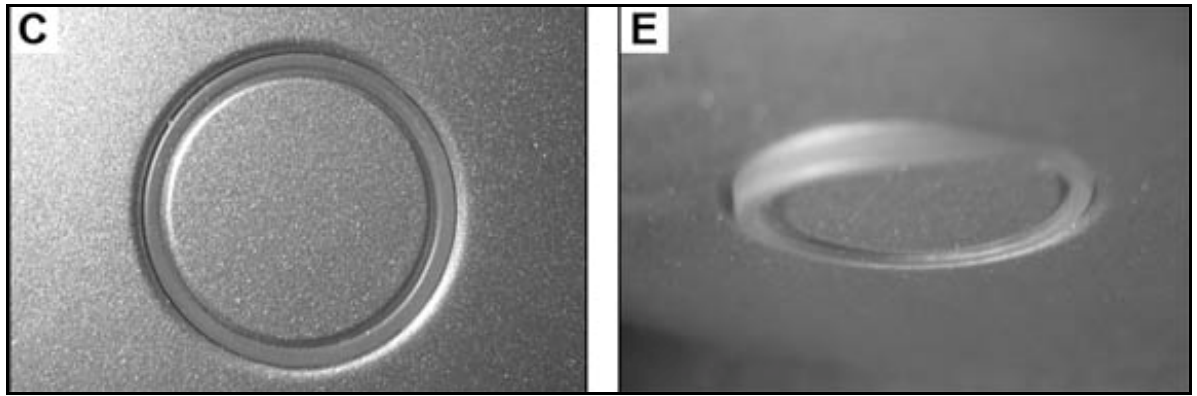
P54.65-4743-04

Figure 4. Correct installation (C); Incorrect installation (E).
