# **Service Campaign Bulletin**

### Campaign No. 2015030006, June 2015

SUBJECT:	Model 221, Model Year 2010	
	Replace Power Electronics

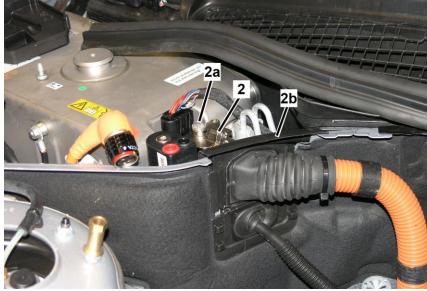
Figure 2 (supplemental illustration for WIS instructions)

Please refer also to Figure 2 when disconnecting high voltage battery connector from high voltage battery (step 5 of WIS: AR08.10-P-0011SXH).

- 2 High voltage battery connector
- 2a Screw
- 2b Bracket
