**DTB**

Date: September 26, 2008  
Order No.: P-B-72.00/57b  
Supersedes: P-B-72.00/57a dated May 23, 2008  
Group: 72

**SUBJECT: Model 216.371/376/377/379  
Model 221.171, VIN Range A009500 to A027500  
Door Stop Is Loose**

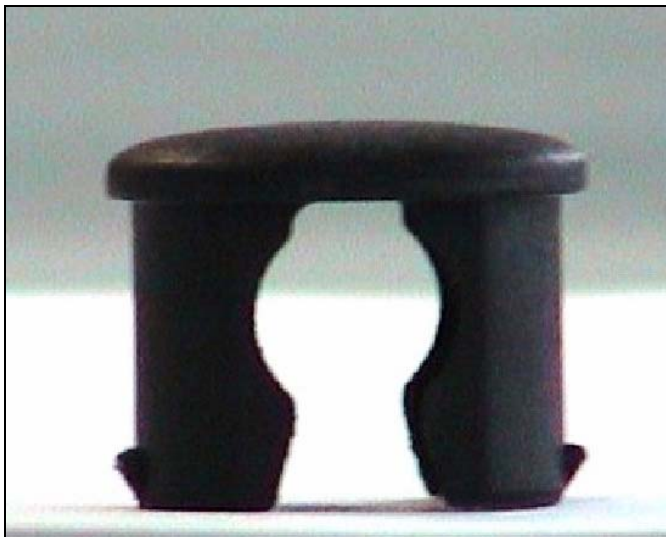
Figure 1

If you receive customer reports in the above model vehicles that either the front or rear door stop is loose because the plastic retainer (Figure 1) at the rod end has broken, the plastic retainer is now available as a spare part. Carefully align the new retainer with the socket when installing. It is no longer necessary to replace the complete front or rear door stop.

Qty.	Part Name	Part Number
1	Retainer	A221 727 12 14

**Operation:** Retainer – door stop (specify location), replace (72-0000)
