Order No.: P-B-91.40/115a

SUBJECT: Model 221.171/176/177/179/186 (with Option Code 223 or 223+224)

Rear Seat Belt Comfort Fit and/or Head Restraint Raising Mechanism Not

**Functioning When Fastening Seat Belt**

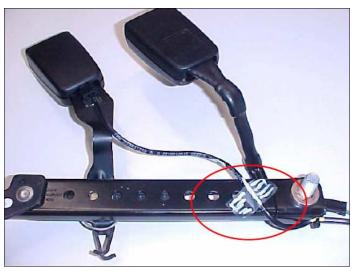
If you receive customer reports in the above model vehicles of the rear seat belt comfort fit and/or head restraint raising mechanism not functioning when fastening seat belt, the wiring from the buckle may be damaged. To resolve, perform the following procedure.

Figure 1 – Wiring secured with fabric tape P-B-91.40/115

- 1. Remove seat belt buckle. Refer to WIS document AR91.40-P-1516SX.
- 2. Secure the wiring on the replacement buckle using fabric tape as shown in (Figure 1).
- 3. Install in reverse order.
