Service Campaign Bulletin

Campaign No. 2010080002, September 2010

SUBJECT: **Model 221.195, Model Year 2010**
Re-route Wiring Harness for the Electric Air Conditioner Compressor

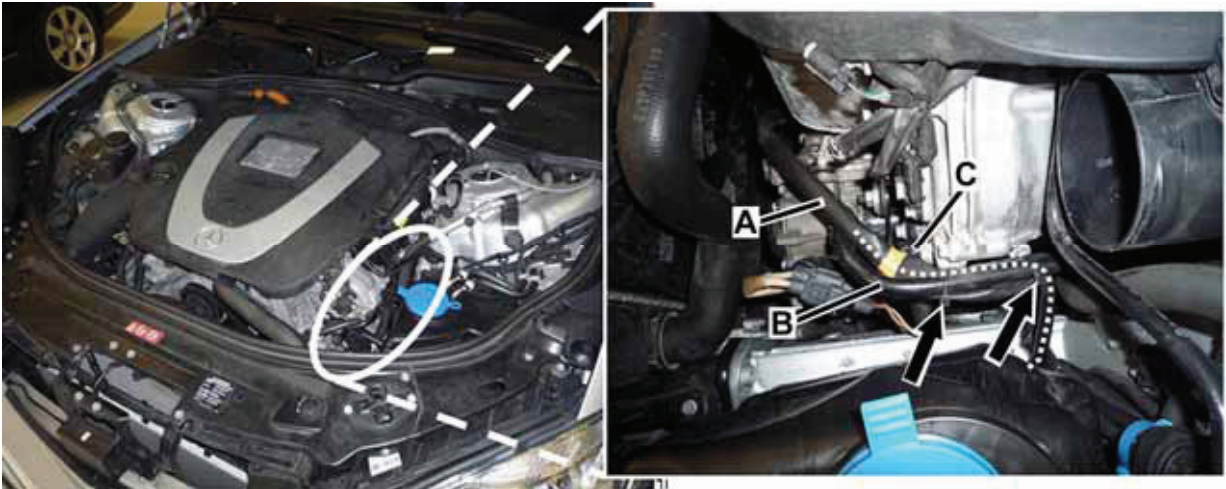
Figure 2

- Dotted line represents **incorrect** electric air conditioner compressor wiring harness routing.
- Do **not** remove cable tie (C), attached to electric air conditioner compressor wiring harness, secured to cylinder head cover (near yellow tape on harness).

2. Remove cable ties (arrows, Figure 2) securing electric air conditioner compressor wiring harness (A, Figure 2) to vacuum line (B).

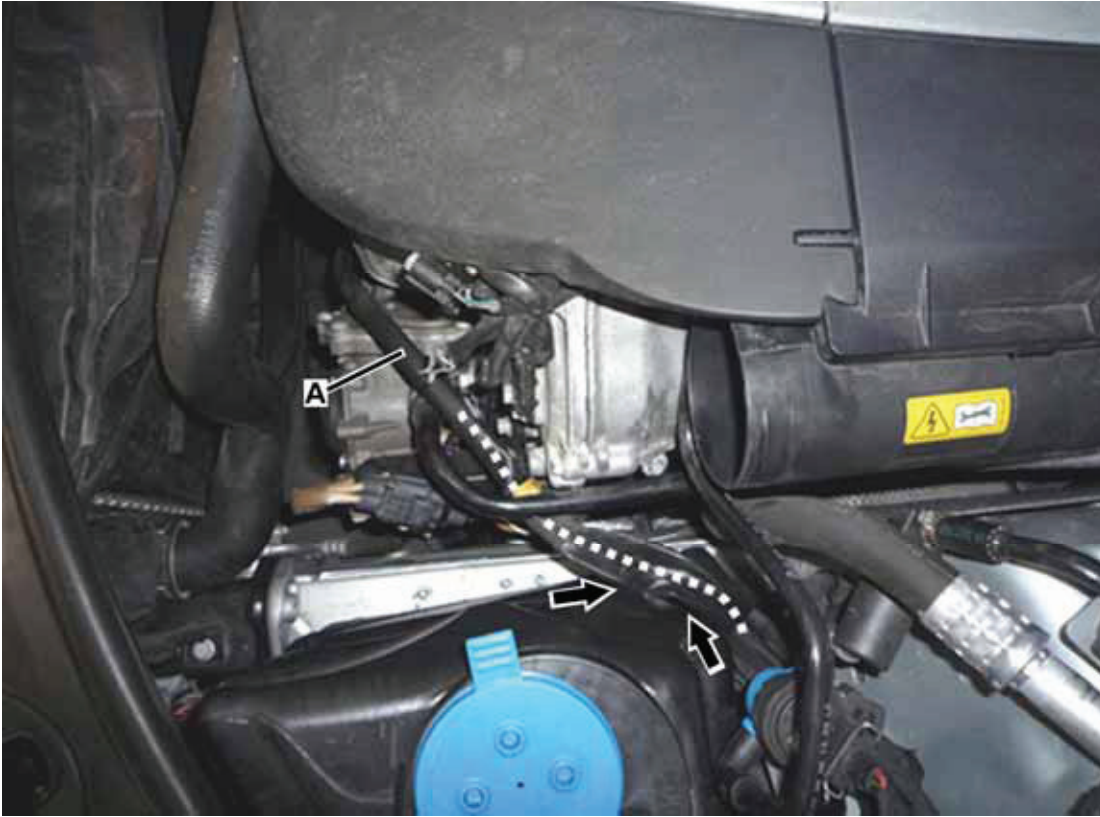
Figure 3

- Dotted line (Figure 3) represents **correct** electric air conditioner compressor wiring harness routing.
- Electric air conditioner compressor wiring harness must be routed so that harness is free of tension and so it cannot chafe on vehicle's components (e.g., body, engine components, etc.).

3. Re-route electric air conditioner compressor wiring harness (A, Figure 3) near lower part of windshield washer reservoir (arrows, Figure 3).
