Service Campaign Bulletin

Campaign No. 2012080004, November 2012

SUBJECT: **Model 221 (S400 Hybrid), Model Years 2010 - 2012**
Check the Power Electronics Module, Replace if Necessary

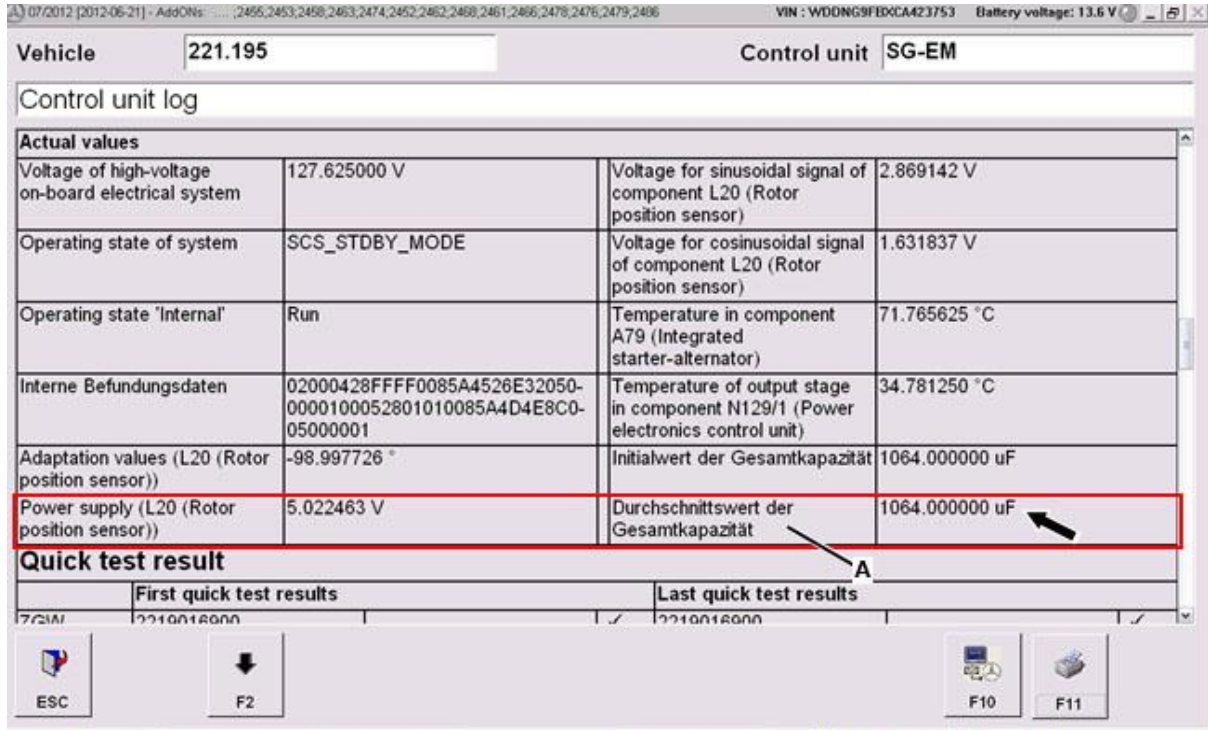
Figure 1

If the average value "0" is shown, the test sequence has not been completed successfully. The measurement (step 3) is to be performed here until a value greater than "0" is displayed.

- If average value is **equal to/greater than 800 uF (OK): Procedure is complete.**
- If average value is **less than 800 uF (NOT OK):** Proceed to subject **B**.

- The text in SDS is written partially in German (A, Figure 1) in the screen print below:
 "Durchschnittswert der Gesamtkapazität" this translates to: "Average value of total capacity".

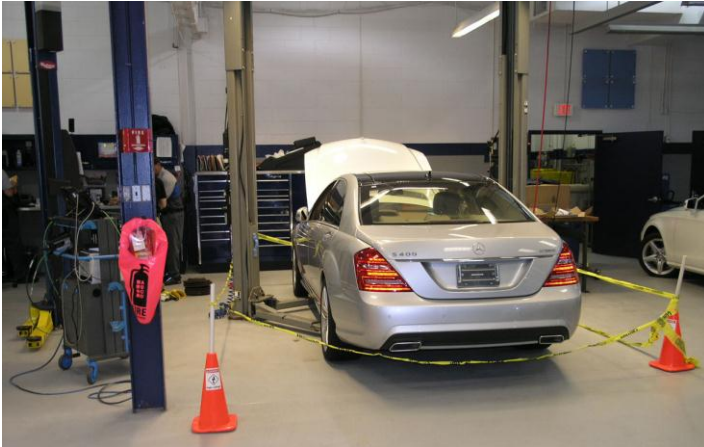
Figure 2

- Secure work area with high voltage warning tape and cones (Figure 2).
- Follow all safety precautions and notes in above WIS instructions.

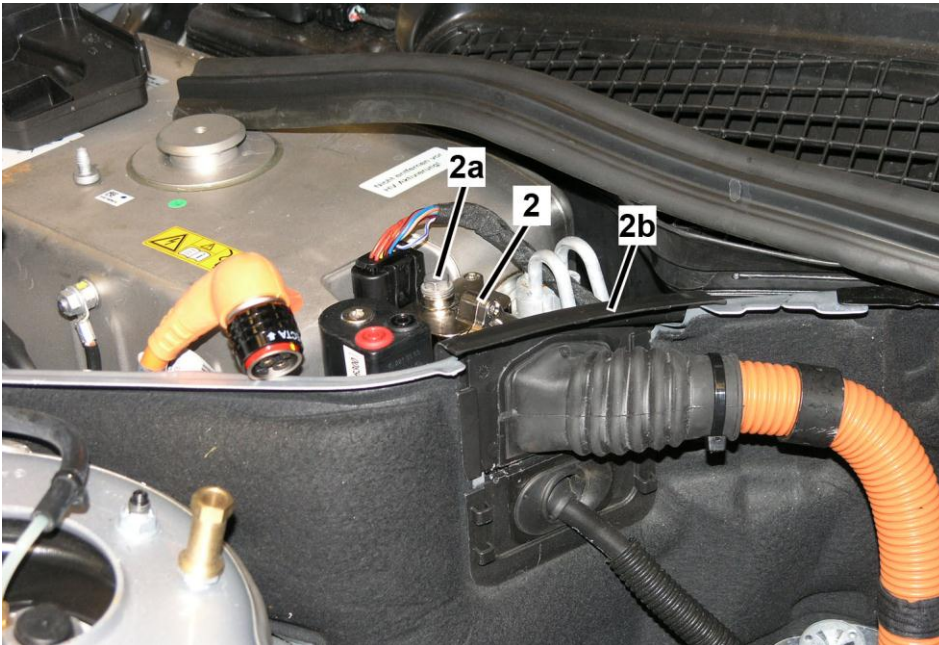
Figure 3 (supplemental illustration for WIS instructions)

- Please refer also to Figure 3 when disconnecting high voltage battery connector from high voltage battery (step 5 of WIS: AR08.10-P-0011SXH).

- 2 High voltage battery connector
- 2a Screw
- 2b Bracket

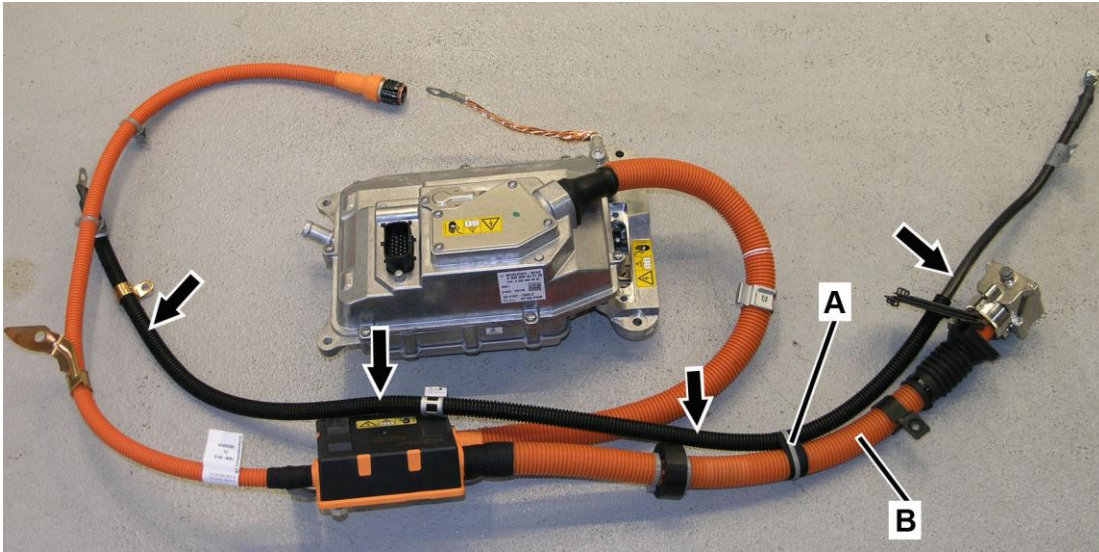
Figure 4

- Do not remove the existing alternator cable (arrows, Figure 4) from vehicle when removing power electronics module. Cut cable tie (A) to detach existing alternator cable (arrows) from old power electronics cable (B) and leave existing alternator cable (arrows) on vehicle
- Prior to installing **new** power electronics module, cut cable tie (A, Figure 4) and remove **new** alternator cable (arrows) attached to **new** power electronics module cable (B). The **new** alternator cable (arrows) does not get installed on vehicle.

IMPORTANT: Secure original alternator cable (arrows) to same position on **new** power electronics cable (B) with **new** cable tie (A) after installing power control module. Be sure to use **only** the cable tie listed in parts table.
