Coolant loss

Topic number	LI01.40-P-048649
Version	1
Function group	01.40 - Crankcase, timing case cover, end cover
Date	10/14/10
Validity	Engine 273 with 5.5 liters displacement in models 164, 209, 211, 216, 219, 221, 230, 251, 463 Engines with engine end numbers higher than 2739xx30270007 are not affected by this problem.
Reason for change	Cleanpoint added under Validity / Supersedes DTB S-B-01.40/25a

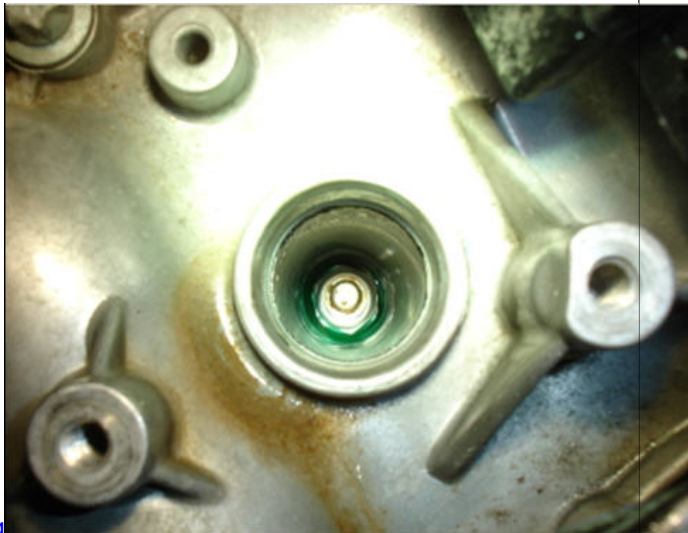
Coolant in spark plug recess

Engine has internal coolant loss.

If cylinder liners are poorly connected, coolant can pass through the valve cooling bore between the cylinders into the not pressurized oil galley in the cylinder crankcase.

This is repaired by gluing metal sleeves into the valve cooling bores in the cylinder crankcase.

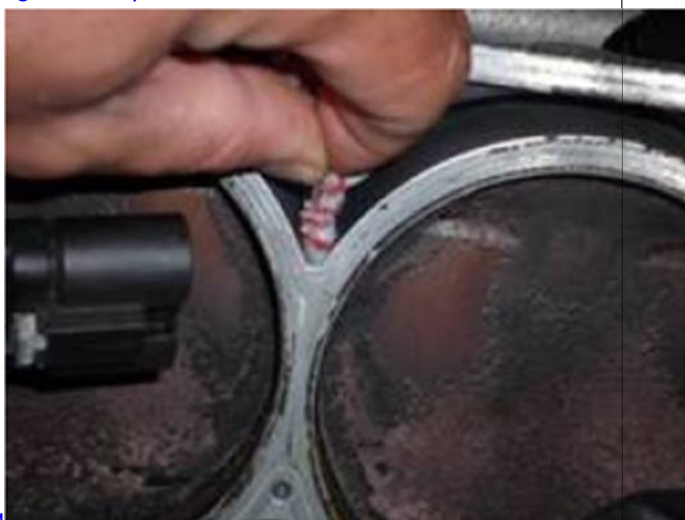
Attachments	
File	Description
cleaning coolant passa-ge.jpg	cleaning coolant passage

- Remove left and right cylinder heads (refer to WIS document in group 01).
- Clean the coolant passages in the crankcase with compressed air and pipe cleaner (make sure there no obstruction in the coolant passage - metal sleeves to be inserted must go all the way into the 3 mm coolant passage). Apply some Loctite with a new pipe cleaner into the 3 mm coolant passages (on the intake side) all the way down.

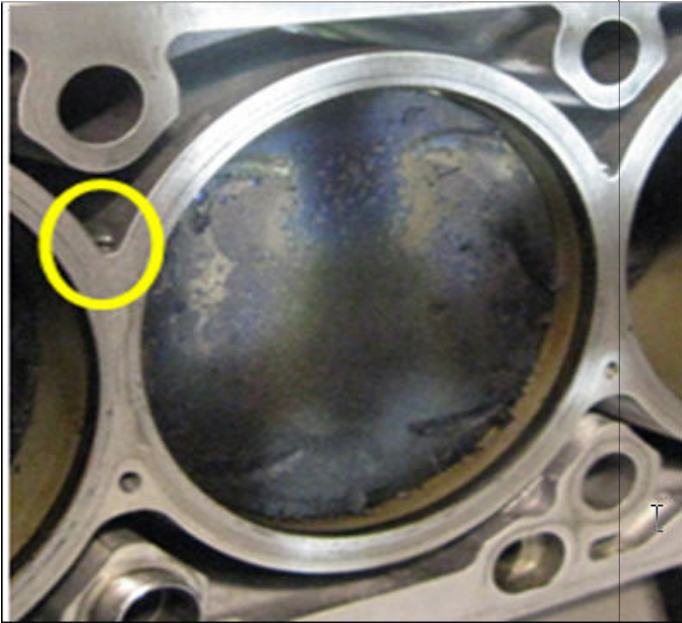
Coolant passage

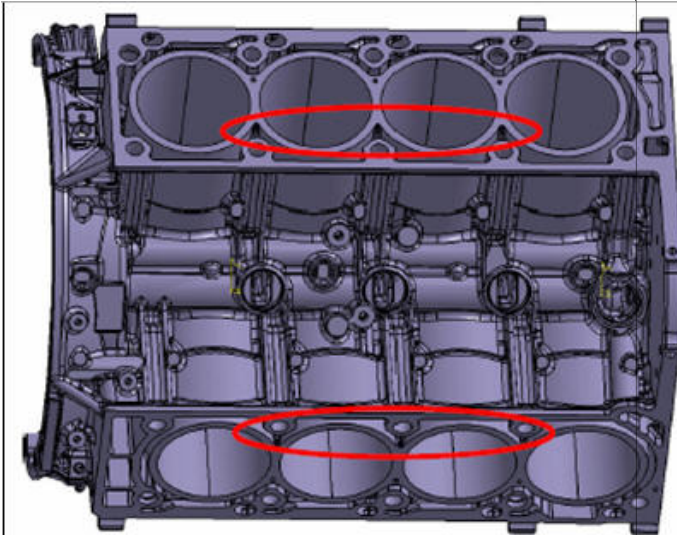
Coolant passages

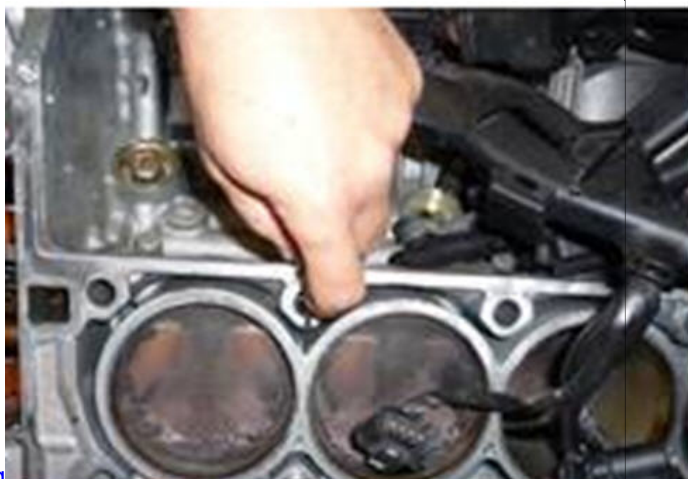
inserting metal sleeve

- Place one sleeve on a punch and apply Loctite 290 slightly on the whole surface.
- Insert the sleeve on the punch into the 3 mm coolant passage in the crankcase as shown in the illustration (metal sleeve must be flush with the coolant passage opening on the crankcase intake side).
- Fill the other side (4 mm) of the coolant passage (exhaust side) with Loctite nearly to the top. (Sleeves are only necessary for passages on the intake side - 3 mm opening of each cylinder bank.)
- Cover the 4 mm coolant passage opening (exhaust side) with a clean cloth. Remove the excess of Loctite applied after 2 hours by carefully blowing compressed air through the 3 mm side (intake side with the inserted sleeve) coolant passage opening. There is no concern that too much applied Loctite hardens in the coolant passage.
