FILE SERVICE: GROUP 00 OF SERVICE INFORMATION BINDER
PARTS: GROUP 1 OF INFORMATION_PARTS AND ACCESSORIES BINDER

Campaign No. 2009010002, March 2009

SUBJECT: **Model 221, Model Year 2007**
Check Both Front ABC Struts,
Replace Front Strut Ball Joints if Necessary

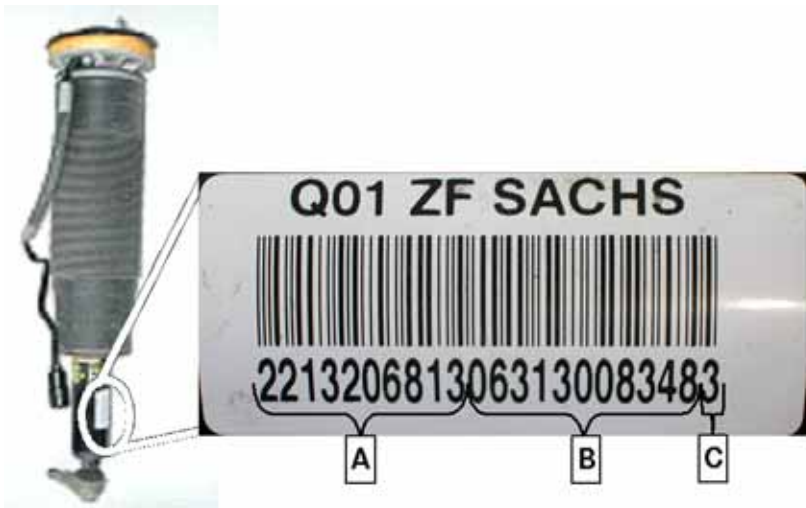
Figure 1

- **If only one of the of the front strut ball joints requires replacement (as indicated above), replace both front strut ball joints.**
- Disregard the last number (C, Figure 1) when checking the part number (this is a check digit)

2. In the table (above) Check whether the production number is lower than listed in the line of the existing part number:

- If production number higher than or the same procedure is complete.
- If production number is lower than listed proceed to Subject B (Replace Both ABC Front Strut Ball Joints).
