Service Campaign Bulletin

Campaign No. 2016110001, December 2016

SUBJECT: **Models 205, 217, 222, 253; Model Years 2015-2017**
Check Relays in Rear Fuse and Relay Module

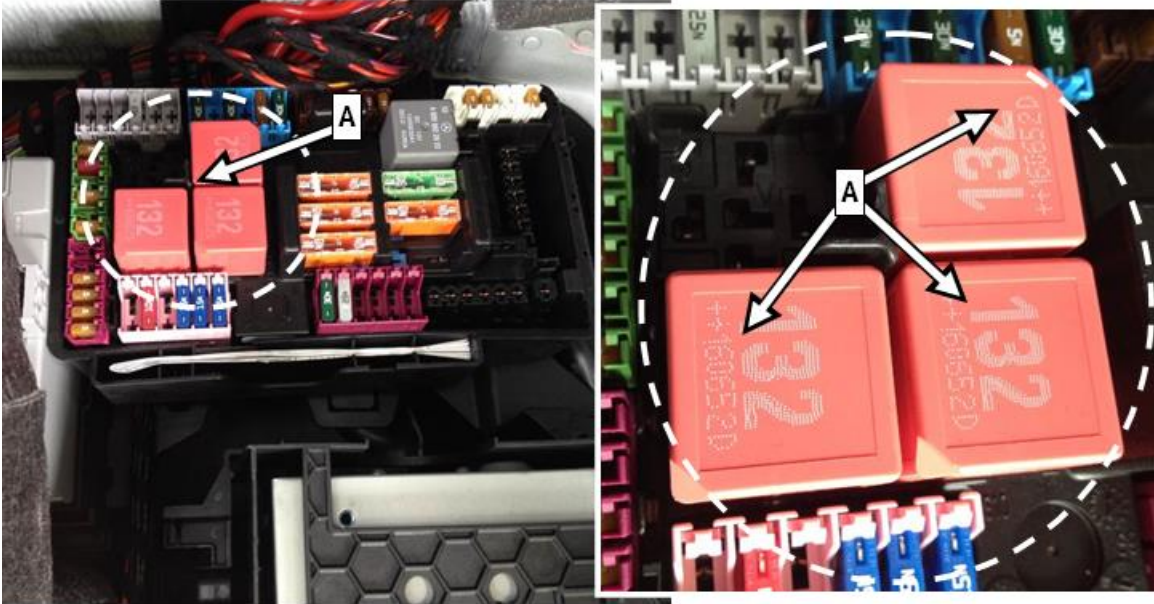
Figure 1

Check manufacture date of three relays (A, Figure 1) in rear fuse and relay module.

- If relay(s) do **NOT** have date code of: **1529** (15=year, 29=week) **(OK)**: Reassemble in reverse order, Procedure is complete.
- If relay(s) **have** date code of: **1529** (15=year, 29=week) **(NOT OK)**: Proceed to **Subject C**.

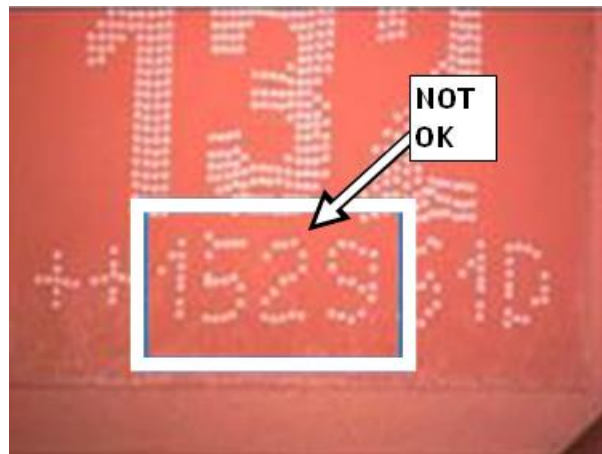
Figure 2 (Not OK) 1529 (15=year, 29=week)

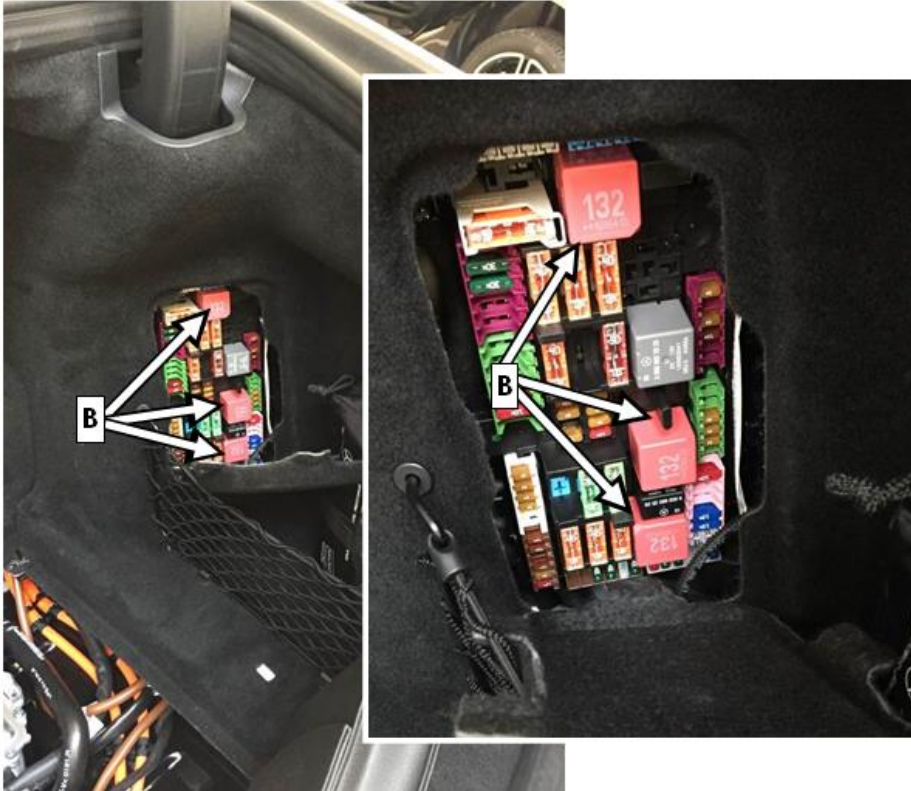
Figure 3

1. Open trunk lid.
2. Lift cover above rear fuse and relay module.
3. Check manufacture date of three relays (B, Figure 3) in rear fuse and relay module.

- If relay(s) do **NOT** have date code of: **1529** (arrow, Figure 4) **(OK)**: Reassemble in reverse order, Procedure is complete.
- If relay(s) **have** date code of: **1529** (arrow, Figure 4) **(NOT OK)**: Proceed to **Subject C**.

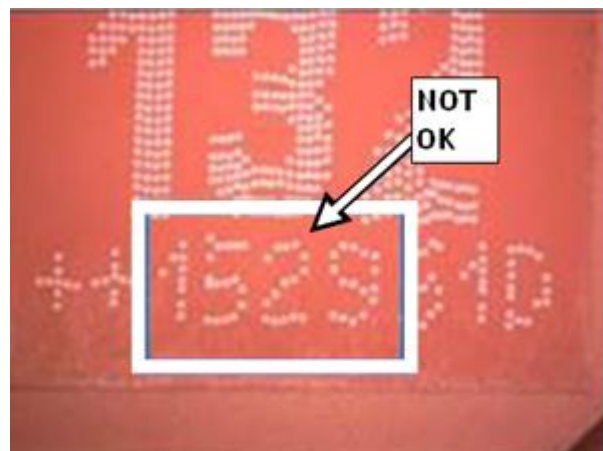
Figure 4 (Not OK) 1529 (15=year, 29=week)
