Model 222, model 463 with M176 engine low oil level, rough running and or misfire may be observed

Topic number LI01.00-P-068795

Validity 222 and 463 vehicles with M176 engine

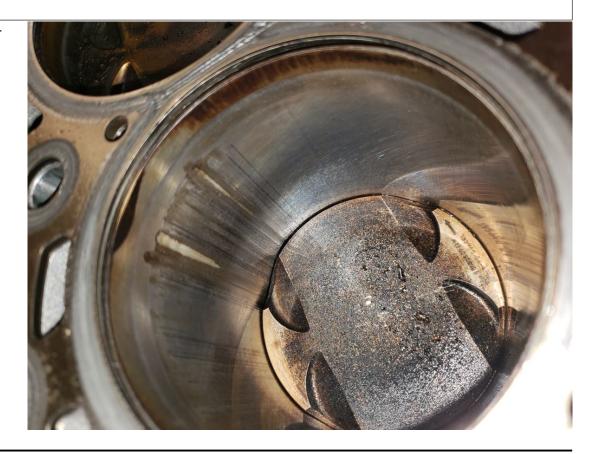
Cylinder #2 picture 1. JPG:

Attachments		
File	Description	
Cylinder #2 picture 1.JPG	cylinder wall head removed	
560 6.jpg	spark plug # 8	
BK560351.JPG	cylinder wall borescope picture	
spark plug close.JPG	spark plugs	
IMG_0798.jpg	piston damage

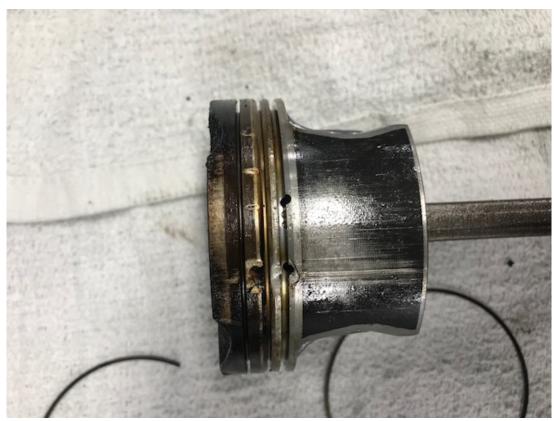
IMG_0798.jpg:

Piston assembly installation during production process may not meet specifications.
