Service Campaign Bulletin

Campaign No. 2015050004, August 2015

SUBJECT: **Model 222 (S-Class), Model Year 2014 - 2015**
Check Radiator Fan, Replace If Necessary

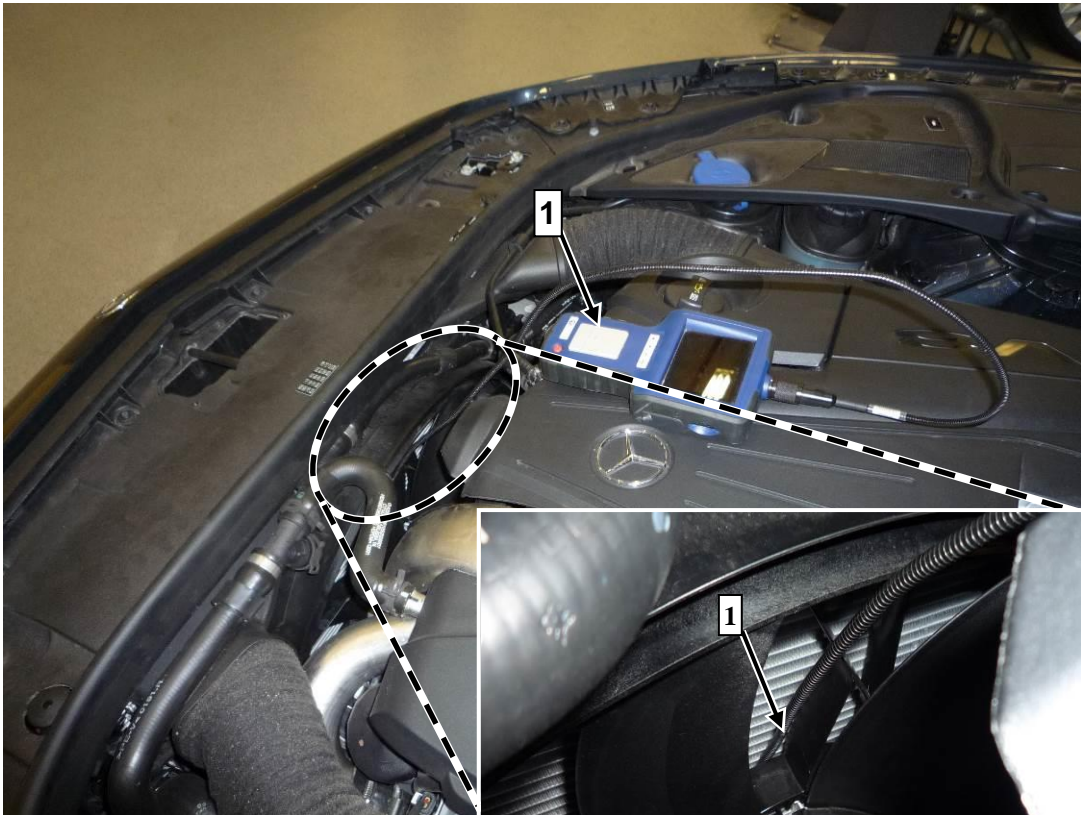
Figure 1

Check production date on radiator fan using bore scope (1, Figure 1):
Insert bore scope (1) with 5.5 mm viewer from above, between radiator and radiator fan.

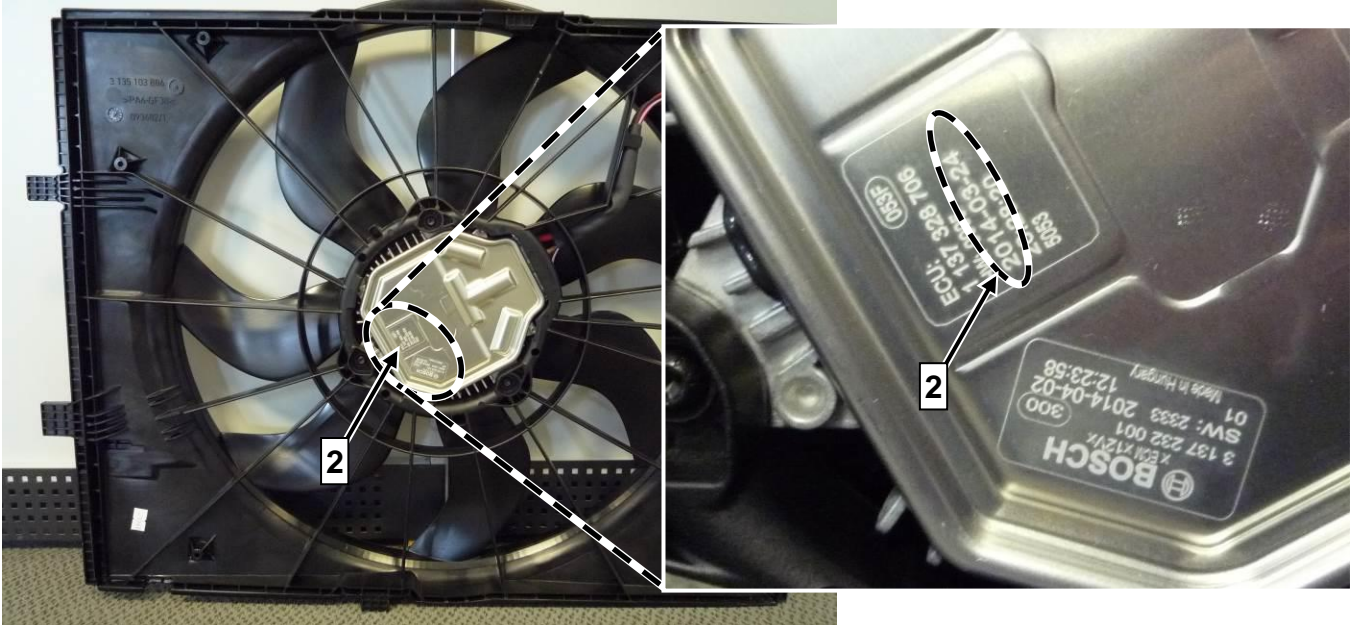
Figure 2

- Use only specified bore scope (refer to equipment table in this bulletin)
- The production date (2, Figure 2) is located in the lower section of the radiator fan motor (Figure 2).
- If **no** production date (2) can be found in the lower section of the radiator fan motor (**OK**):
Procedure is complete.

If **no** production date (2, Figure 2) can be found in the lower section of the radiator fan motor (OK): Procedure is complete.

Radiator fans with a production date **as of: 2013-04-22 up to and including 2013-05-08** (April 22 – May 8, 2013) or **as of 2013-10-11 up to and including 2013-10-15** (October 11 – October 15, 2013) **must be replaced (NOT OK).**

- If production date *is not* as of 2013-04-22 up to and including 2013-05-08 or as of 2013-10-11 up to and including 2013-10-15 (OK): Procedure is complete
- If production date *is* as of 2013-04-22 up to and including 2013-05-08 or as of 2013-10-11 up to and including 2013-10-15 (NOT OK): Proceed to step 2.
