# Service Campaign Bulletin

Campaign No. 2019030005, April 2019

SUBJECT: **Model S-Class and S-Class Coupe vehicles (217 and 222 platforms)  
Model Year 2018-2019**

**Check lock for trunk lid, replace if necessary**

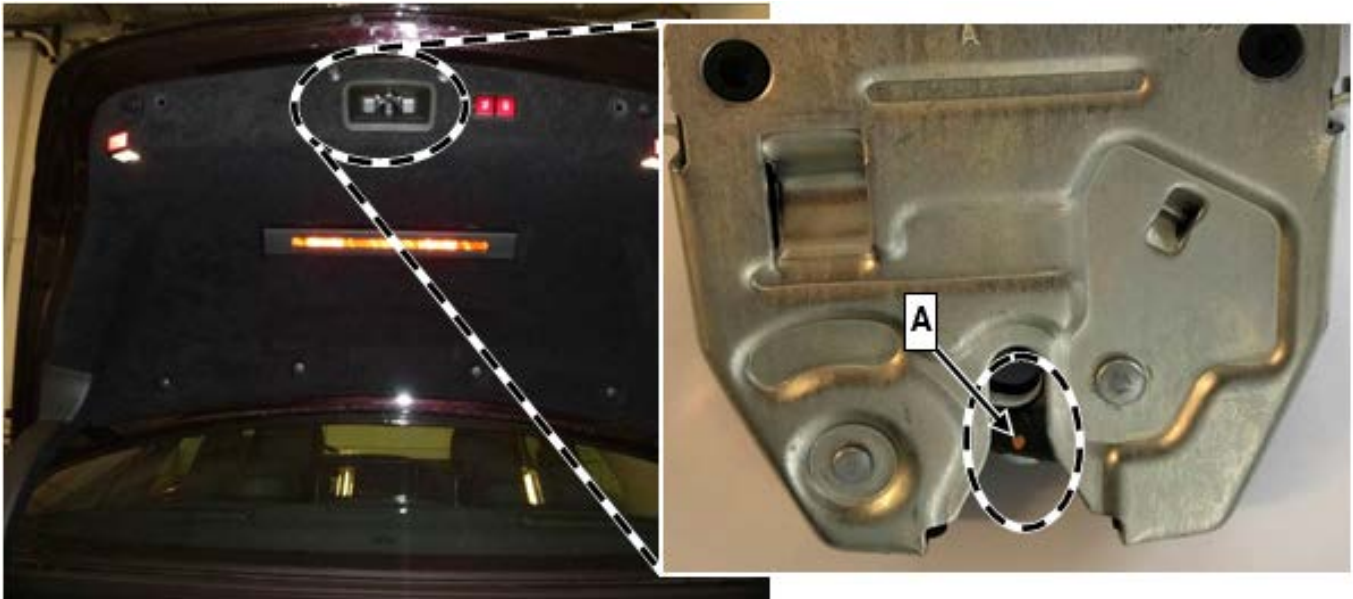
Figure 1

Daimler AG ("DAG"), the manufacturer of Mercedes-Benz vehicles, has determined that on certain Model Year ("MY") 2018-2019 S-Class Coupe, S-Class, and SL-Class vehicles (217, 222, and 231 platforms) the trunk locking mechanism may not meet production specifications. As a result the trunk may require repeated attempts to close. An authorized Mercedes-Benz dealer will check the locking mechanism and replace it if necessary.

1. Open the trunk lid and check the **orange** marking (A, figure 1) on the lock for the trunk lid.  
**i** To carry out the check, the lock must be locked using a suitable tool.

- a. **Orange** mark (A) on lock **not** present: Carry out **work procedure**.
- b. **Orange** mark (A) present on lock: **End measure**.
