Noises in area of front seat backrests

Topic number	LI91.10-P-057914
Version	1
Design group	91.10 Front seats
Date	12-20-2013
Validity	As of start of production - VIN WDD2221651A016968
Reason for change	
Reason for block

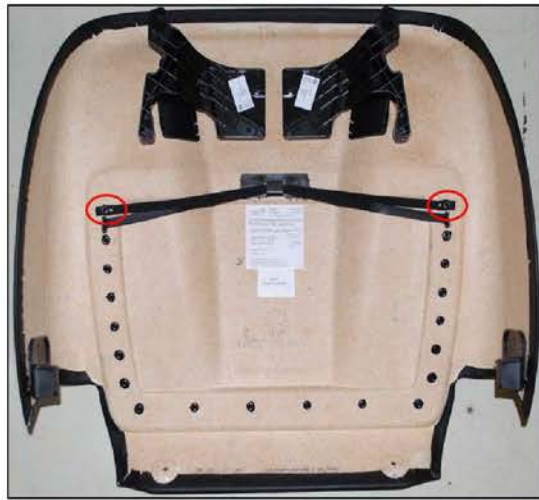
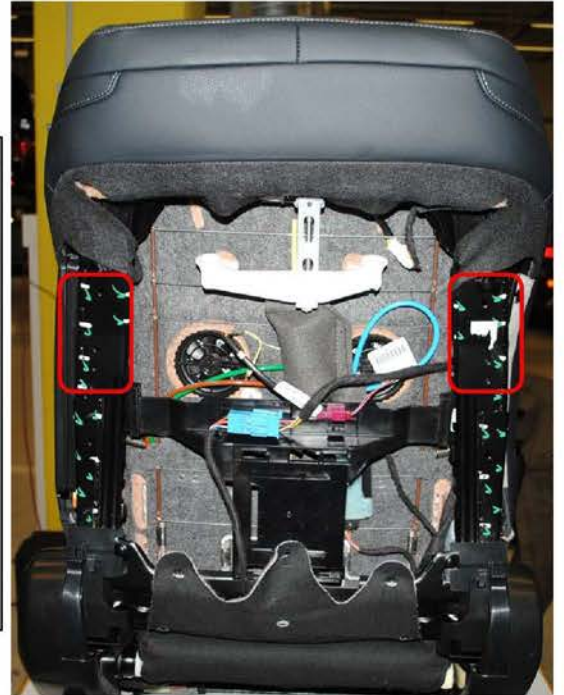
Pic1.jpg:

Contact between the upper rivets inside the backrest cover and the backrest frame (Pic1).

Attachments	
File	Designation
Pic1.jpg	View of noise source - Backrest cover/seat-back lining versus backrest frame

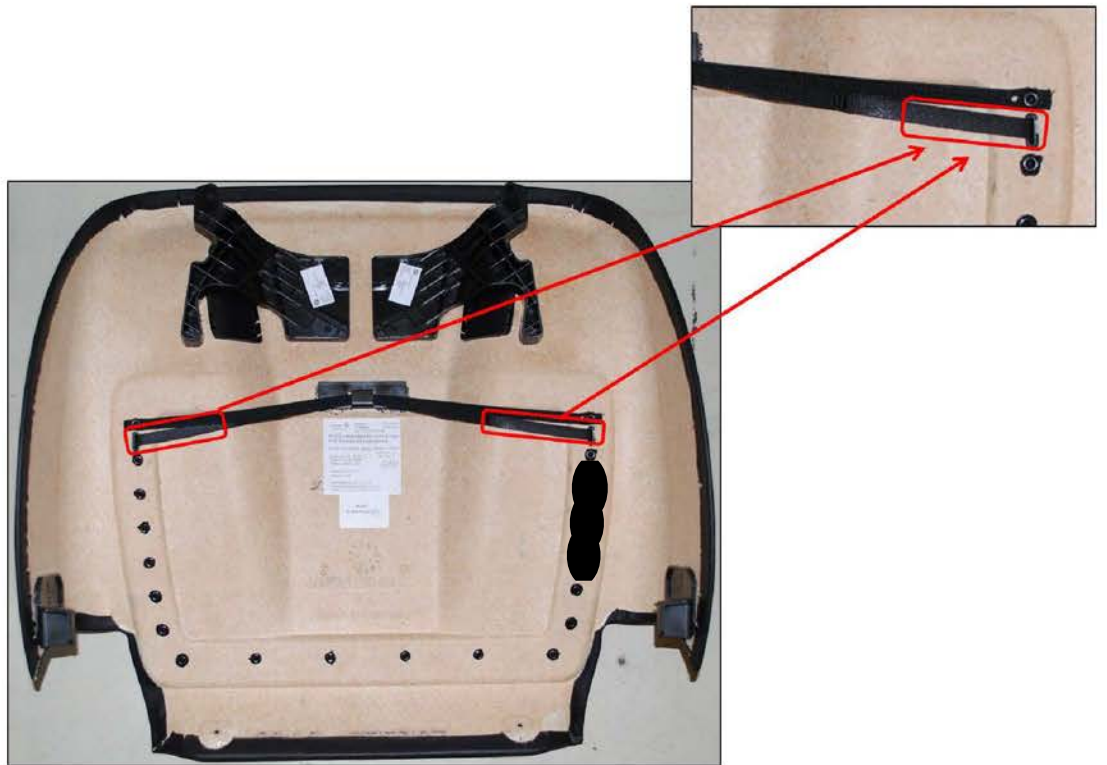
Pic3.jpg:

Caution: The felt must not touch or obstruct the rubber cable as shown in the picture (Pic3).
