## Throttle lift-off clunking noises at drive shafts of front axle

Topic number	LI33.30-P-056665
Version	7
Function group	33.30 - Final drive, differential, drive shaft
Date	12/7/22
Validity	Models: All Mercedes-Benz cars with front-wheel drive and 4x4 vehicles
Reason for change	Add Op code

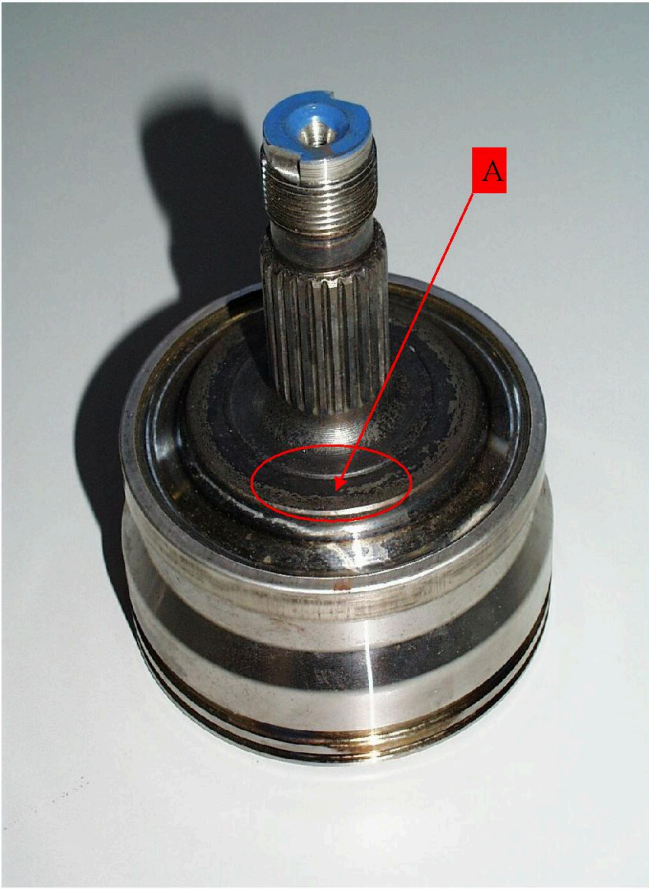
Attachments	
File	Description
<a href="#">Gelenkgehäuse aussen vor.jpg</a>	Before coating with Molykote paint

If the complaint is eliminated by experimentally loosening the outboard collar nut (by 1 turn), the concern is due to micromovement in the connection between the wheel bearing inner race and the joint housing of the side shaft.

1. Remove outboard side shafts (extract outer joint gearing from wheel hub)
2. Clean contact surface A (see image file in attachment "Outer joint housing before") before coating with Molykote paint (free of dust and grease)
3. Coat contact surface A (see image file in attachment "Outer joint housing after") with Molykote and leave to dry for one hour in removed condition
4. Reinstall side shafts

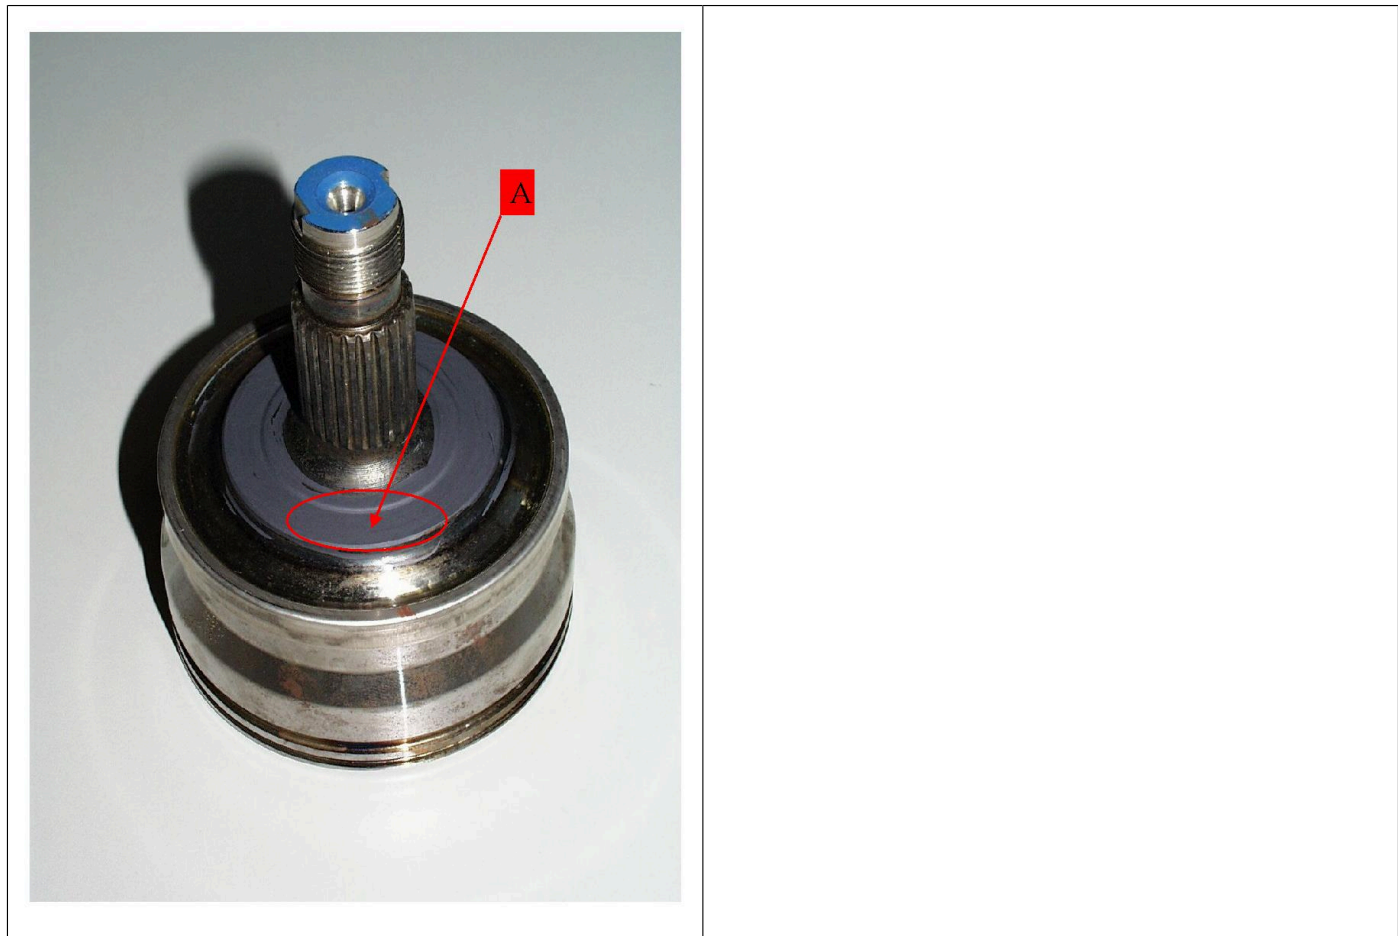
Gelenkgehäuse aussen nach.jpg

After coating with Molykote paint
