# Recall Campaign Bulletin

Campaign No. 2022030024, April 2022

SUBJECT: **Model S-Class (223 platform)**  
**Model Year 2021**

## **Check Airbag Control Unit Installation**

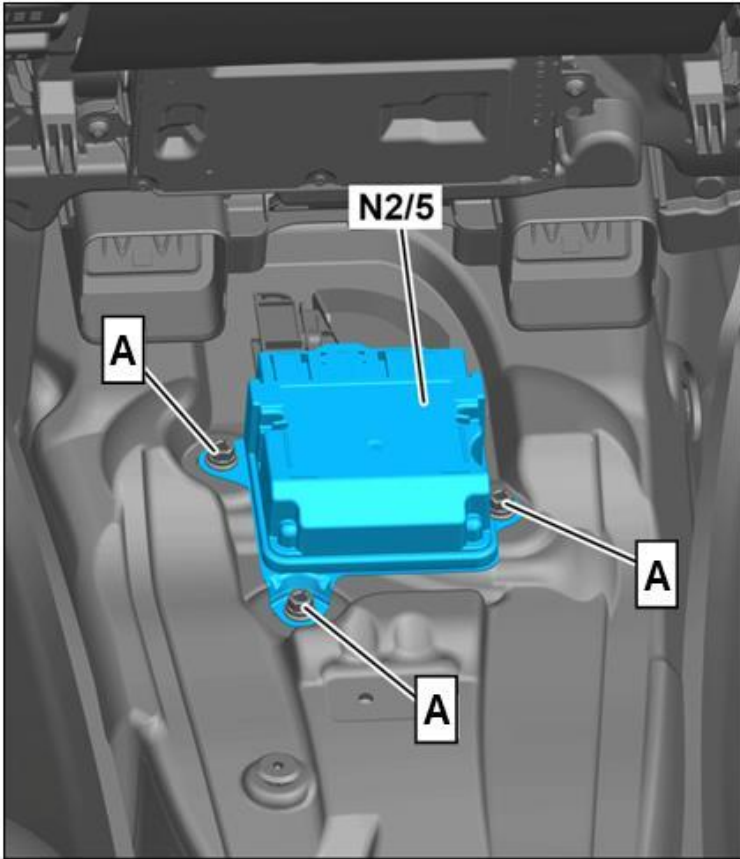
Figure 1

Mercedes-Benz AG ("MBAG"), the manufacturer of Mercedes-Benz vehicles, has determined that on certain Model Year ("MY") 2021 S-Class (223 platform) vehicles, the airbag control unit fastening nuts might not have been tightened according to current production specifications. This may cause the airbag control unit to detect incorrect acceleration values while driving. As a result, the restraint systems might deploy unintentionally in the vehicle. In addition, in the event of a crash, the restraint systems might not be activated as specified. Depending on the scenario, the risk of a crash or injury could be increased. An authorized Mercedes-Benz dealer will check the installation of airbag control unit fastening nut on the affected vehicles and correct it, if necessary.

1. Expose restraint system control unit until the three bolting points (**A, figure 1**) can be accessed.

1. Remove 3 nuts (**A, figure 1**) and check thread at threaded studs including the nuts.
  - a. Thread at threaded studs and nuts **without** damage:  
Carry out **work procedure A**.
  - b. Thread at threaded studs and nuts damaged:  
Perform **work procedure B**.

1. **Tighten** nuts at bolting points with **specified torque**.

Nut, restraint systems control unit to vehicle floor **10 Nm**

1. Completely remove restraint system control unit.
2. Replace threaded studs with damaged thread.
  - a) Remove lines as well as insulation mats in the repair area of the bodyshell screw bolt.

- f) Pre-drill hole and then drill with a **8.1 mm Ø** for positioning the new bodyshell weld stud.
  - g) Insert new bodyshell weld stud and weld on in a MAG welding process.
