Complaints About Noises or Poor  
Windshield Wiper Wiping Performance

Topic number	LI82.30-P-059239
Version	13
Function group	82.30 - Windshield wipers
Date	2/14/23
Validity	All passenger car model series
Reason for change	Addition of information regarding replacement of wipers
Reason for block	Addition of information regarding replacement of wipers

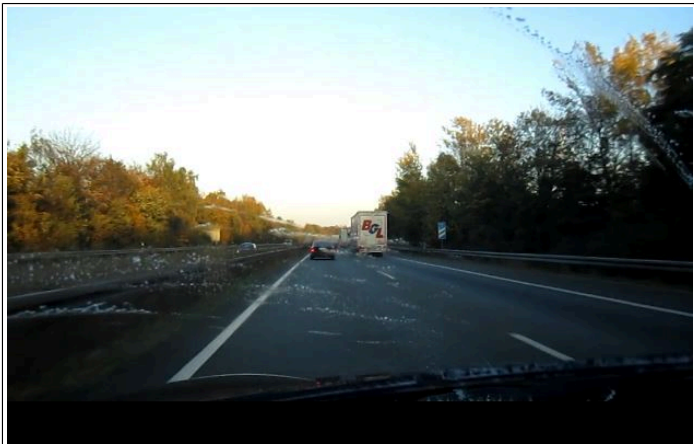
- A: Wiper blades squeaking
- B: Wiper blades shuddering
- C: Windshield not completely wiped (streaking)
- D: During downward movement, water is pulled back onto the windshield from the A-pillar (picture 1)
- E: After windshield cleaning, water keeps spraying onto the windshield for several wipe cycles (picture 2)

Water is pulled back onto the windshield by the differential pressure created as the wiper arm moves downwards.

Problem inherent in design for which there is no technical remedy.

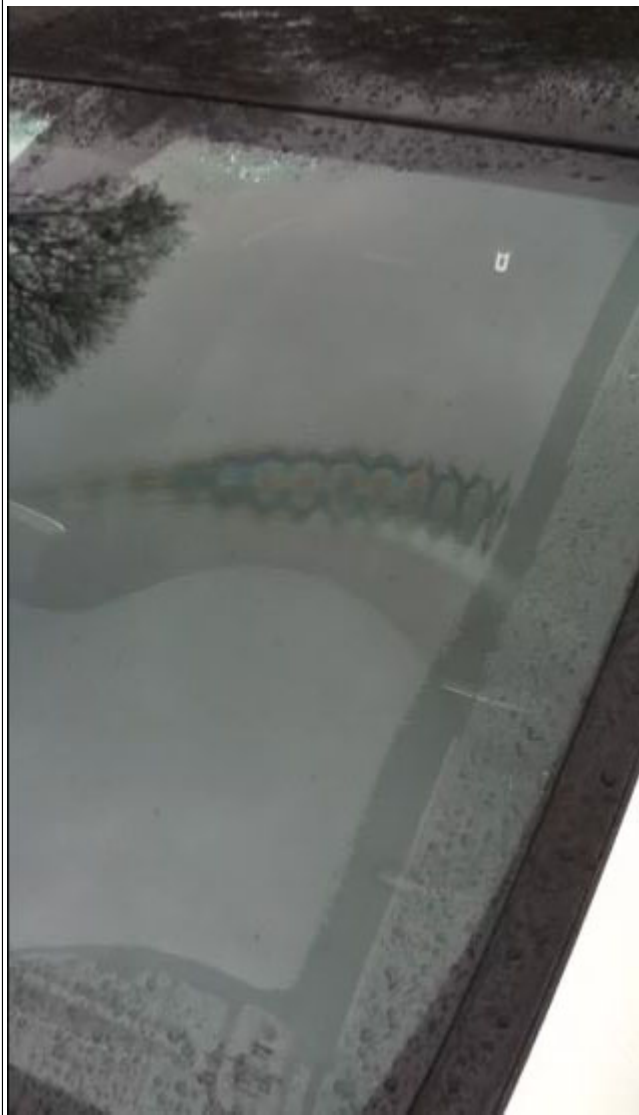
Bild 3.JPG

Streaking Due to Excessive Downforce of the Wiper Arm

C3: Clamping force of wiper arm not OK (picture 3)

C3: Check wiper arm for sluggishness in the bearing. Restore mobility or replace wiper arm if necessary.

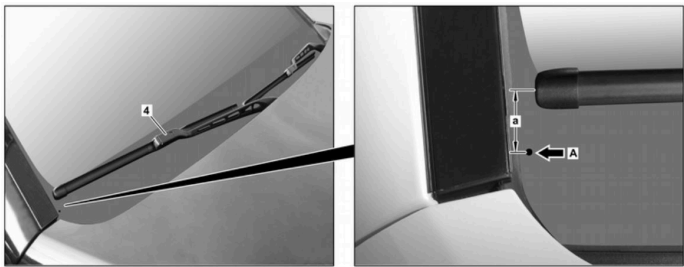
Attachments	
File	Description
<a href="#">Bild 4.JPG</a>	Park position of tip of blade on X204 passenger-side wiper arm with Top Lock

Exception: X204 up to 02/2014. In these vehicles it is possible to install the design configuration of vehicles as of 02/2014. This includes wiper arms (styled arms) with improved behavior in this respect. It is also necessary to replace the wiper blades because the styled arms feature a Top Lock connection (previously Side Lock). When installing the passenger-side wiper arm, observe the new park position (21 mm) via the marking on the windshield (Figure 4).
