Initial startup not possible after replacement of TRANSMISSION 725.0 or of electrohydraulic controller unit

Topic number	LI27.00-P-068206
Version	2
Function group	27.00 - General
Date	10/27/22
Validity	All vehicles with TRANSMISSION 725.0
Reason for change	Clarify Wording

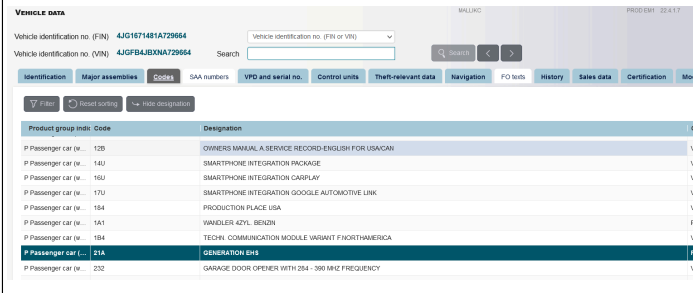
The wrong or the old SA code (Option code) is documented in VeDoc for the newly installed transmission or the newly installed electrohydraulic controller unit, EHS (ValveBody).

Attachments	
File	Description
VeDoc Code Location.PNG	Example of SA code as seen in VeDoc

Redocument the new SA code in VeDoc according to the EPC footnote for the transmission or electrohydraulic controller unit (EHS) ordered, and then perform initial startup.
