Noise From Front Seat Backrest Trim Strip With Code 735

Topic number	LI91.10-P-074890
Version	1
Function group	91.10 - Front seats
Date	5/27/22
Validity	Model series 223
	Only code 735 (Additional trim element scope)
	Cleanpoint 21.05.2022
Reason for change

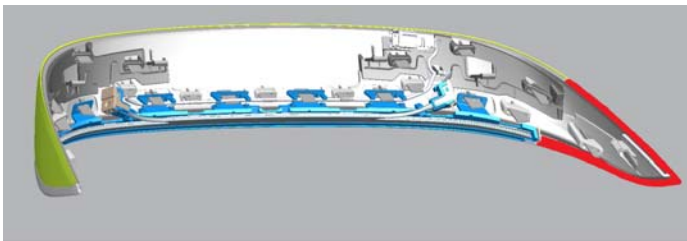
Attachments	
File	Description
Pic 1.png

Noise between inner side of trim element and seat-back lining

Narrow tolerance concept

Lubricate both ends of trim element using lubricant (A0009893660).

See red marking in attachment, Pic 1 / Pic 2
