# TrueFrame™ REPORT

## COMPREHENSIVE VEHICLE CONDITION REPORT

Model S CLASS S63 AMG

Inspection No. 123653

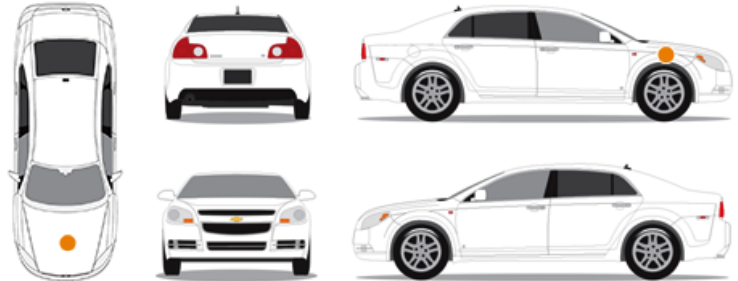
### Cosmetic Inspection

The highlighted points on this vehicle diagram indicate the general areas on the vehicle where our inspection found either prior repairs or existing cosmetic issues. These issues are not structural in nature and are considered to be purely cosmetic.

Condition
Front Bumper Cover	Original
Hood	Refinished
Left Fender	Original
Left Front Door	Original
Left Rear Door	N/A
Left Cosmetic Rocker	Original
Left Cab Corner	N/A
Left Quarter Panel	Original
Left Bedside	N/A
Roof	Original
Left Roof Rail	Original
Right Roof Rail	Original
Rear Bumper Cover	Original
Deck/Liftgate/Tailgate	Original
Right Fender	Refinished
Right Front Door	Original
Right Rear Door	N/A
Right Cosmetic Rocker	Original
Right Cab Corner	N/A
Right Quarter Panel	Original
Right Bedside	N/A
Cladding/Mirror Housing	N/A
