Date: November 24, 2008
 Order No.: **P-B-32.50/34e**
 Supersedes: P-B-32.50/34d September 16, 2008
 Group: 32

SUBJECT: Model 215.373/374/375/376/378/379
Model 220.170/173/174/175/176/178/179, Equipped with Code 487 (Active Body Control)
Model 230.474/475/476/479
Vehicle Level Lowers After Being Parked

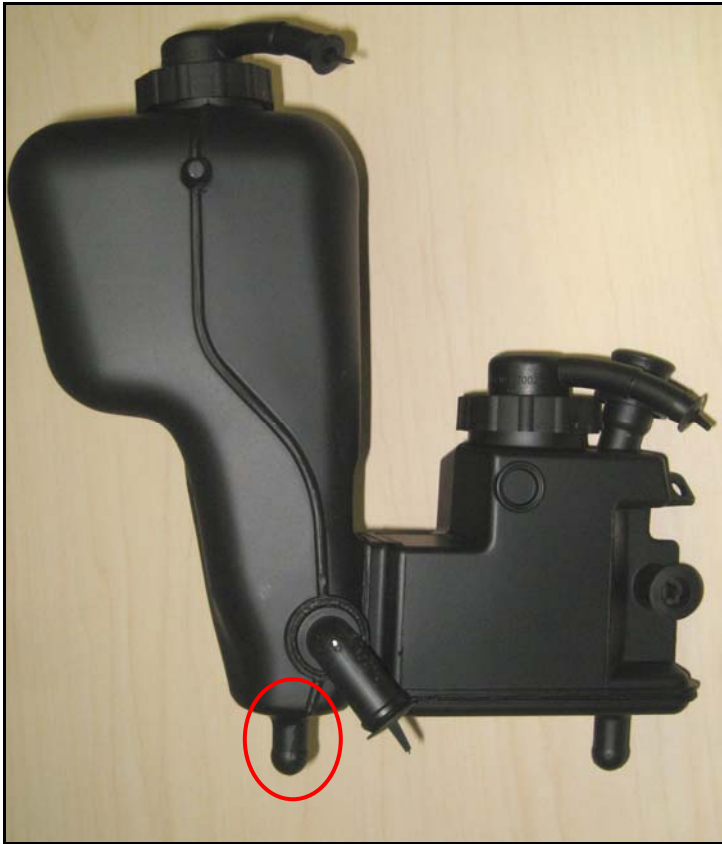
Figure 1

1. Clean the oil reservoir, especially the lower portion of tank which has a small "tit" (Figure 1, circle) which can get a build-up of debris. You may need to pick the debris out of this area. Refer to WIS document GF32.50-P-4900A.
