Service Campaign Bulletin

Campaign No. 2005060011
September 2005

SUBJECT: **MODEL 171/211/215/219/220/230, MODEL YEAR 2003-2006**
DIRECT MAIL DISTRIBUTION OF NAVIGATION DVD FOR COMAND

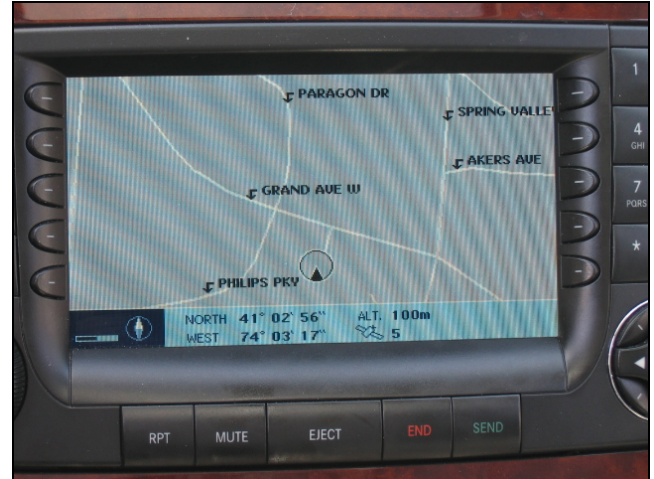
Figure 1 COMAND Display after pressing MAP key

3. Turn COMAND on by pressing the power button. (If not already on.)
4. After COMAND is up and running, press the “MAP” key on the left side of the screen once or twice until the map is displayed. See Figure 1 for a sample display.

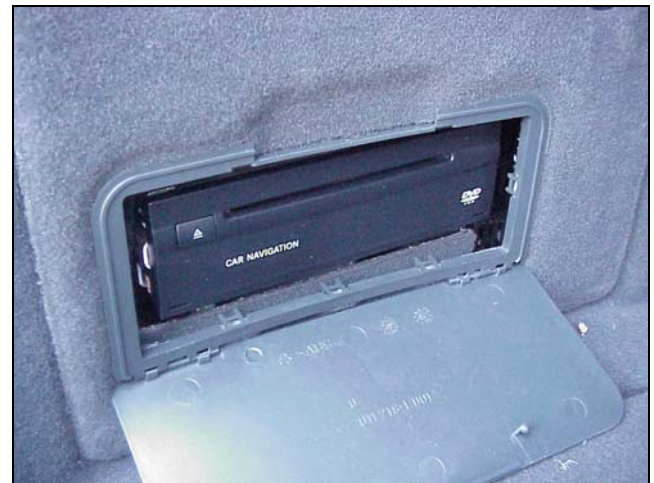
Figure 2 Remove DVD from Car Navigation Drive

5. **All Models Except SLK:** Open the trunk and locate the navigation disk drive, on the left hand side. The drive should be hidden by a rectangular access cover. Twist the knob and open the cover. The disk drive is labeled **CAR NAVIGATION**. See Figure 2.
SLK Models: In the SLK the drive is located in the center of the trunk below the luggage cover for the retractable roof.

6. Press the eject button, on the left side of the drive to remove the existing DVD. This DVD will no longer be used and should be discarded.

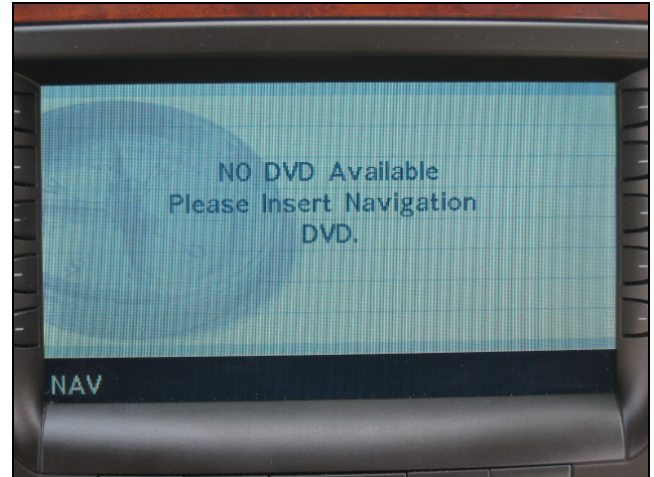
Figure 3 COMAND Display with DVD removed

- Once the old DVD is removed, the display on the COMAND screen should look like Figure 3.

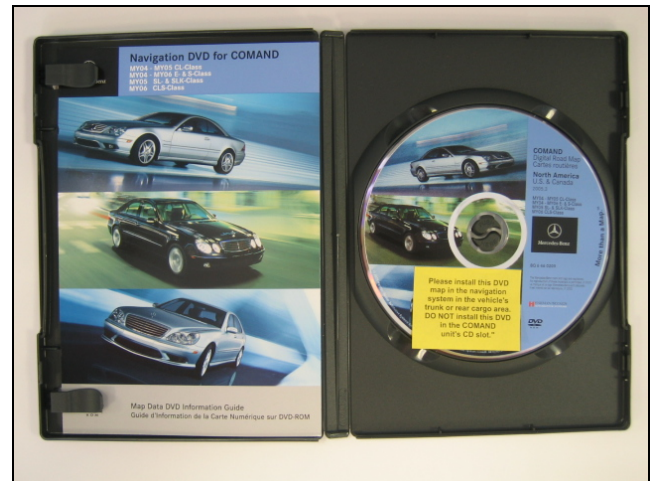
Figure 4 New Version 2005.3 DVD

- Locate the supplied navigation DVD (Version 2005.3), read and then remove the yellow Post-it[®]. Note. **DO NOT** insert the DVD with the Post-It[®] attached as this will damage the drive.
- Carefully remove the DVD from its package handling the DVD only by its edge.

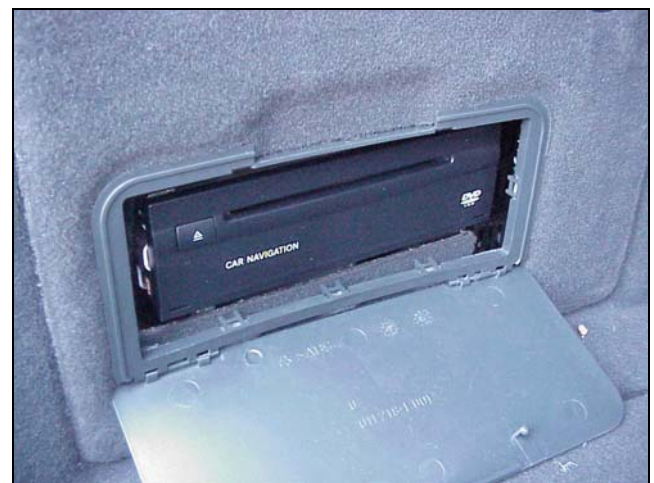
Figure 5 Insert DVD into Car Navigation Disk Drive

- Insert the new DVD into the **car navigation** disk drive, in the trunk and close the access cover (except SLK).

- DO NOT** insert the DVD with the Post-It[®] attached as this will damage the drive
- The new DVD needs to remain in the disk drive at all times for operation of the navigation system.

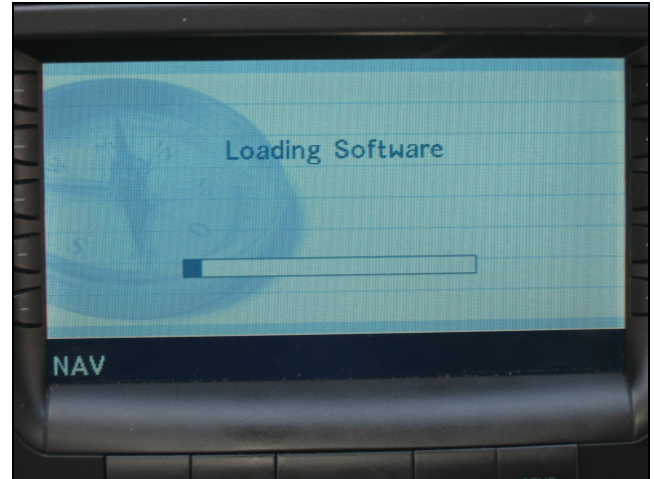
Figure 6 COMAND Display during software update

11. The update process should take only a few minutes.
12. During the software update process you will see a progress bar displayed on the COMAND screen. (Figure 6)
13. **DO NOT PRESS ANY BUTTONS OR OPERATE ANY VEHICLE CONTROLS DURING THE UPDATE PROCESS! FAILURE TO COMPLY WITH THIS STEP MAY RENDER THE NAVIGATION SYSTEM INOPERABLE.**

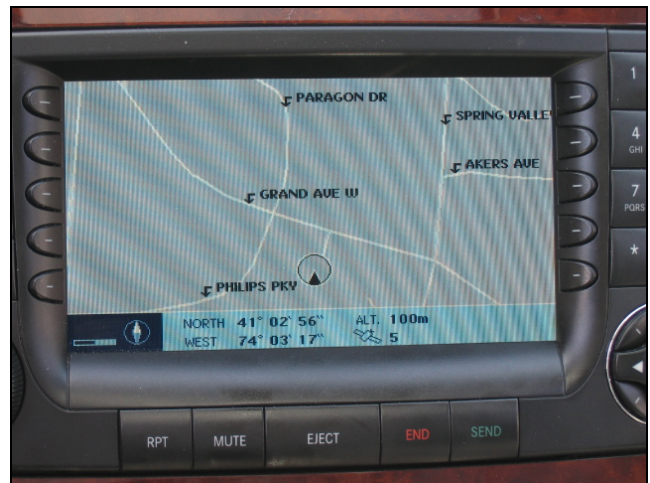
Figure 7 COMAND Display after position is reacquired

14. When the update process is complete the progress bar is no longer shown.
15. Switch the vehicle off, remove the key, exit the vehicle, and lock the car.
16. Wait at least 5 minutes before re-entering the vehicle.
17. Enter vehicle and restart the engine.
18. The current vehicle position should be displayed in about 5 - 30 minutes; depending on environmental conditions and time of day. (Figure 7)
