Service Campaign Bulletin

Campaign No. 2007010004, March 2007

SUBJECT: **MODELS 211, 219, 221, 230, X164**
MODEL YEAR 2007
CHECK INTAKE MANIFOLD AND REPLACE IF NECESSARY; INSTALL UPDATED
ENGINE CONTROL MODULE SOFTWARE (M273 ENGINE)

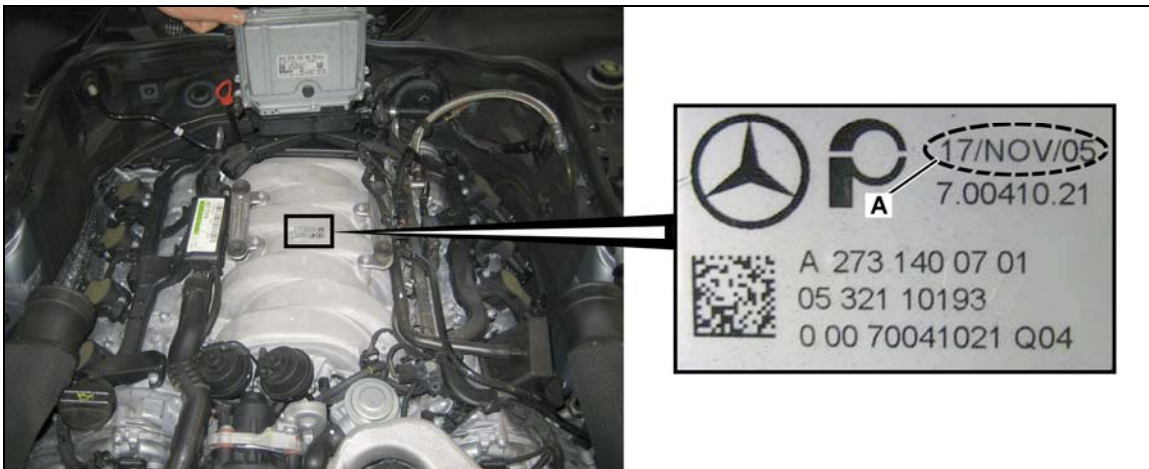
Figure 1

1. Remove both engine air intake ducts.
2. Model X164 only: Remove strut tower brace; refer to WIS document AR62.30-P-2500GY.
3. Remove air filter housing; refer to one of the following WIS documents, depending on vehicle model:
 - Model 211/219: AR09.10-P-1150TS
 - Model 221: AR09.10-P-1150SX
 - Model 230: AR09.10-P-1150RX
 - Model X164: AR09.10-P-1150GZA.
4. Detach engine control module from bracket, keeping electrical connectors connected.
5. Check production date of intake manifold (A, Figure 1).

6. Perform one of the following:
 - Manifold production date up to and including 30/SEPT/05: Proceed to Subject **B** to replace manifold.
 - Manifold production date between (and including) 01/OCT/05 and 28/FEB/06: Proceed to Subject **C** to install engine control module software.
